**Godre'r Graig Primary School, Godre'r Graig
Preliminary Landslide Hazard and Risk Assessment**

Report Reference: ESP.7234e.3221

Godre'r Graig Primary School Preliminary Landslide Hazard and Risk Assessment

Prepared for:
Neath Port Talbot County Borough Council
 The Quays, Baglan Energy Park,
 Brunel Way, Briton Ferry,
 SA11 2GG

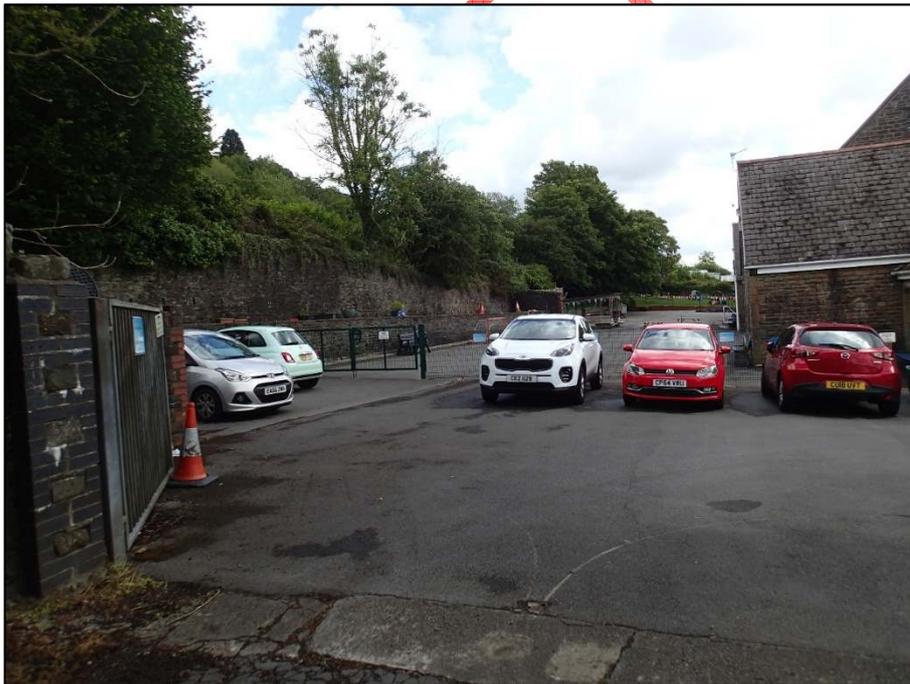
The elements at risk are the school building (temporally and spatially fixed) and the population of the school (temporally and spatially variable). The school was built between 1899 and 1918 (Section 4.3) and is of masonry construction. The school playground is located at the rear of the school below a masonry retaining wall (Plate 1).

Plate 1: Retaining wall between the school playground and the natural slope.

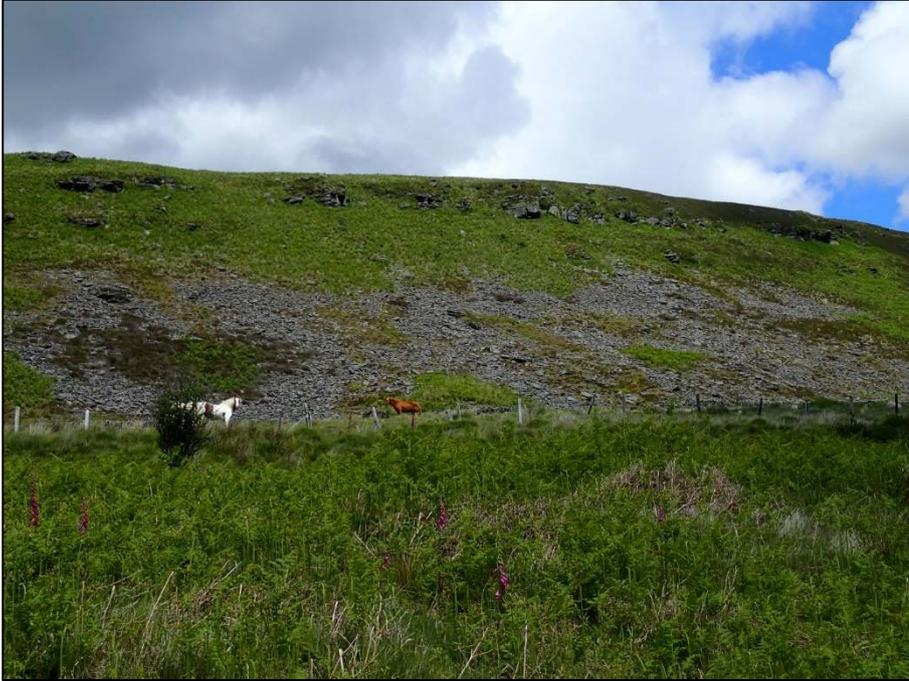
The highest terrain is formed by Mynydd Allt-y-grug which rises to a height of 338mOD. The summit is relatively gently sloping. A sharp convex break in slope is present at approximately 292mOD associated with a linear rock outcrop below which the terrain is steep (25-30°) and associated with limited vegetation and a talus drape. A dry stone wall is present at the toe of the talus slope and there was no evidence of damage to the wall from rock fall nor any evidence of repairs resulting from rock fall.

Plate 2: Rock outcrop (Rhondda Sandstone) with the associated talus slope below.

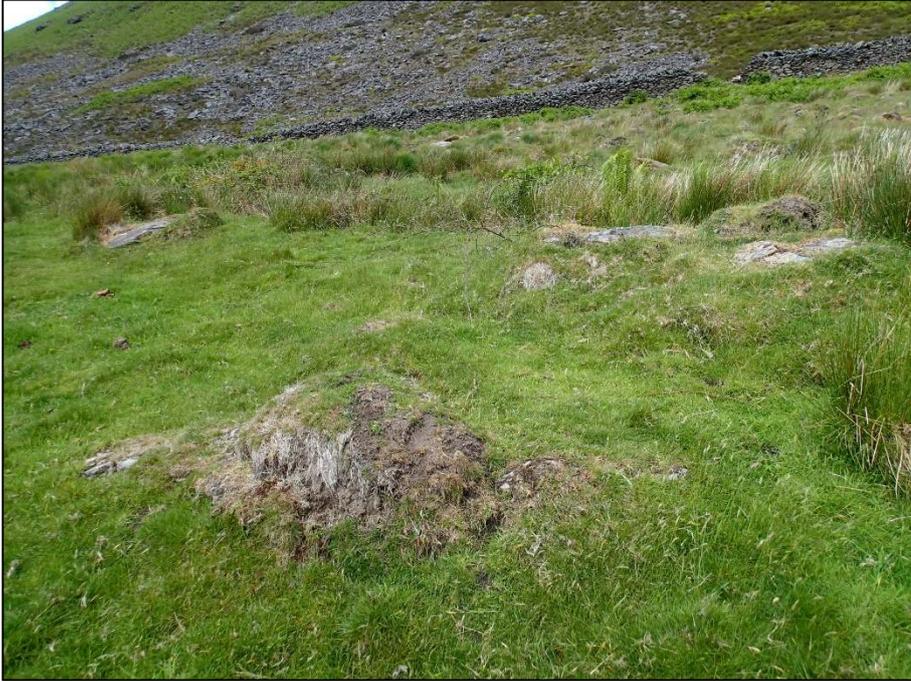
Larger individual blocks (rock falls) are present extending further downslope from the talus drape, the largest of which is 0.2m x 3.0m x 2.0m. A number of the features initially identified as rock blocks from the API actually comprise soil mounds (Plate 3). It is considered that the generation of large rock falls was probably associated with periglacial conditions at the end of the last ice age (apx 11, 700 years BP) and consequently the main trigger for rock fall processes is no longer active. Smaller falls of cobble size blocks may still occur although again this process would have predominantly been active during periglacial conditions.

Plate 3: Soil mounds and rock blocks below the talus slope

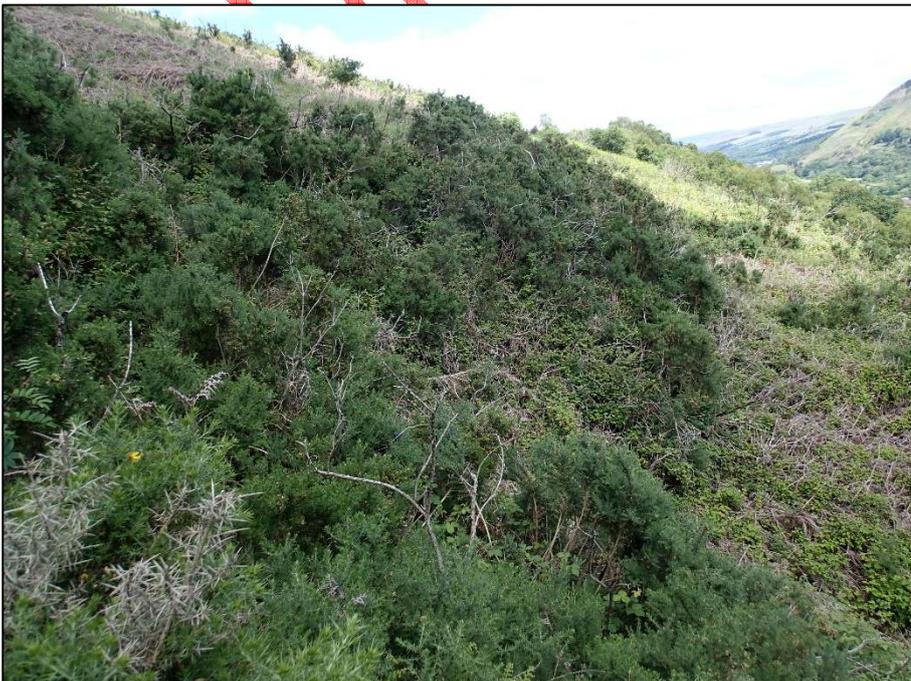
The base of this steeper terrain is marked by a distinct concave break in slope which corresponds to the outcrop of the No2 Rhondda coal seam at the base of the Rhondda Sandstone. Coal workings are evident in the form of adits and associated spoil in the NE of the study area, with the working of the seam apparently evident in the 1973 and 1975 aerial photographs. Below the No 2 Rhondda the Llynfi Beds are present, comprising alternating sandstone and mudstone resulting in stepped topography. The published geological map shows the Upper Pinchin Coal seam as outcropping at approximately 178mOD. This is associated with over steep, anthropogenically modified, terrain as well as a series of adits reflecting its historical working (Plate 4).

Plate 4: Anthropogenically modified over steep slope and location of a formed adit

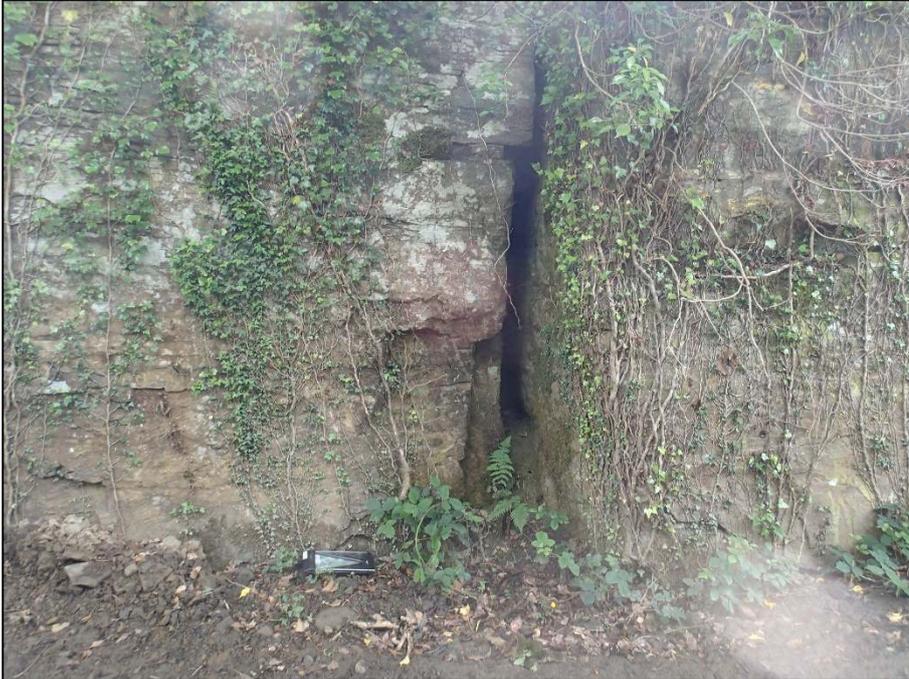
Two abandoned quarries are also present located above the outcrop of the Upper Pinchin. These are shown on the earliest historical maps (1877). Both quarries are associated with spoil heap with extend down slope. The Llynfi Beds are exposed at the Quarry to the NW of the School comprising weak to medium strong, thinly bedded, dark grey, partially weathered to unweathered, micaceous sandstone. Bedding dips at 20/185. Two additional discontinuity sets were observed 84/274 with an approximately 1m spacing and 74/018 with a spacing of approximately 5m. The latter set is dilated with an aperture of up to 10cm (Plate 5), reflecting either the effects of mining or cambering.

Plate 5: Bedding dipping from left to right (20/185) the rock face is formed by joint set 84/274 and the dilated joint set is formed by 74/018.

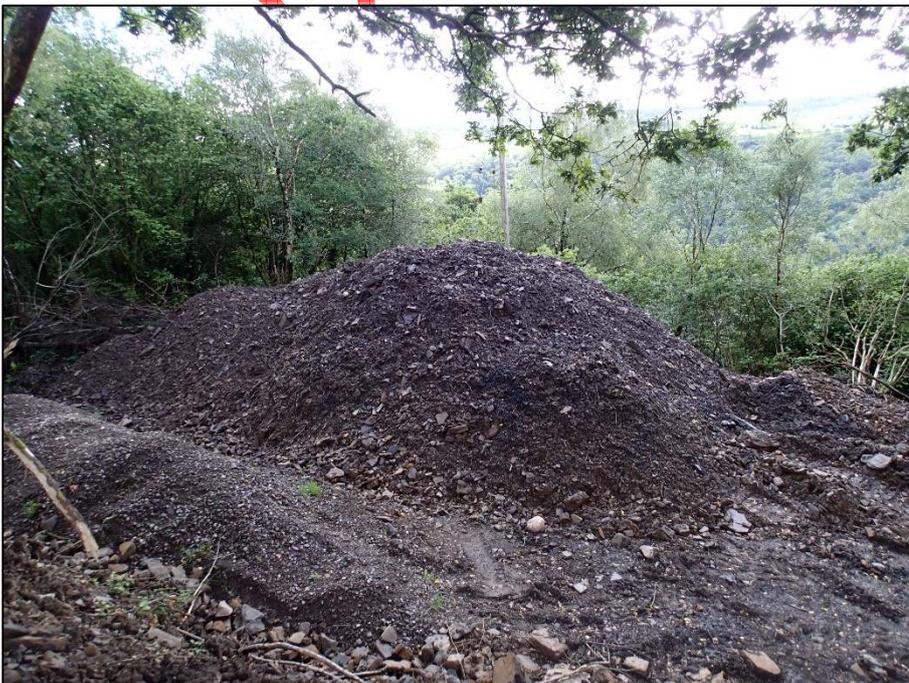
Plate 6: Recently deposited spoil from work in the quarry to the NW of the School.

Recent works have been undertaken in the NW quarry with an improved access road constructed. Spoil from this work has been end tipped below the quarry entrance (Plate 6).

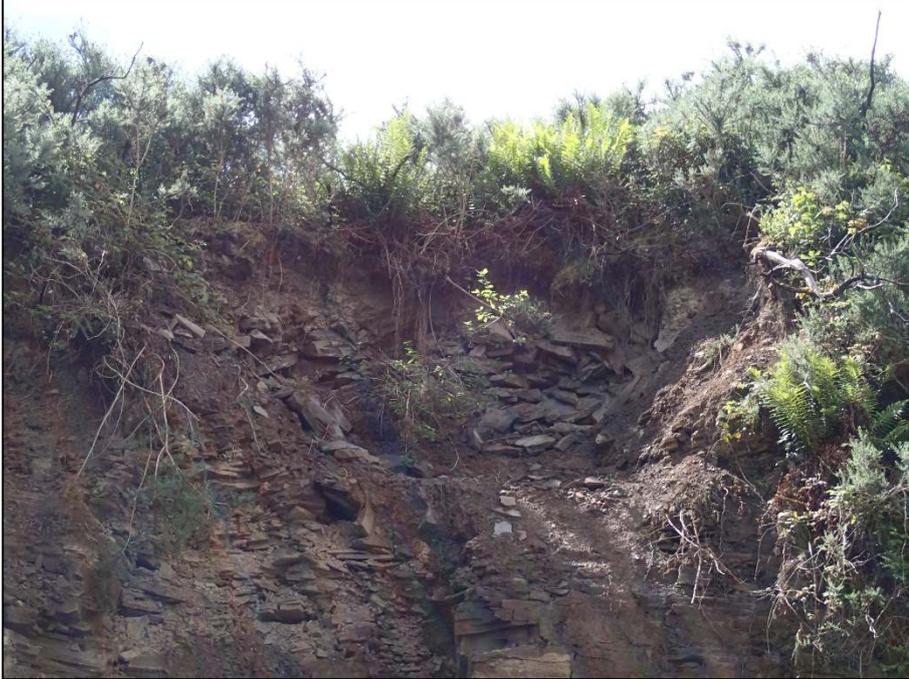
Based on the exposure in the NW quarry, the spoil comprises interlocking, angular and tabular boulders and cobbles of weak to medium strong sandstone (Plate 7). The spoil associated with both quarries is associated with very dense vegetation, especially brambles limiting access.

Plate 7: Spoil exposed in the NW quarry

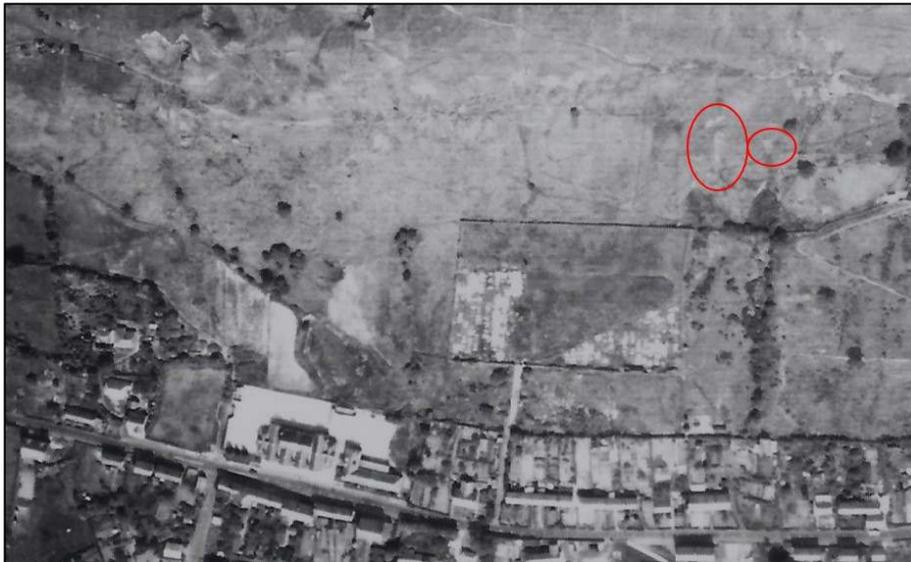
There was very limited evidence for previous landslides from the API. These possible landslides were tentatively identified in the 1952 aerial photographs (Insert 5). Three arcuate depressions are located below these features that, based on the API, were considered to have been possible formed by landslide processes.

Insert 5: Extract from 1952 photograph with possible landslides circled

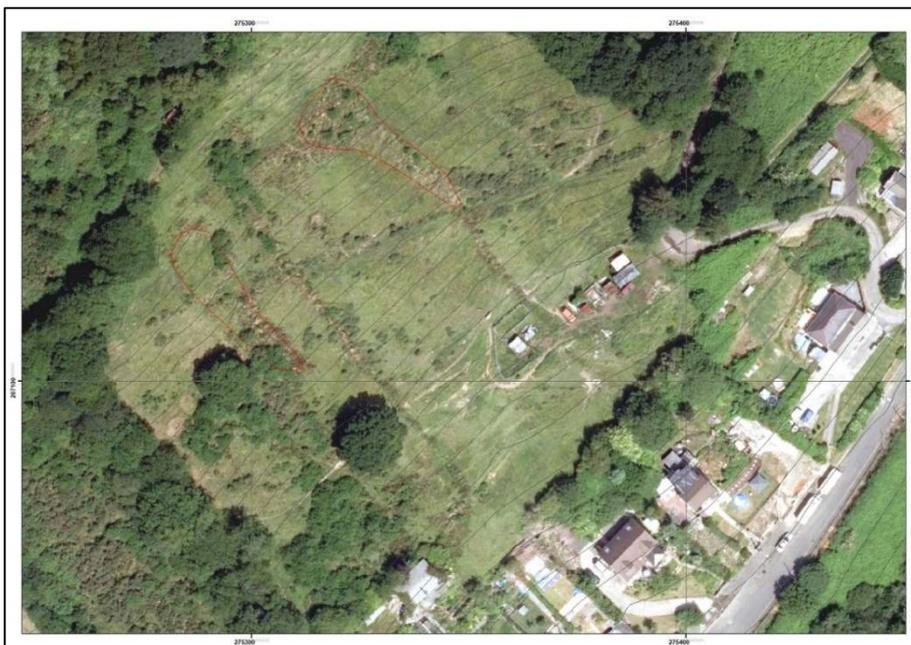
The “shallow slips” recorded on the geological map are not apparent on the historical aerial photographs. However, two areas interpreted as being associated with hydrophilic vegetation are evident in the 2013 orthophotograph (Insert 6).

Insert 6: Enlargement of 2013 Orthophotography showing possible landslides identified in the area of “shallow slips” recorded on the geological map

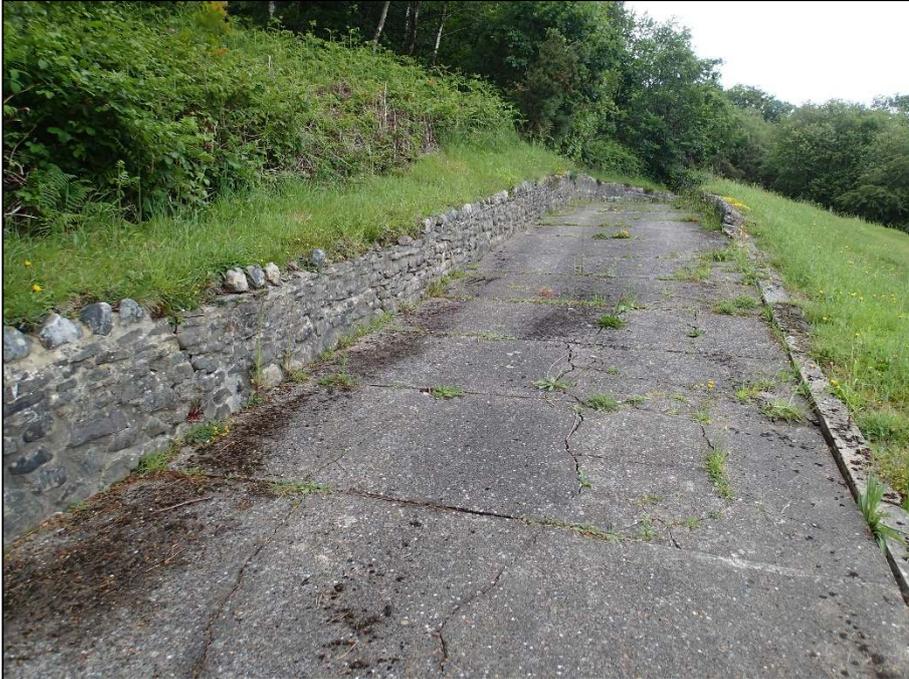
The area of “shallow slips” comprises a series of shallow depressions associated with springs and hydrophilic vegetation. A small cut slope 0.2m – 0.3m high, associated with a former tramway crosses the toe of these features. This exposes of clayey silt with occasional sub angular, medium to coarse gravel which has been interpreted as colluvium. There is no evidence of movement in this cut slope. Shallow (<0.2m) earthslides/earthflows may be associated with these depressions. This terrain extends across the study area to the SW and instability, in the form of a distressed

road (Plate 8) and a shallow depression, was noted within the cemetery at approximately the same level. At the rear of the School there was no evidence of landslides or distress. However, terracettes suggesting very shallow soil movement and wet ground is present.

Plate 8: Distress evident in the upper part of the cemetery.

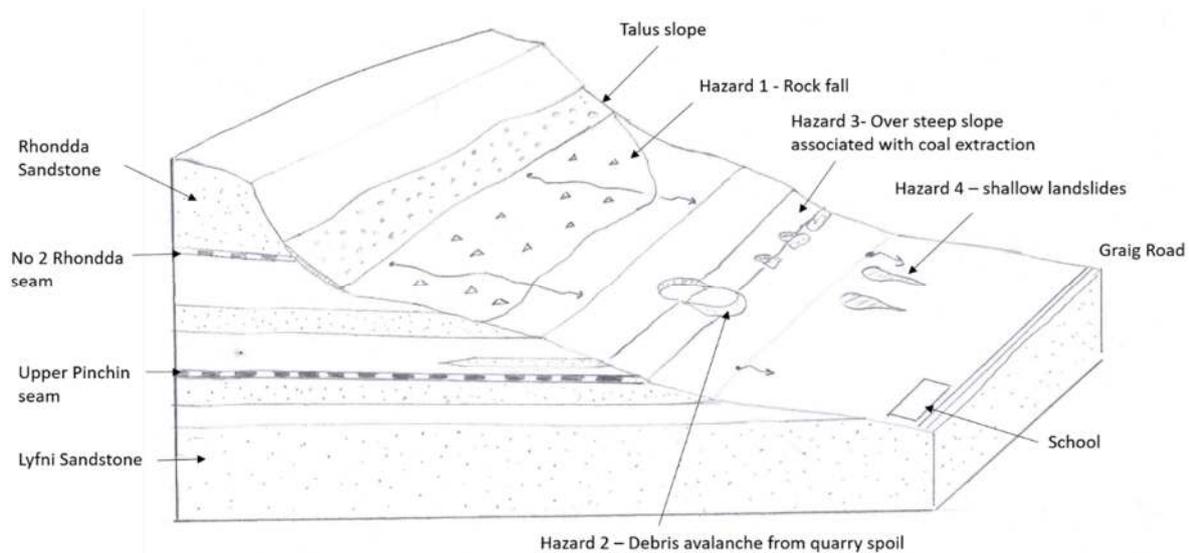
Based on the initial API, four possible hazard types were identified (Insert 7):

- Hazard type 1. Rock fall;
- Hazard Type 2. Debris avalanche initiating from quarry spoil;
- Hazard Type 3. Debris avalanches initiating from over steep slope; and
- Hazard Type 4. Shallow earth slides.

Insert 7: Conceptual Engineering Geological Model of site from API
