**The Coal  
Authority**

## **Site Inspection Report**

### **L44 – Godre’r Graig Tips**

**Date: July 2019**

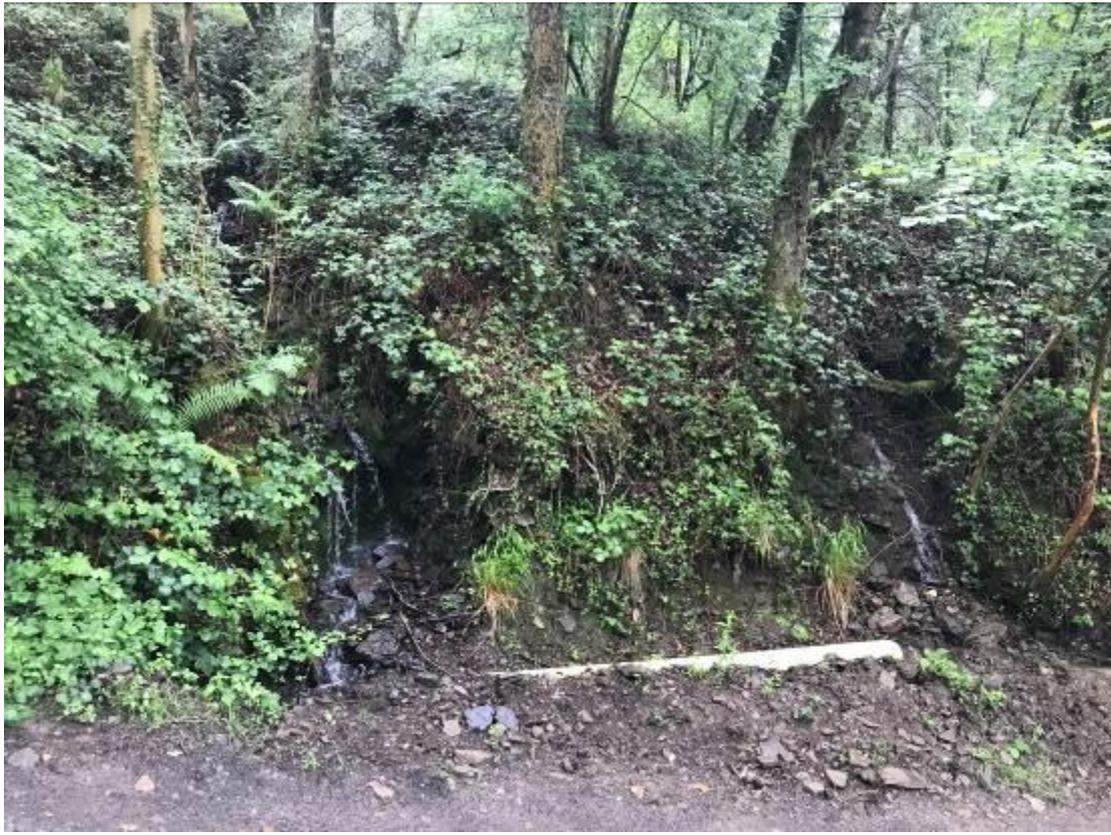
Inspection on the 13<sup>th</sup> June 2019 began at the south-western extremity of Site 1, at the access track leading to Pentwyn Farm and the entrance to Cwar Pentwyn (photographs 1 and 2). It was noted that flows from the mine adits above were entering the roadside drainage channel along the Pentwyn Farm access road (photograph 3). The quarry access track was well used and mounds of what appeared to be quarried material were present over the location of the mine adits and the colliery spoil tip to the south of the track (photographs 4, 5 and 9).

**Photograph 3 – Flows from adit positions to Pentwyn Farm access track**

- Investigate activity within Cwar Pentwyn to establish if planning or quarry regulations have been breached.
- Ensure drainage system from adit positions at Cwar Pentwyn is maintained.

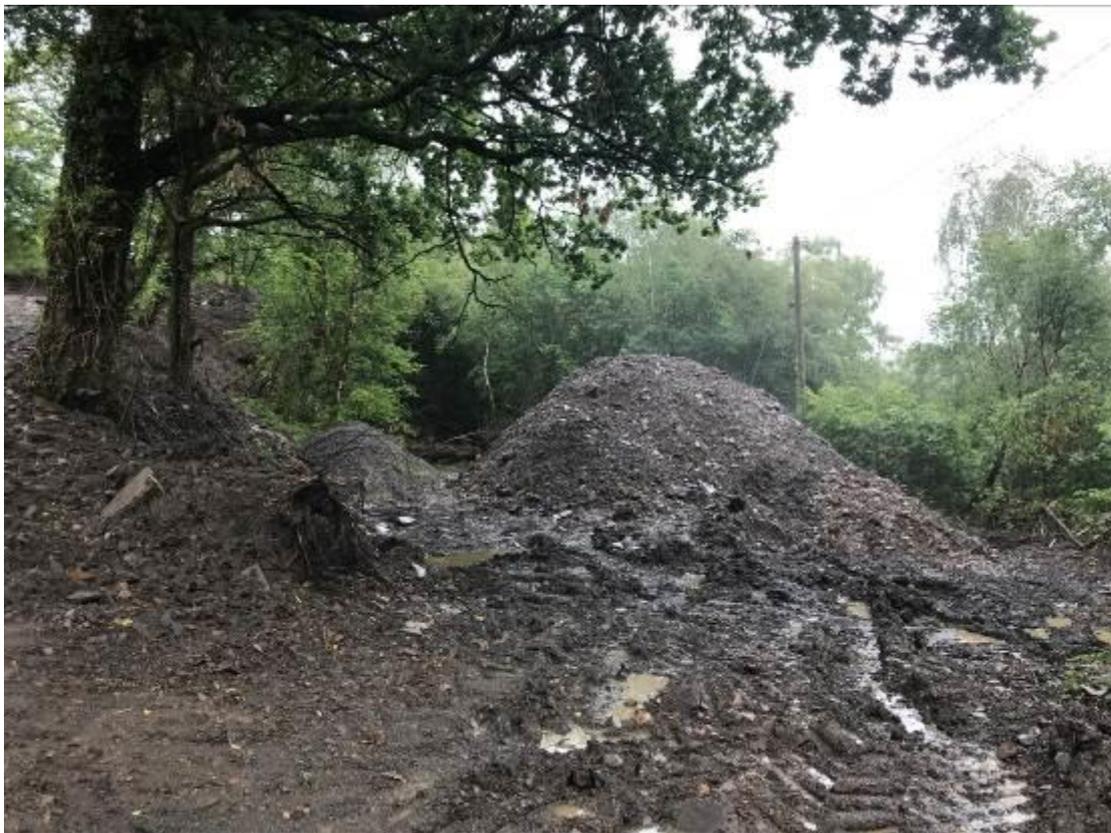
Very little evidence of recent instability was observed, with the exception of a small degraded shallow slip at approximate NGR 274910E 206861N and occasional areas of soil creep. Surcharging of existing historic colliery and quarry spoil materials could take place following recent deposition of materials. A significant failure of the spoil heaps would impact on the access road to Pentwyn Farm and the properties along the access road. Blockage of the water course emanating from the mine entries could lead to a build-up of pore pressure and saturation of the spoil, leading to failure.

**Photograph 4 – Recent tipping of material at Site 1**

- Investigate ownership of Site 1 and establish what measures, if any, have been taken with regard to placing recent materials over historic spoil materials.

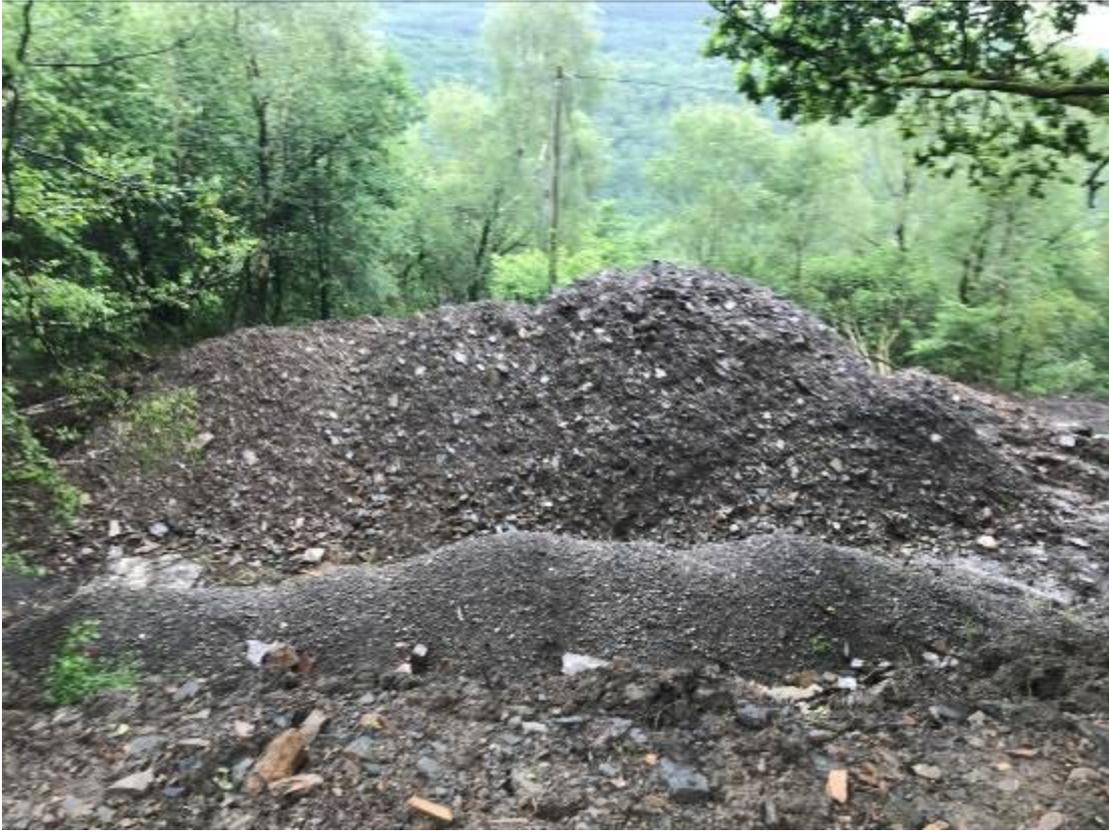
**Photograph 5 – Recent tipping of material at Site 1**

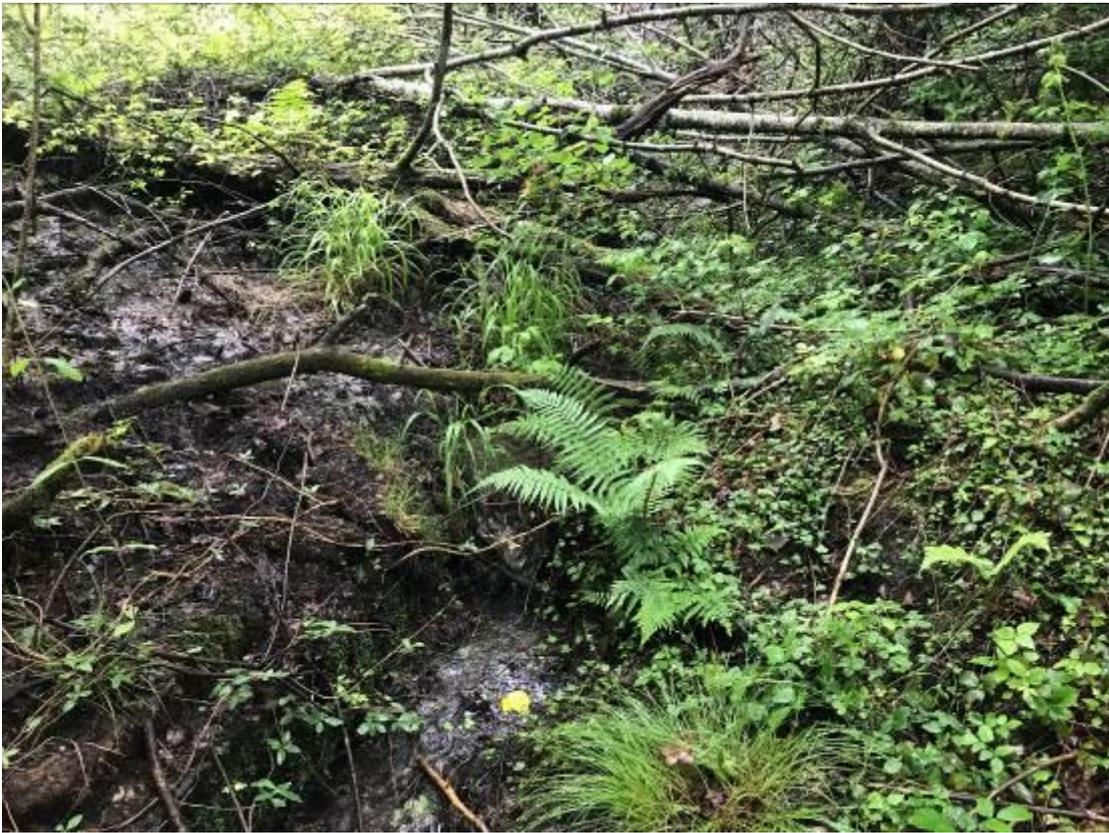
The recorded adit positions in this area were evidenced by flows entering a partially lined channel, conveying water to the roadside channel along Pentwyn Farm access road (photographs 6 and 7).

**Photograph 6 – Discharge from adit positions at Site 1**

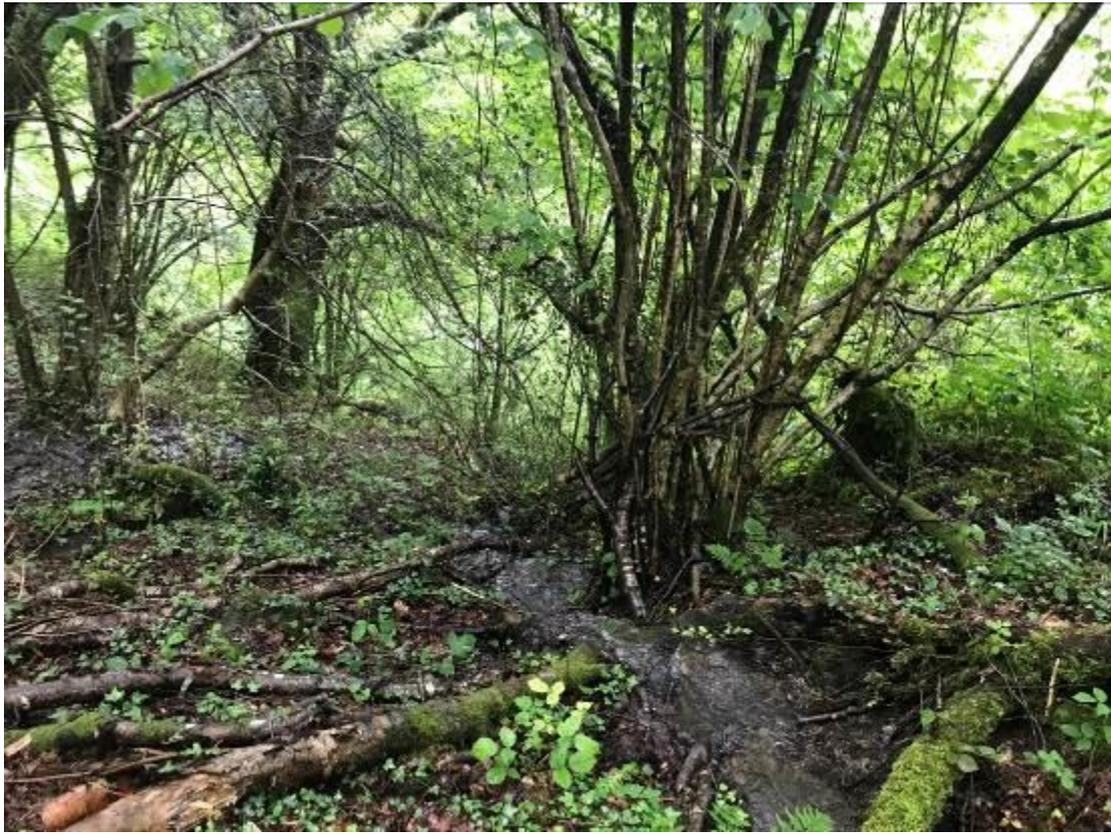
**Photograph 7 – Discharge from adit positions at Site 1**

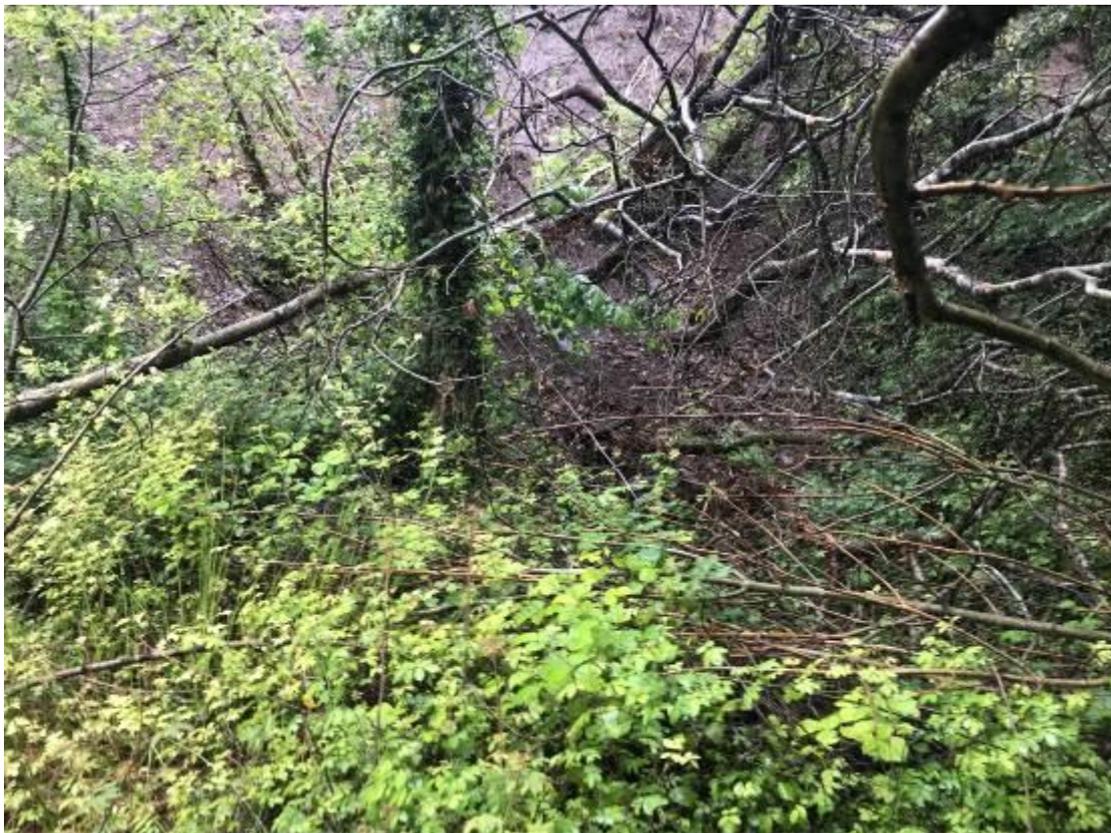
The flanks of the colliery and quarry spoil mounds were very steep and densely vegetated, preventing a close inspecting of material and topography (photographs 8, 17, 18 and 19).

**Photograph 8 – Steep densely vegetated flanks of Site 1**

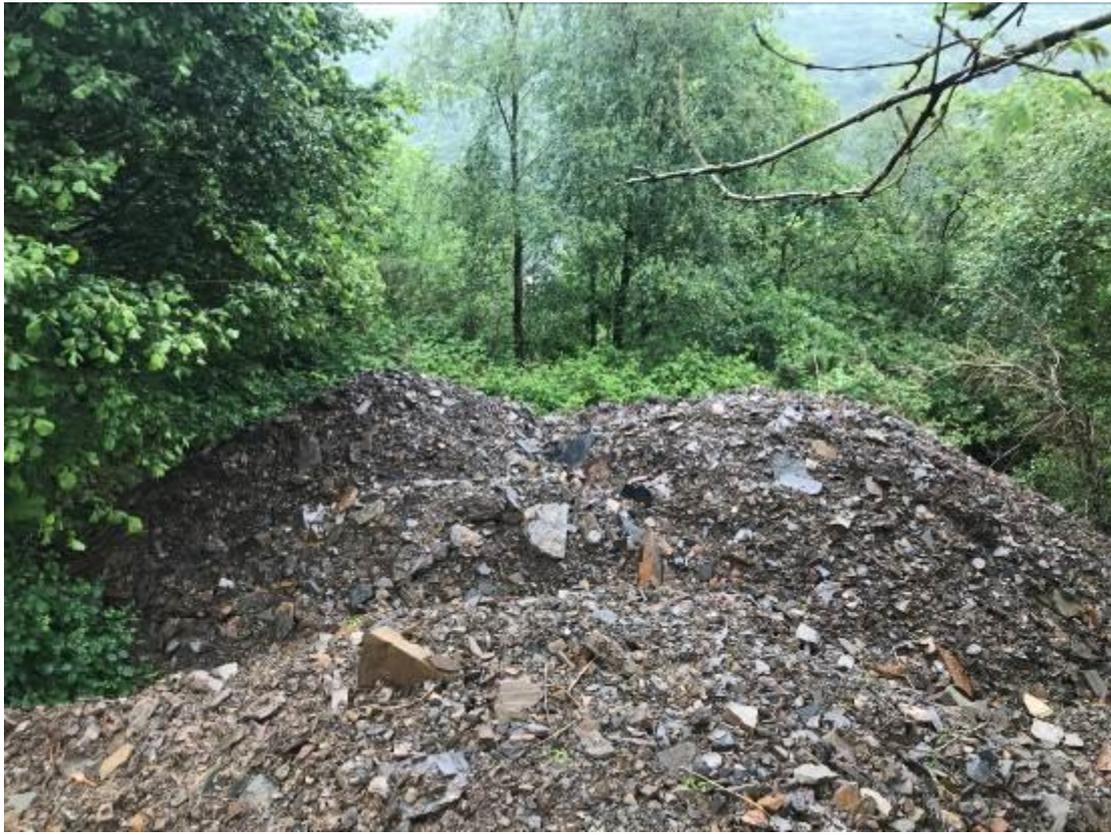
**Photograph 9 – Recent tipping of material at Site 1**

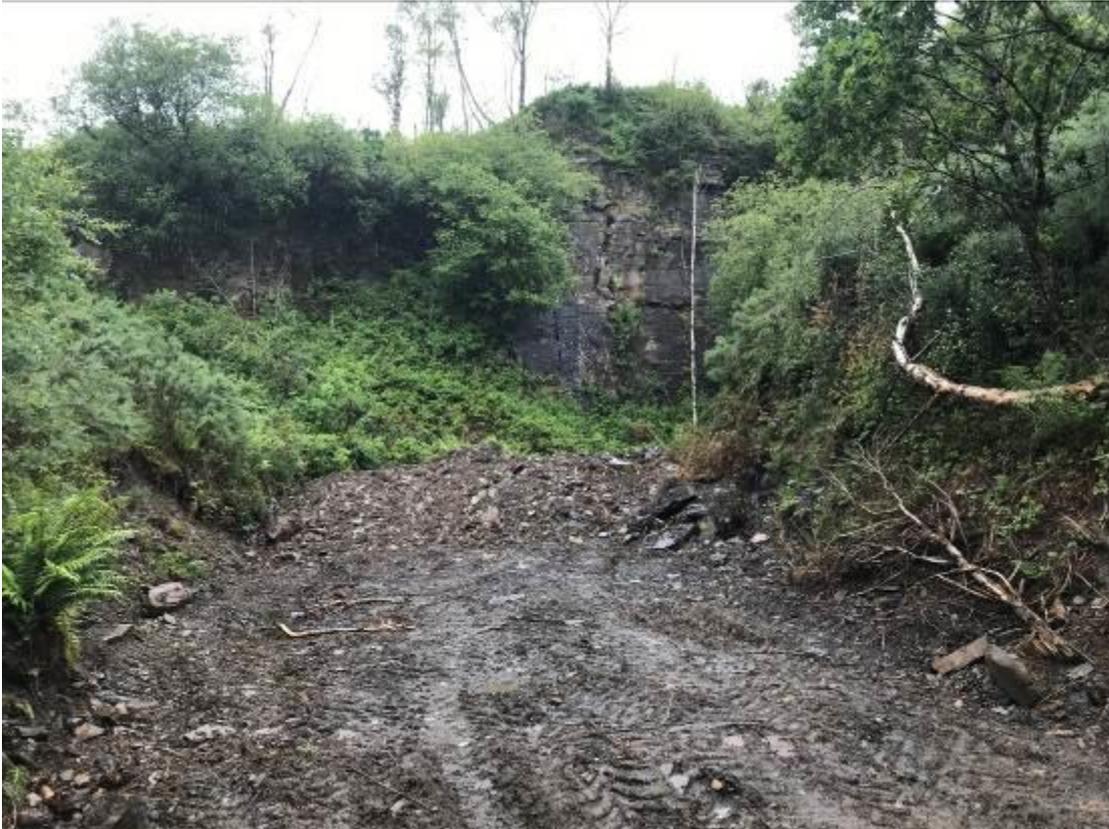
The inspection then viewed the floor and high walls of Cwar Pentwyn. Recent quarrying activity appeared to have taken place, with mounds of excavated material present. Evidence of human activity was also observed as a 'Lazy Spa' type pool, tent and camp bed were present, along with electricity extension cables leading downslope toward the properties named 'Glander' and 'Darren View' (photographs 11 to 16).

**Photograph 11 – High wall of Pentwyn Quarry showing recent tipping**

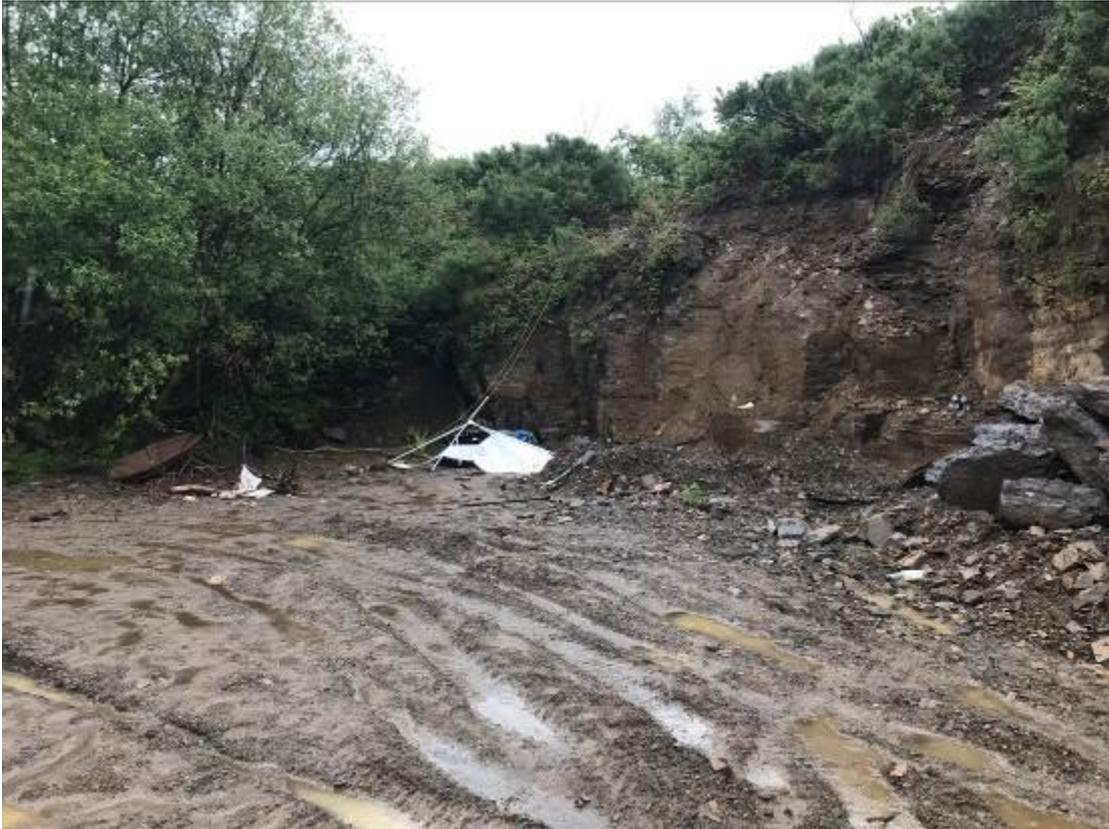
**Photograph 13 – Pentwyn Quarry recent excavations**

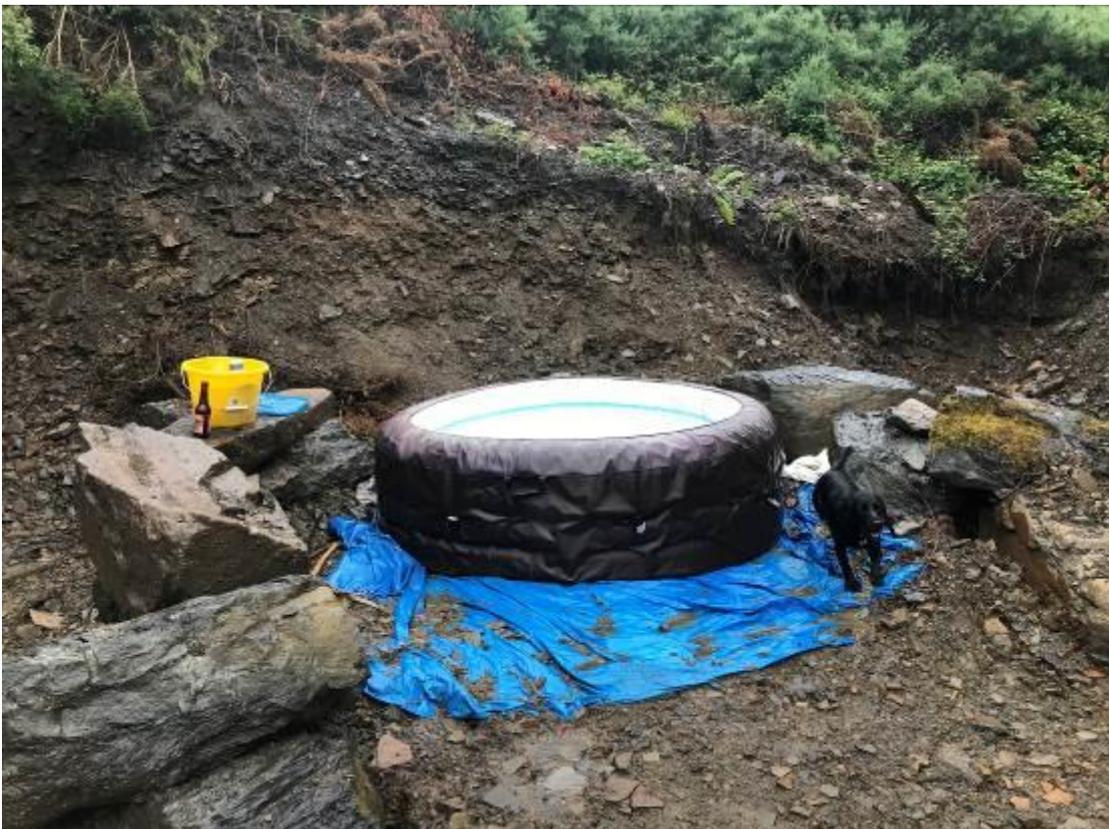
**Photograph 14 – ‘Lazy Spa’ located in quarry floor**

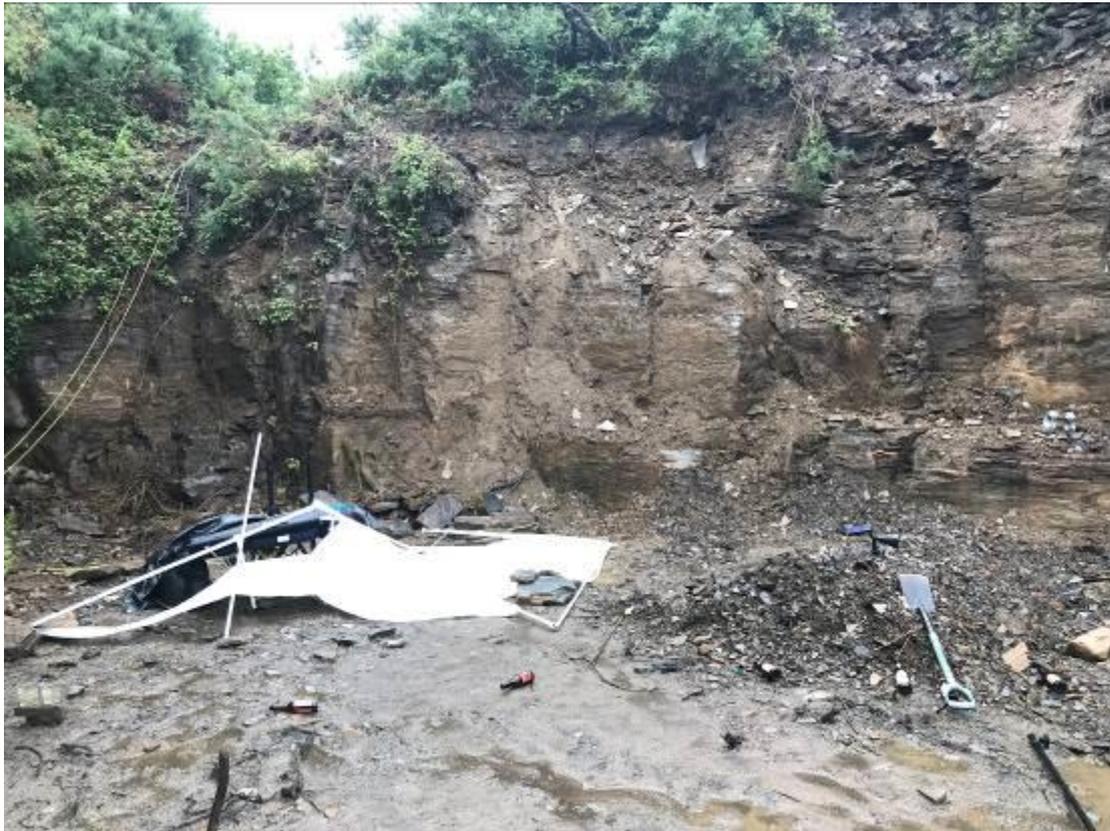
**Photograph 15 – Recently used shelter in quarry floor**

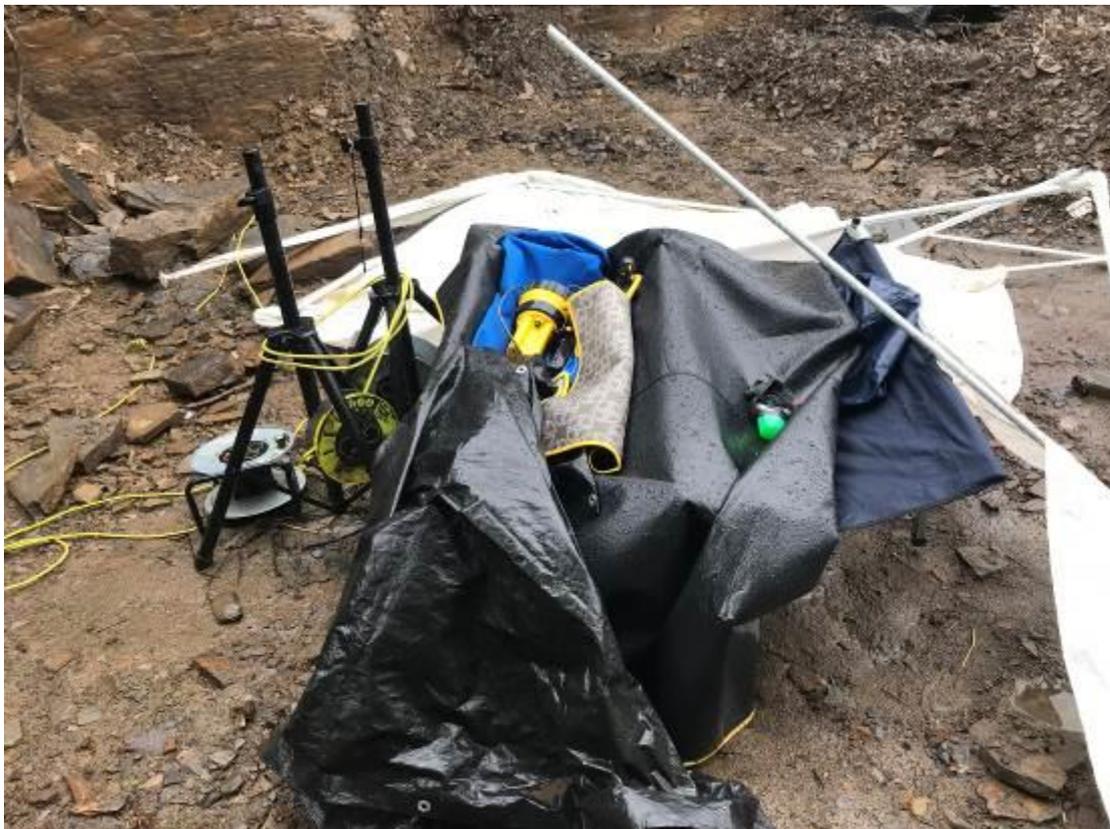
**Photograph 16 – Shelter showing electricity cables**

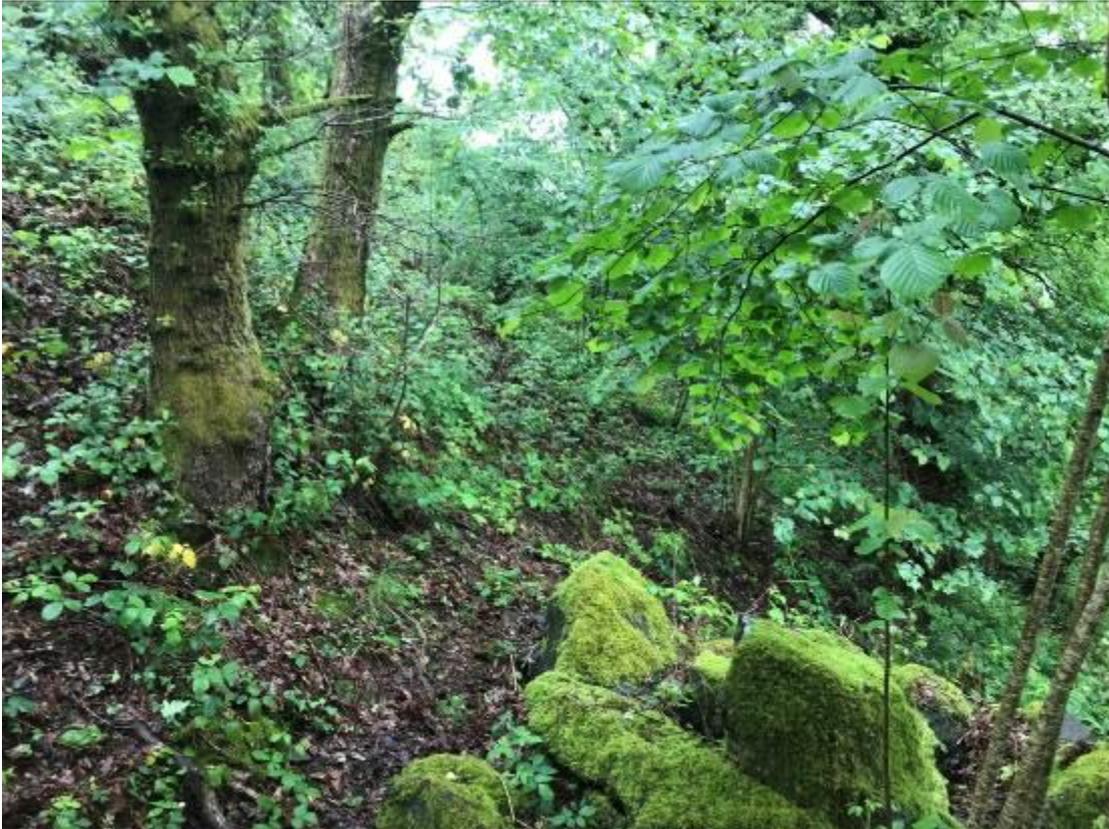
**Photograph 17 – Steep densely vegetated flanks of Site 1**

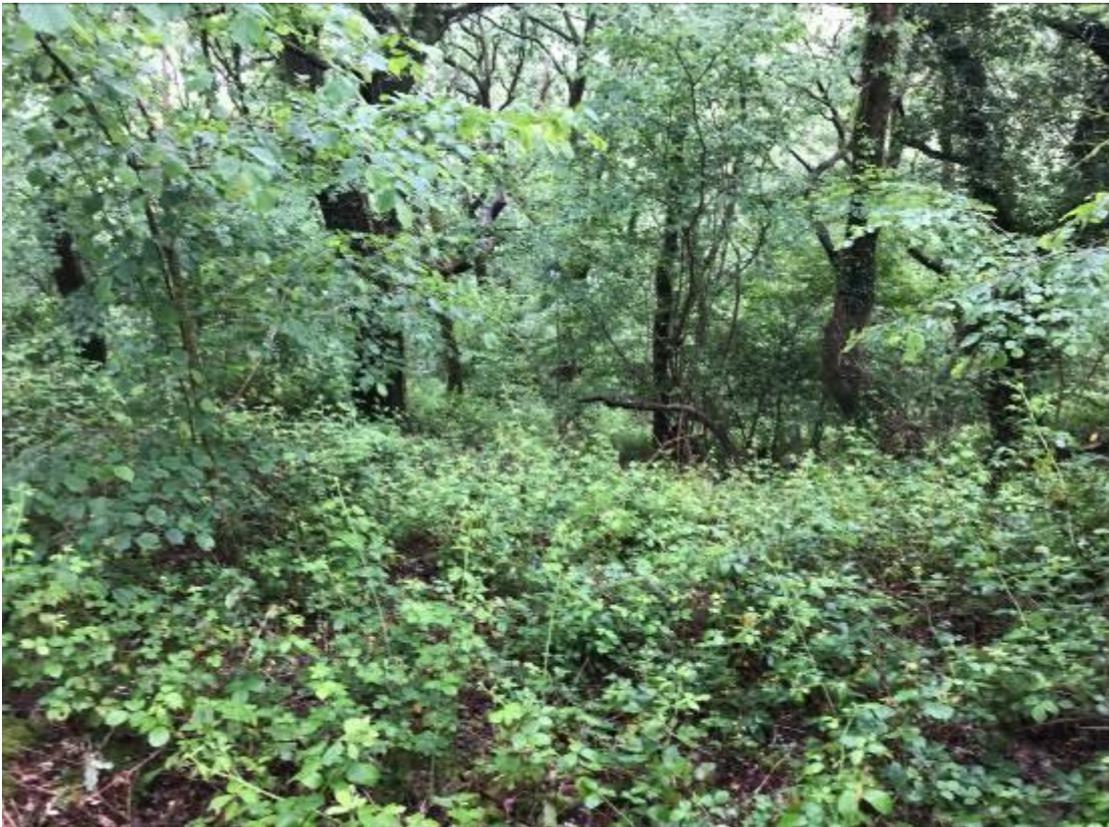
**Photograph 18 – Steep densely vegetated flanks of Site 1**

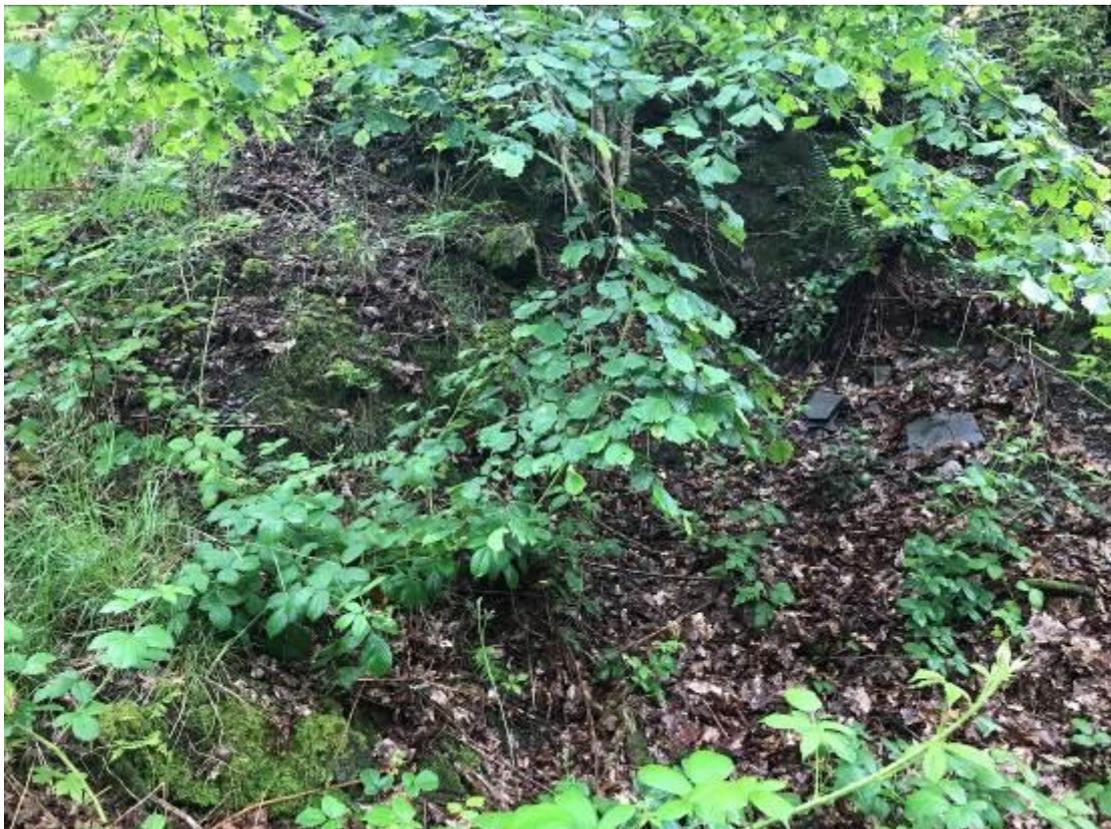
Very little evidence of recent instability was observed, with the exception of a small degraded shallow slip at approximate NGR 274910E 206861N (photograph 20) and some areas of soil creep.

**Photograph 20 – Small slip on flank of Site 1**

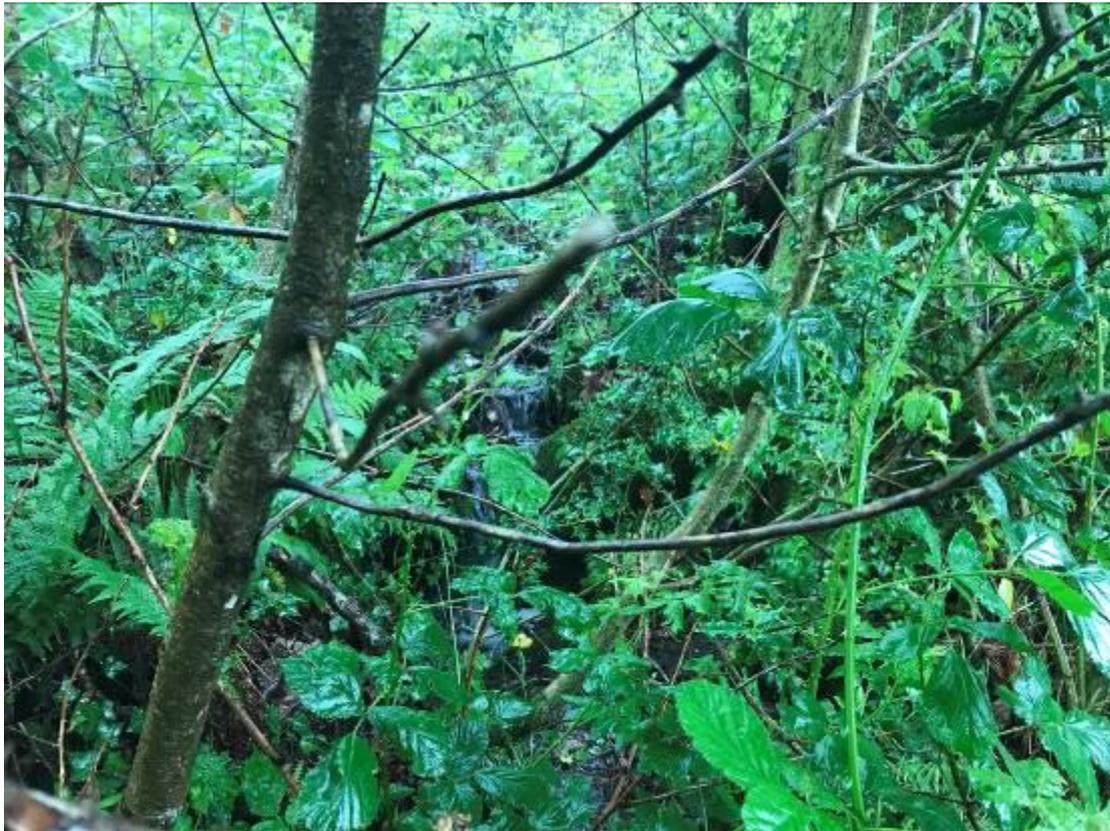
A spring was observed emanating from the vicinity of mine adit reference 274206-026 at NGR 274988E 206957N (photograph 21). The spring was observed as forming a small marshy area, subsequently flowing overland and downslope in a south-easterly direction.

**Photograph 21 – Minor watercourse at head of Site 2**

- Consider clearing vegetation to allow inspection of drainage routes at Site 2.
- Ensure drainage infrastructure to the rear of Godre'r Graig Primary School is regularly inspected and maintained.

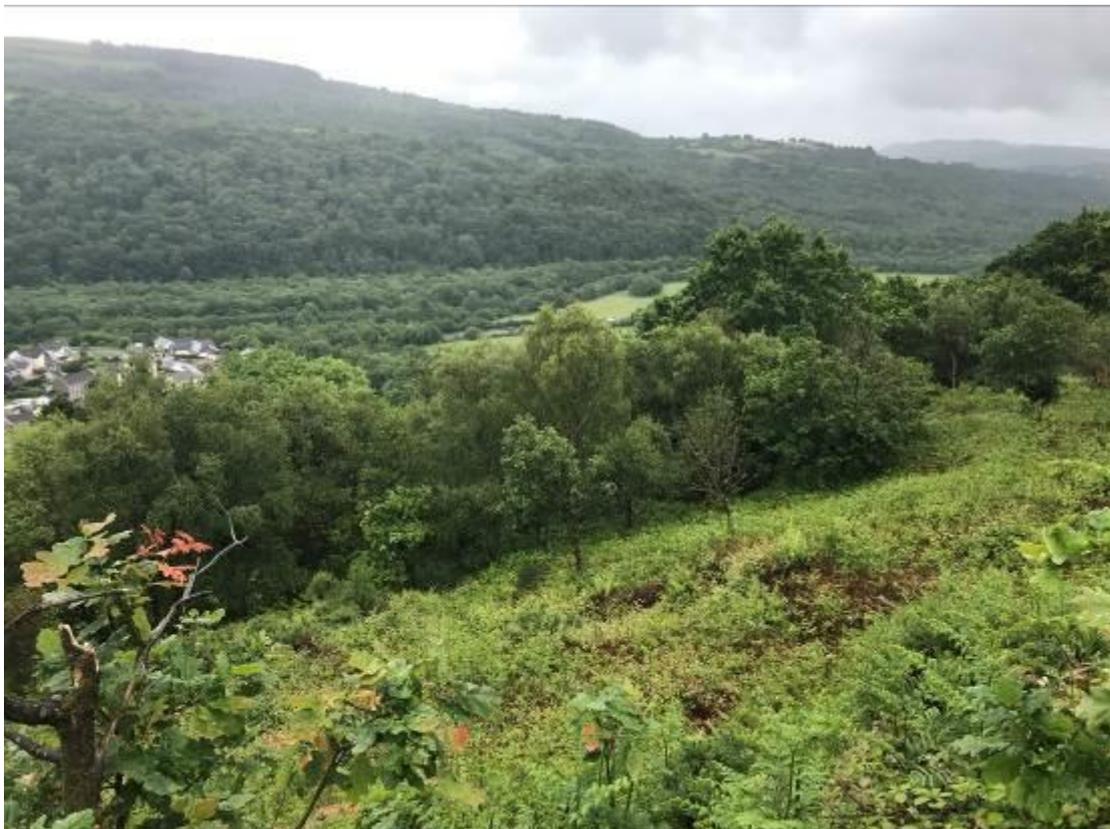
The inspection route then accessed the area encompassed by Site 2, crossing a derelict fence-line and heading east across an area of dense fern and bramble vegetation with a sporadic cover of trees. The density of vegetation prevented close inspection of materials or topography and access was extremely difficult (photographs 22, 24 and 25).

**Photograph 22 – General view of Site 2 showing dense vegetation coverage**

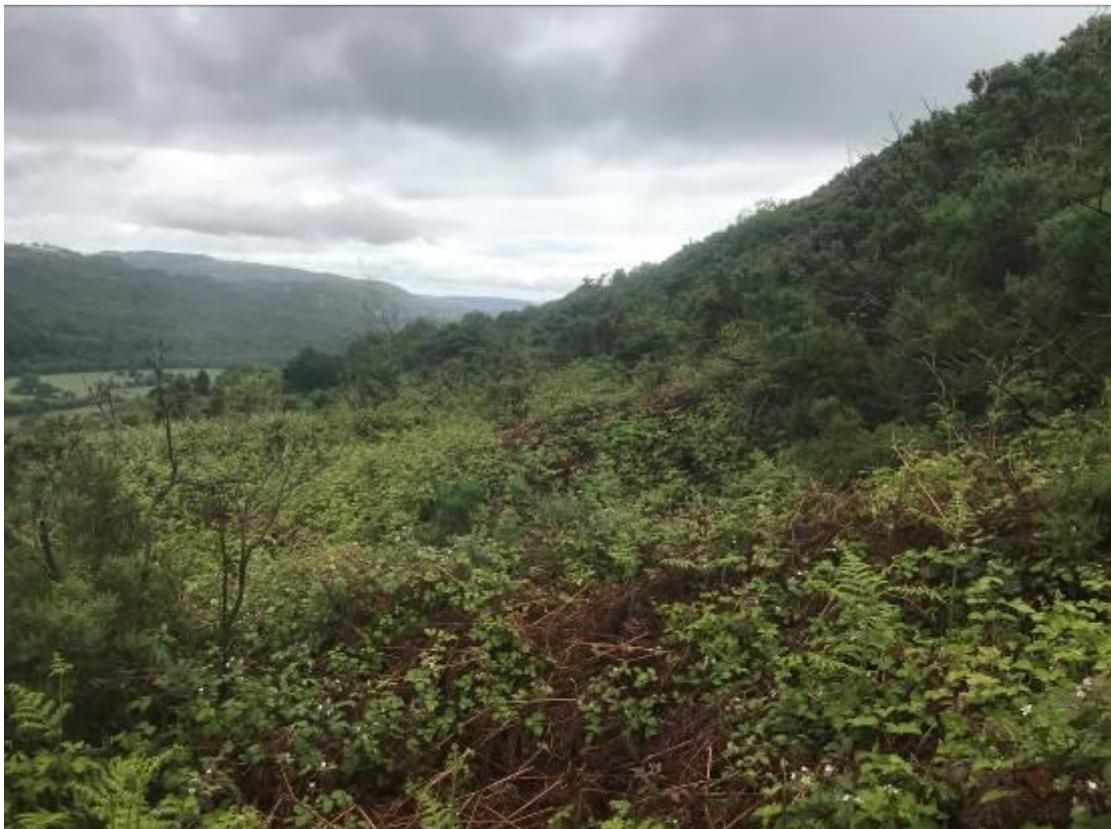
The inspection route then turned north east and viewed the series of recorded mine adits above Site 3, the entrances to which appeared to have collapsed many years ago. The colliery tips associated with these mine entries comprised a liner low mound of spoil forming a ridgeline at the head of Site 3 (photographs 26 to 28).

Evidence of slow soil creep and falls of rock from the escarpment above the line of adits was observed but these likely to present a low risk to public safety.

**Photograph 28 – View of Site 3 showing collapsed adit positions**

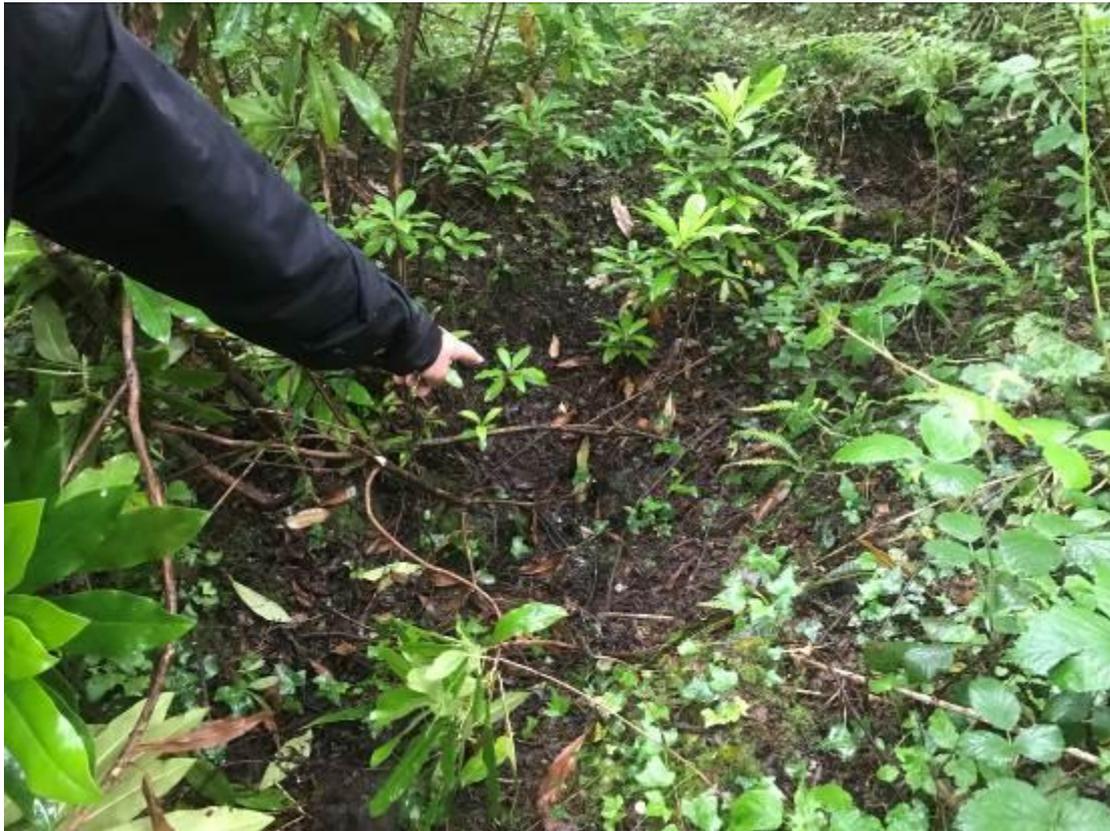
The watercourse disappeared and reappeared at several locations, probably through the coarse quarry spoil present, appearing again as a spring type feature at NGR 275067E 206915N (photograph 29). The watercourse then flowed in an unlined channel to enter a screened chamber at NGR 275135E 206891N (photograph 30), before entering a final chamber to the rear of Godre'r Graig Primary School at NGR 275157E 206892N (photograph 36). The watercourse then appeared to be culverted beneath the school.

**Photograph 29 – Moderate seepage at SW section of Site 2**

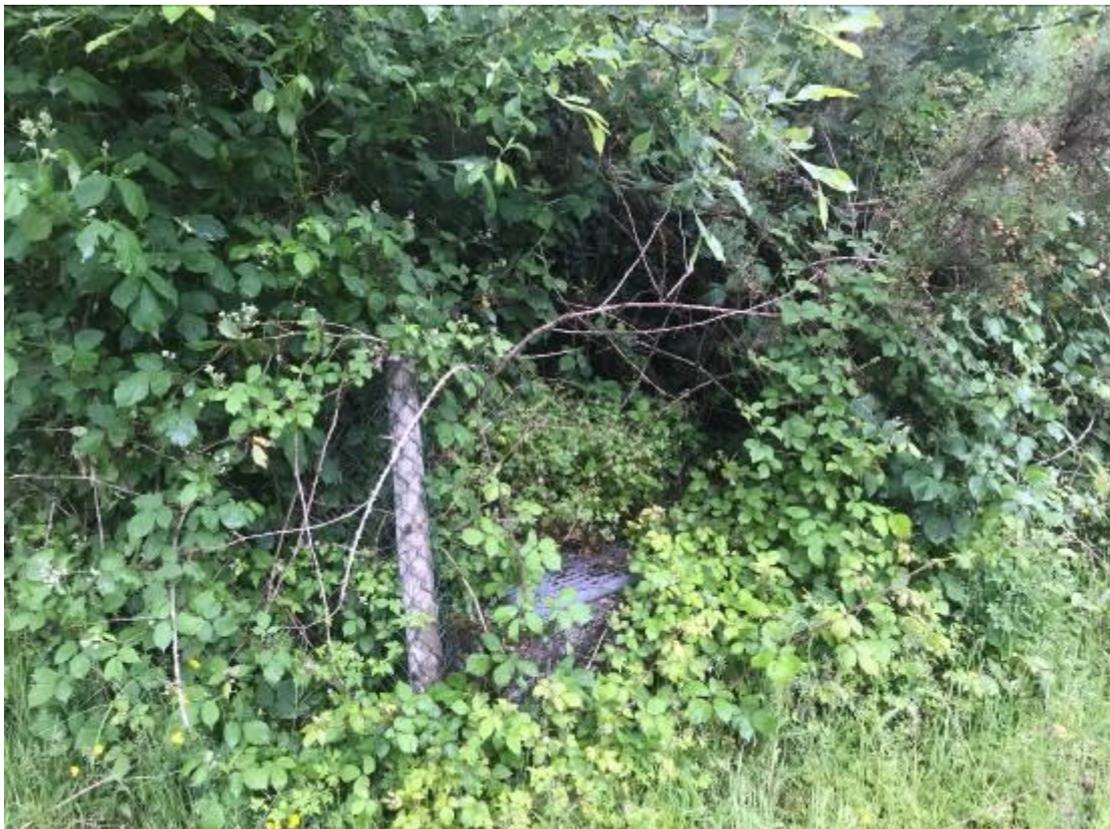
Blockages of the drainage infrastructure to the rear of Godre'r Graig Primary School would result in flooding and potential slope instability.

**Photograph 30 – Inlet chamber to rear of school**

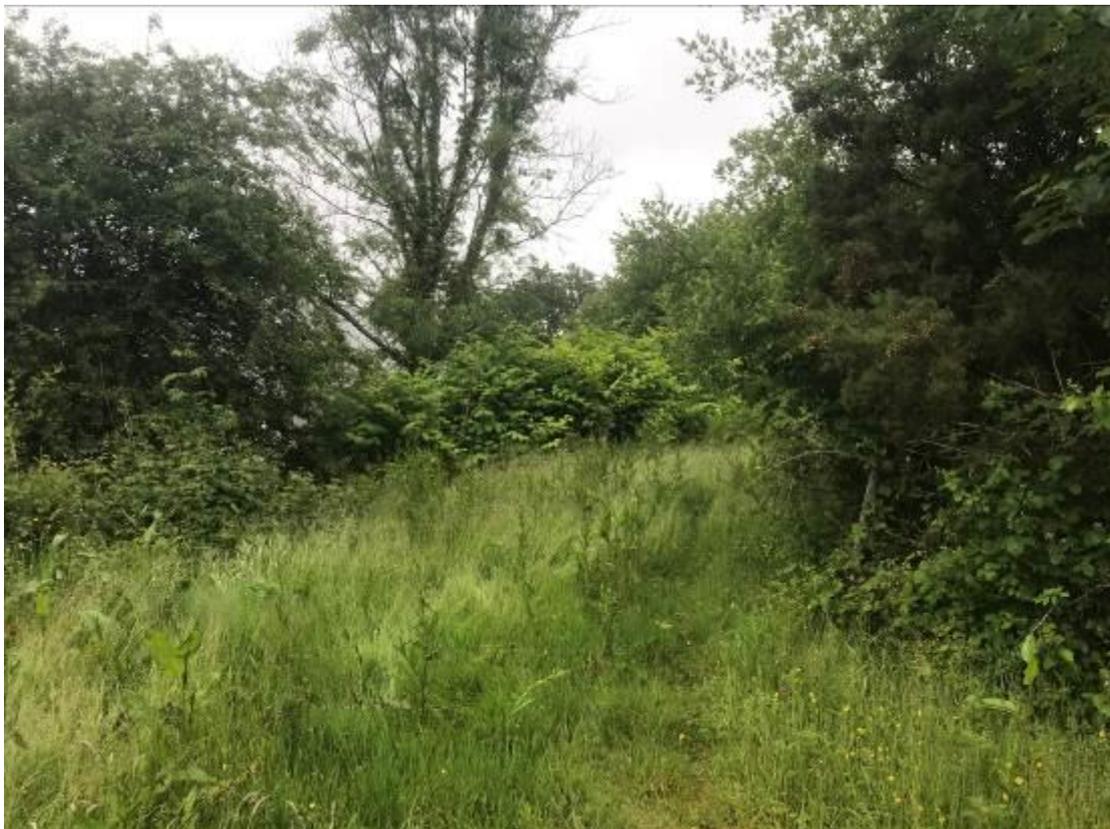
A derelict stable and several stands of Japanese Knotweed were observed present in this area (photographs 32 to 34).

**Photograph 32 – Field to rear of school showing Japanese Knotweed**

- Consider undertaking a slope stability analysis for Site 2 based on available information supplemented by ground investigation.
- Consider spraying of Japanese Knotweed to rear of school.

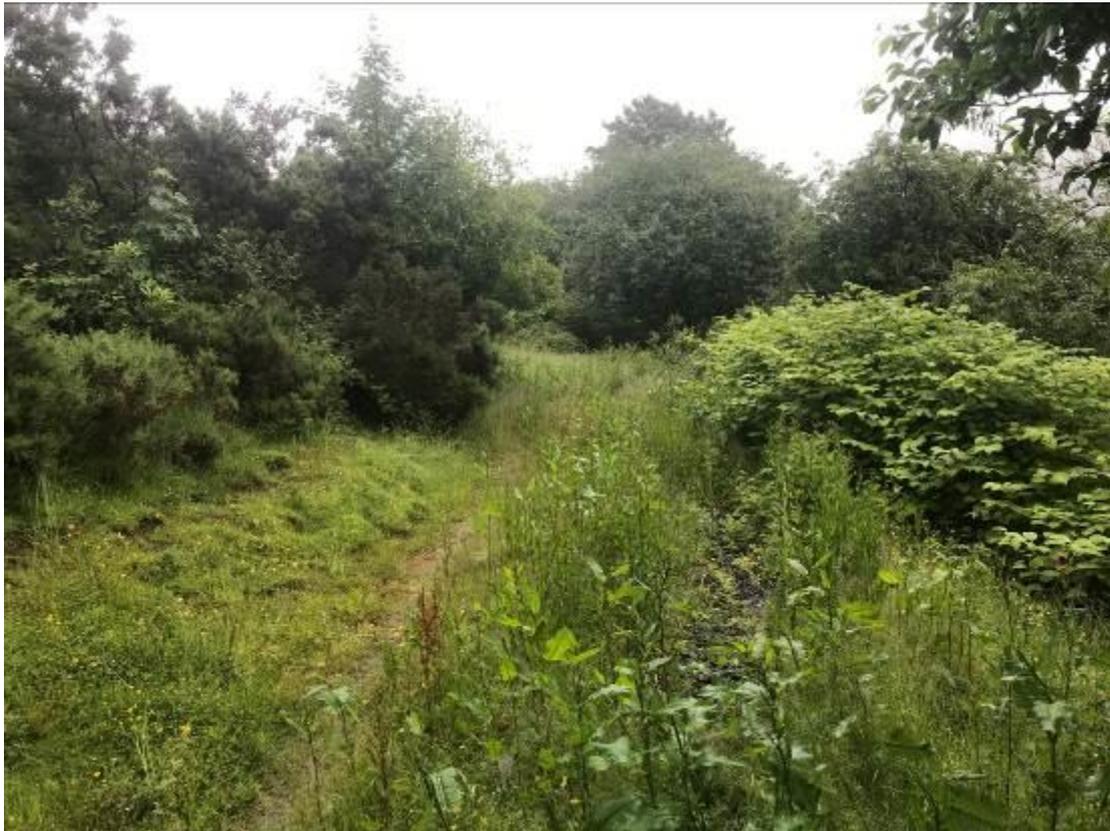
The inspection route traversed the slope behind Godre'r Graig Primary School, viewing the route of the watercourse referenced above and the drainage chambers to the rear of the school. A stone filled cut off drain with several manhole chambers was observed in the grazing field to the rear of the school, along with a spring located at approximate NGR 275164E 206992N. Flows from the spring were captured by the stone cut off drain (photographs 33, 35 and 37).

**Photograph 33 – Stone filled cut off drain to rear of school**

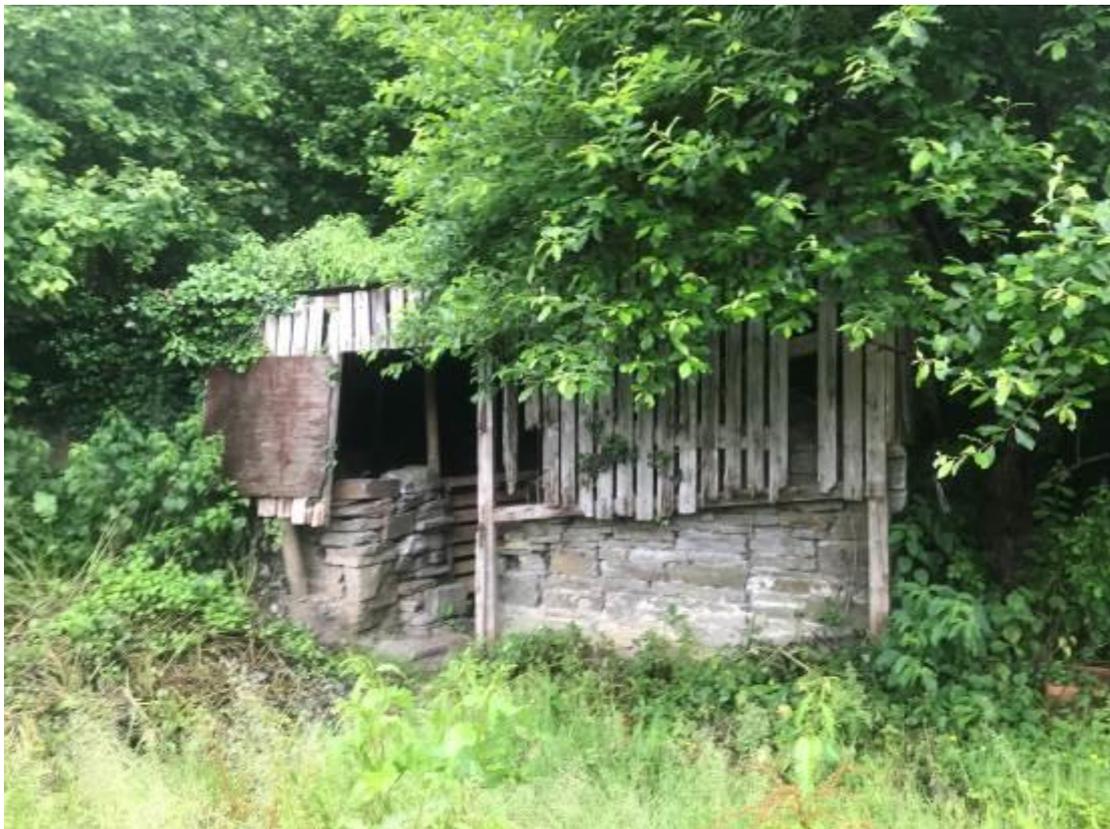
**Photograph 34 – Derelict stable to rear of school**
