**The Coal  
Authority**

## **Site Inspection Report**

### **L44 – Godre’r Graig Tips**

**Date: July 2019**

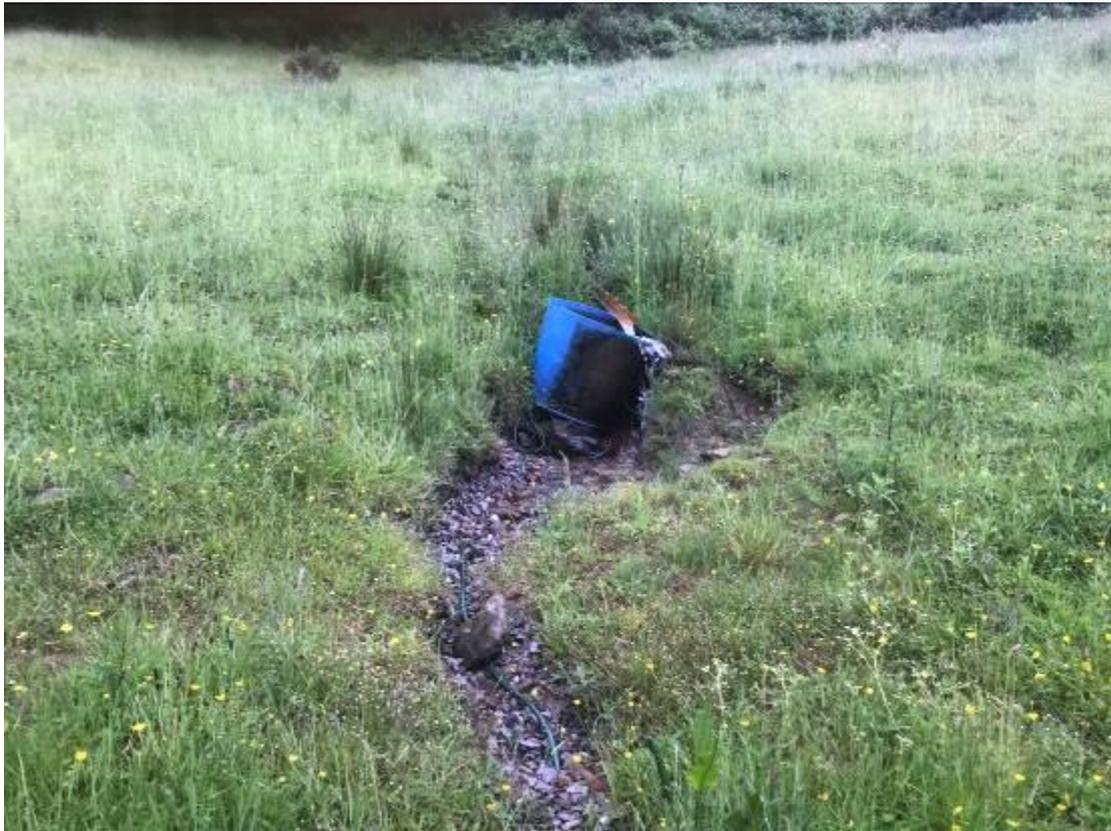
The inspection route traversed the slope behind Godre'r Graig Primary School, viewing the route of the watercourse referenced above and the drainage chambers to the rear of the school. A stone filled cut off drain with several manhole chambers was observed in the grazing field to the rear of the school, along with a spring located at approximate NGR 275164E 206992N. Flows from the spring were captured by the stone cut off drain (photographs 33, 35 and 37).

**Photograph 35 – Strong seepage to rear of school**

- Consider clearing vegetation to allow inspection of drainage routes at Site 2.
- Ensure drainage infrastructure to the rear of Godre'r Graig Primary School is regularly inspected and maintained.

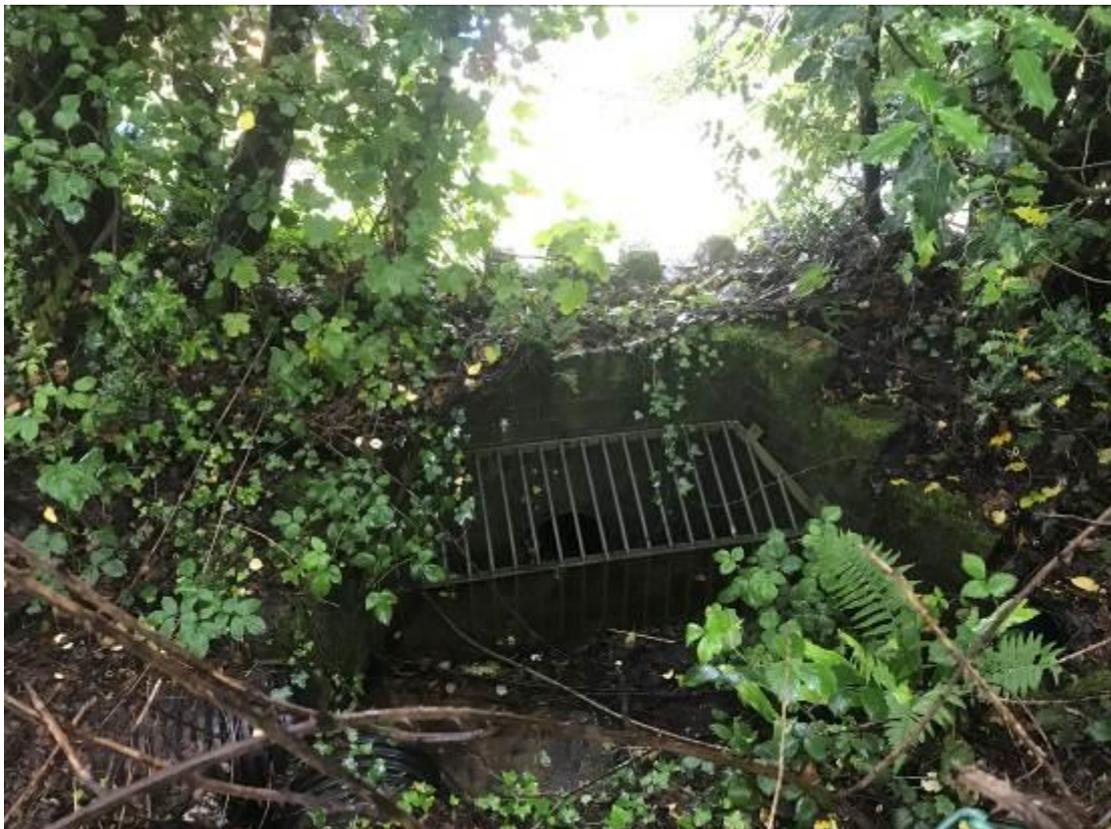
The watercourse disappeared and reappeared at several locations, probably through the coarse quarry spoil present, appearing again as a spring type feature at NGR 275067E 206915N (photograph 29). The watercourse then flowed in an unlined channel to enter a screened chamber at NGR 275135E 206891N (photograph 30), before entering a final chamber to the rear of Godre'r Graig Primary School at NGR 275157E 206892N (photograph 36). The watercourse then appeared to be culverted beneath the school.

Blockages of the drainage infrastructure to the rear of Godre'r Graig Primary School would result in flooding and potential slope instability.

**Photograph 36 – Inlet chamber at rear of school**
