## Godre'r Graig Primary School, Godre'r Graig Preliminary Landslide Hazard and Risk Assessment

Report Reference: ESP.7234e.3221

## Godre'r Graig Primary School Preliminary Landslide Hazard and Risk Assessment

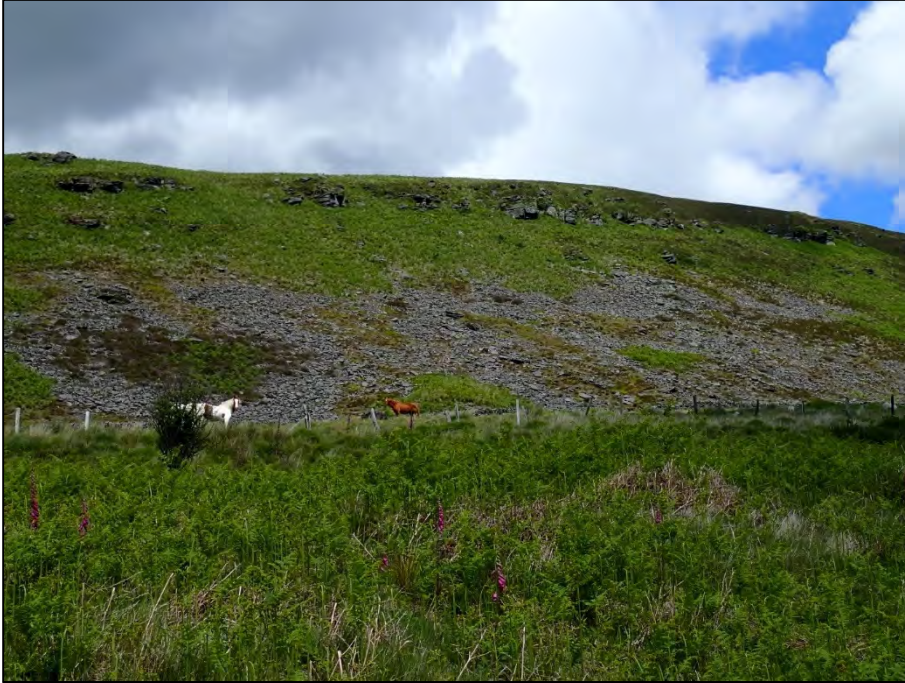
**Plate 2:** Rock outcrop (Rhondda Sandstone) with the associated talus slope below.

Larger individual blocks (rock falls) are present extending further downslope from the talus drape, the largest of which is 0.2m x 3.0m x 2.0m. A number of the features initially identified as rock blocks from the API actually comprise soil mounds (Plate 3). It is considered that the generation of large rock falls was probably associated with periglacial conditions at the end of the last ice age (approx. 11, 700 years BP) and consequently the main trigger for rock fall processes is no longer active. Smaller falls of cobble size blocks may still occur although again this process would have predominantly been active during periglacial conditions.

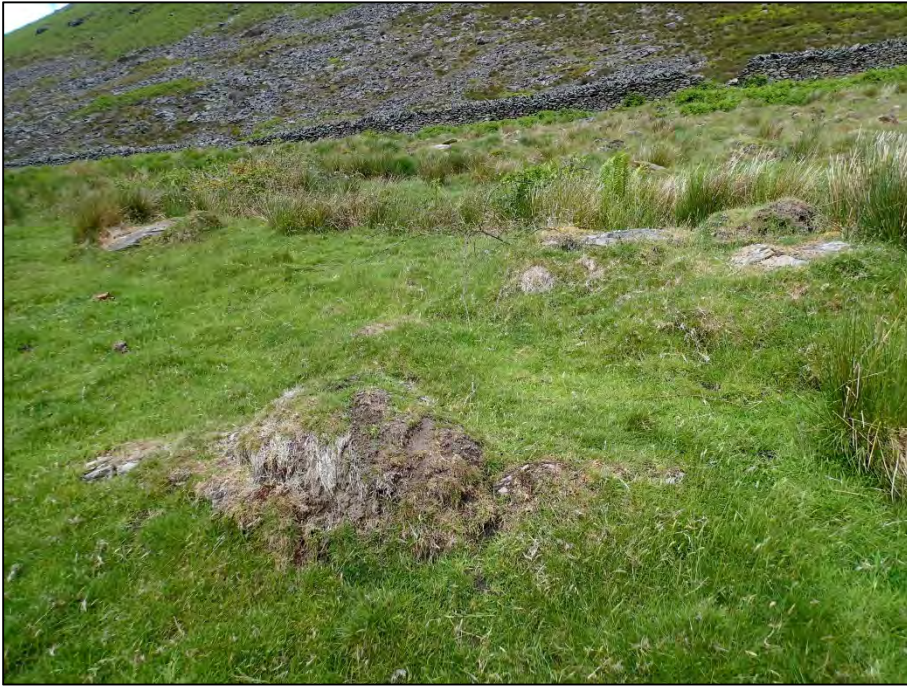
**Plate 3:** Soil mounds and rock blocks below the talus slope

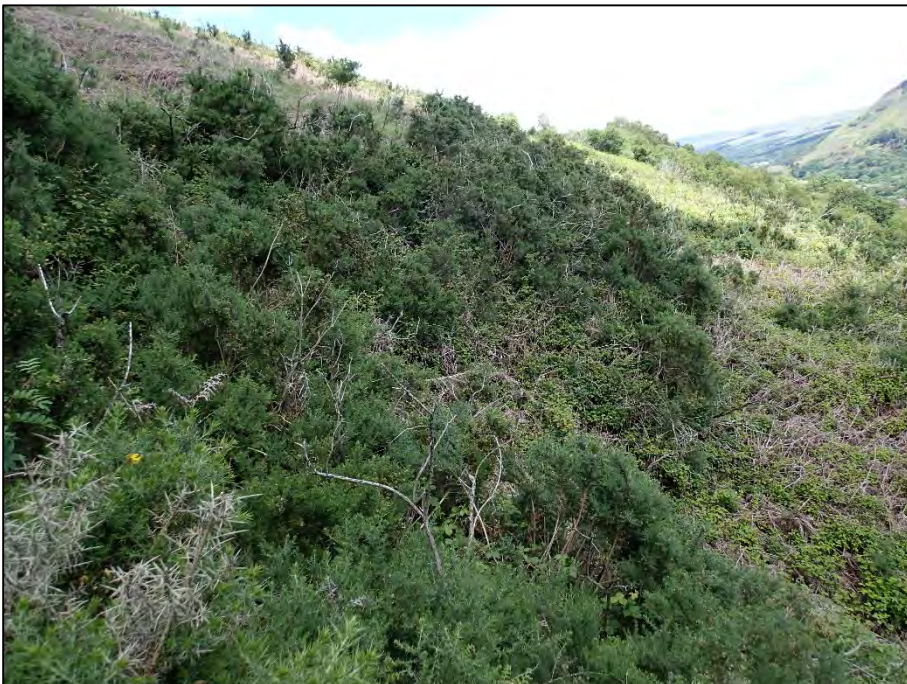
The base of this steeper terrain is marked by a distinct concave break in slope which corresponds to the outcrop of the No2 Rhondda coal seam at the base of the Rhondda Sandstone. Coal workings are evident in the form of adits and associated spoil in the NE of the study area, with the working of the seam apparently evident in the 1973 and 1975 aerial photographs. Below the No 2 Rhondda the Llynfi Beds are present, comprising alternating sandstone and mudstone resulting in stepped topography. The published geological map shows the Upper Pinchin Coal seam as outcropping at approximately 178mOD. This is associated with over steep, anthropogenically modified, terrain as well as a series of adits reflecting its historical working (Plate 4).

**Plate 4:** Anthropogenically modified over steep slope and location of a formed adit

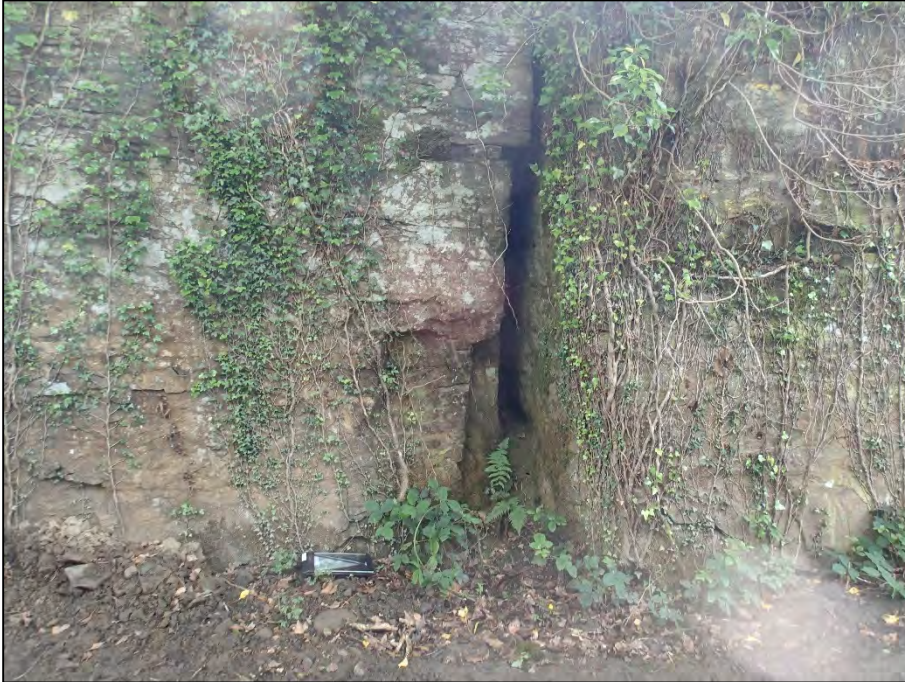
Two abandoned quarries are also present located above the outcrop of the Upper Pinchin. These are shown on the earliest historical maps (1877). Both quarries are associated with spoil heap with extend down slope. The Llynfi Beds are exposed at the Quarry to the NW of the School comprising weak to medium strong, thinly bedded, dark grey, partially weathered to unweathered, micaceous sandstone. Bedding dips at 20/185. Two additional discontinuity sets were observed 84/274 with an approximately 1m spacing and 74/018 with a spacing of approximately 5m. The latter set is dilated with an aperture of up to 10cm (Plate 5), reflecting either the effects of mining or cambering.

**Plate 5:** Bedding dipping from left to right (20/185) the rock face is formed by joint set 84/274 and the dilated joint set is formed by 74/018.

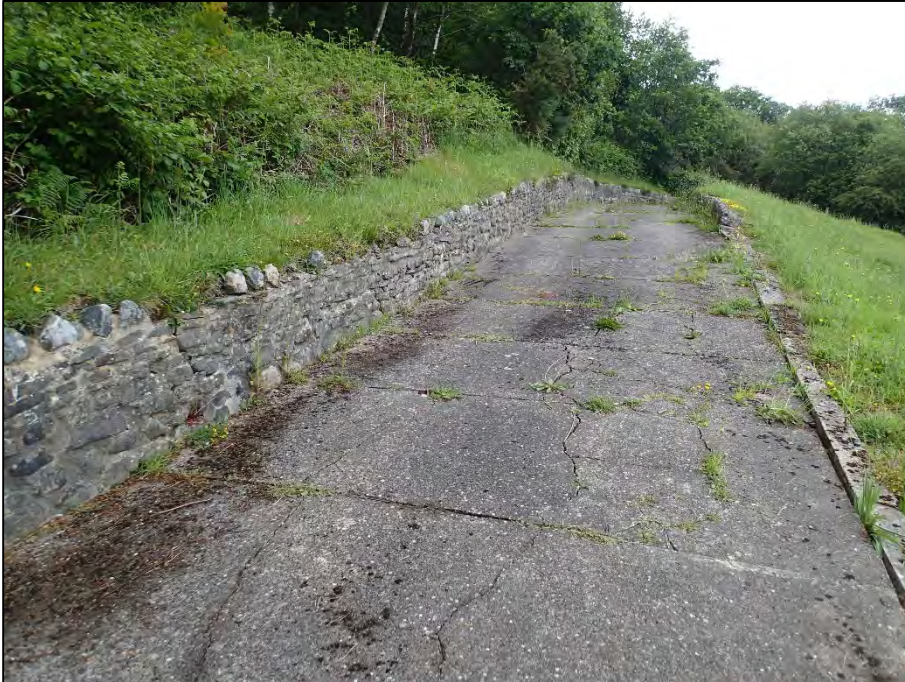
road (Plate 8) and a shallow depression, was noted within the cemetery at approximately the same level. At the rear of the School there was no evidence of landslides or distress. However, terracettes suggesting very shallow soil movement and wet ground is present.

**Plate 8:** Distress evident in the upper part of the cemetery.

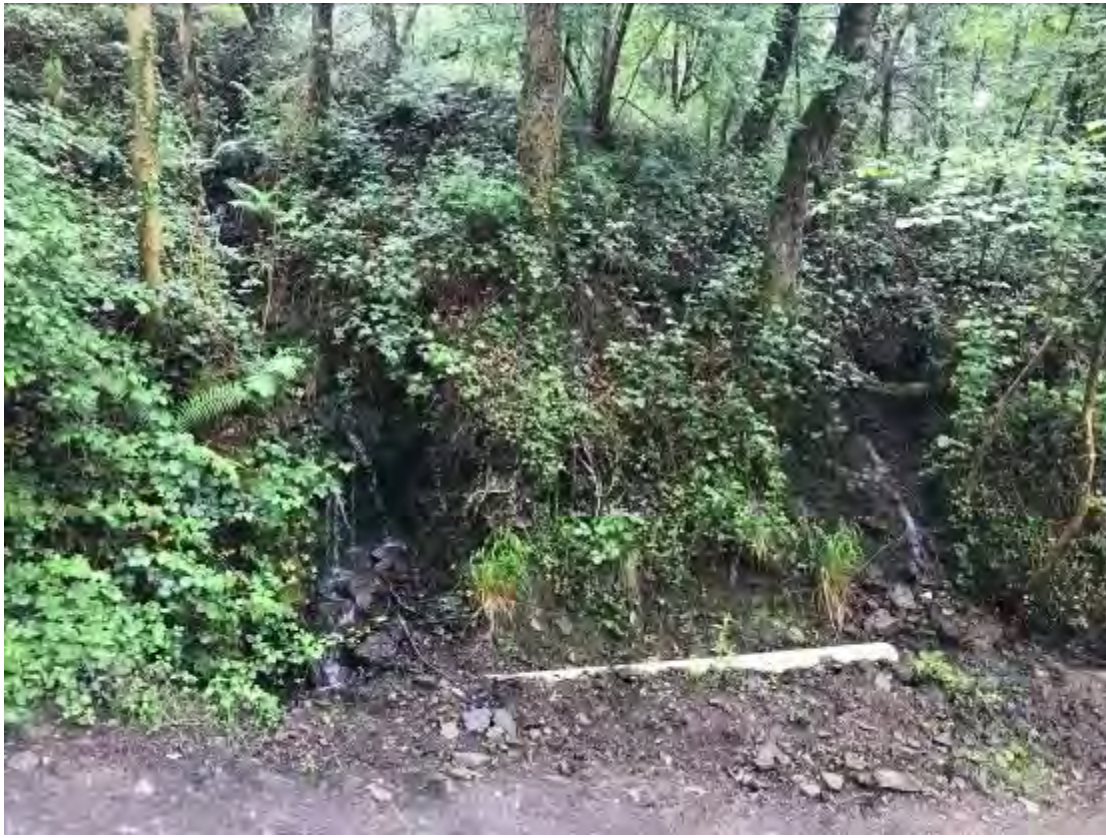
**Photograph 3 – Flows from adit positions to Pentwyn Farm access track**

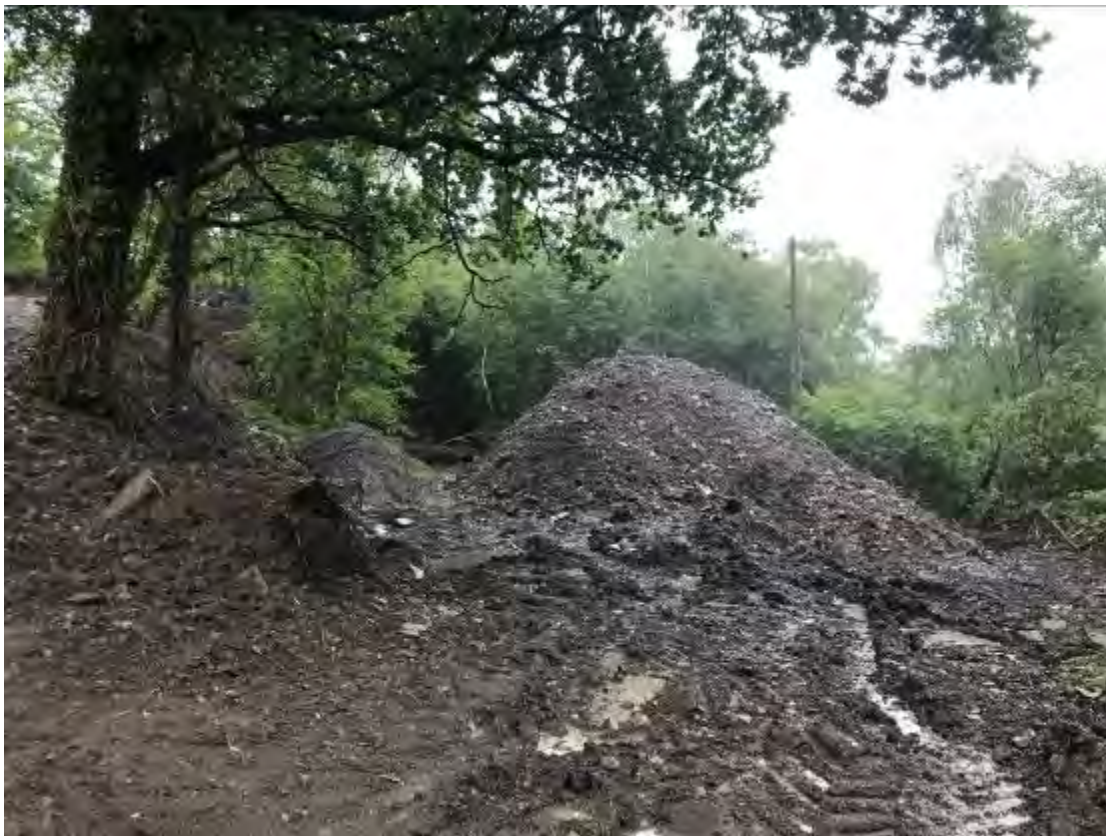
**Photograph 4 – Recent tipping of material at Site 1**

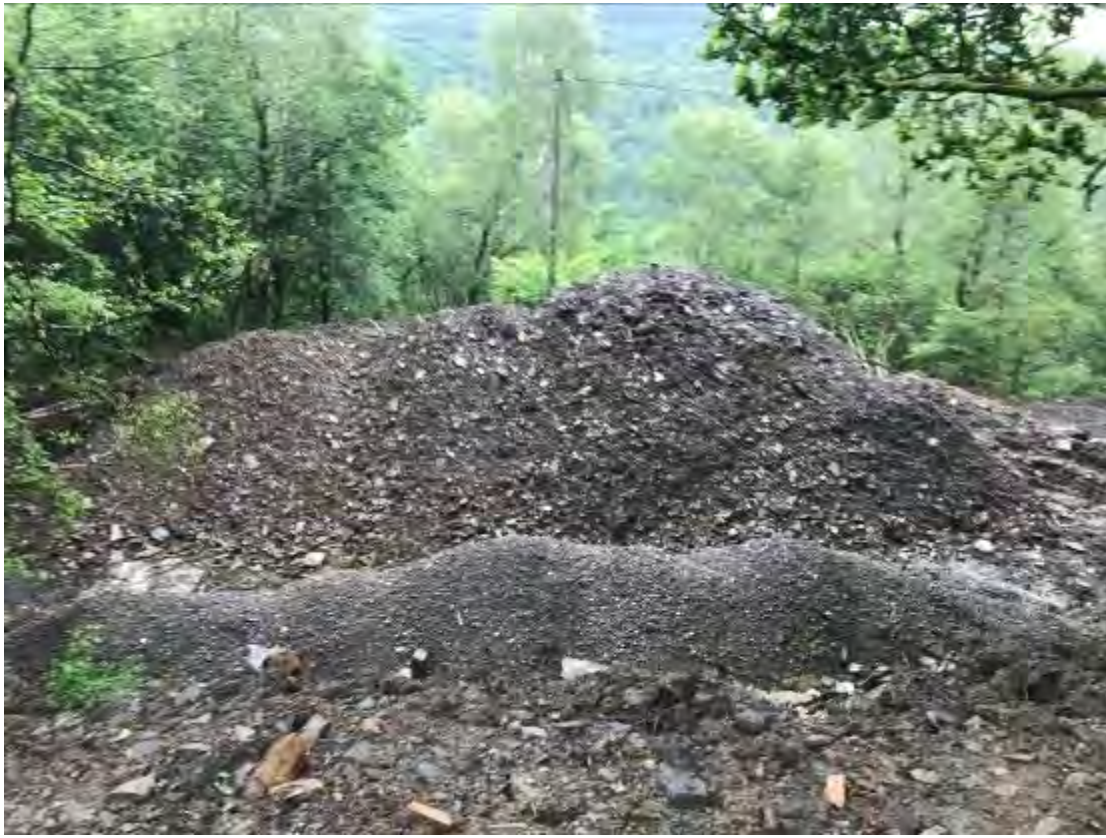
**Photograph 5 – Recent tipping of material at Site 1**

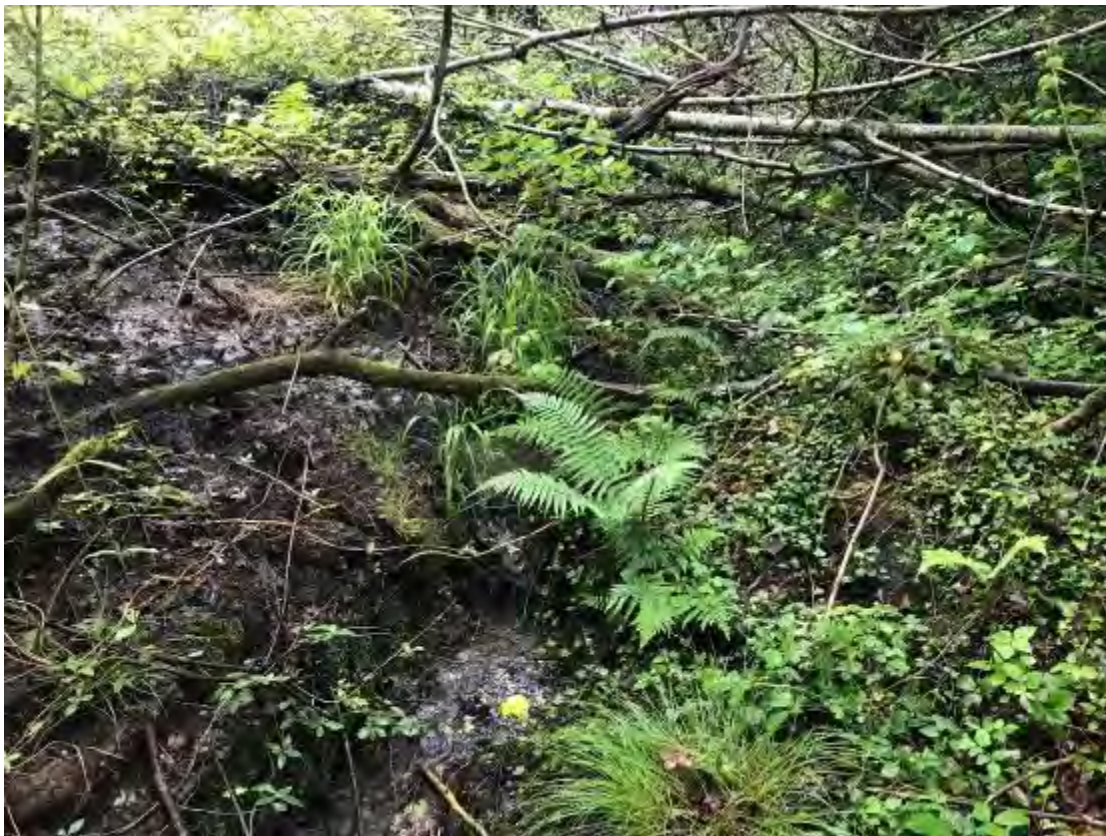
**Photograph 6 – Discharge from adit positions at Site 1**

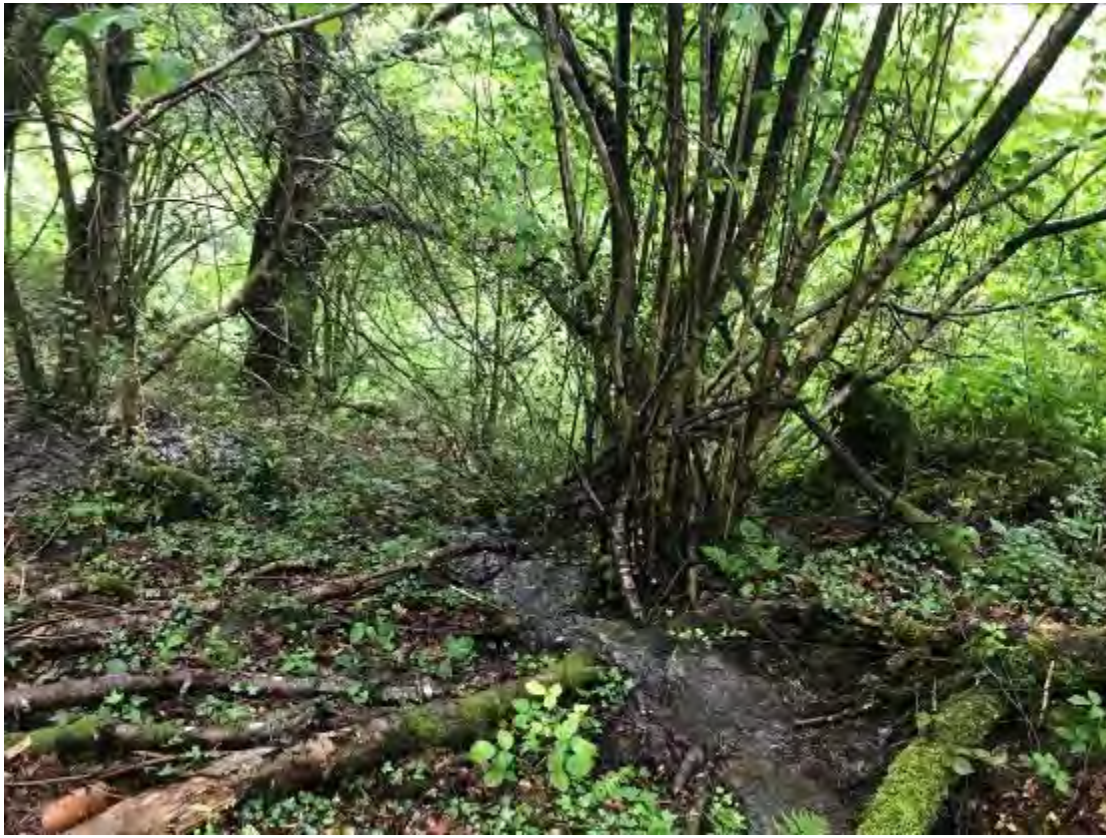
**Photograph 7 – Discharge from adit positions at Site 1**

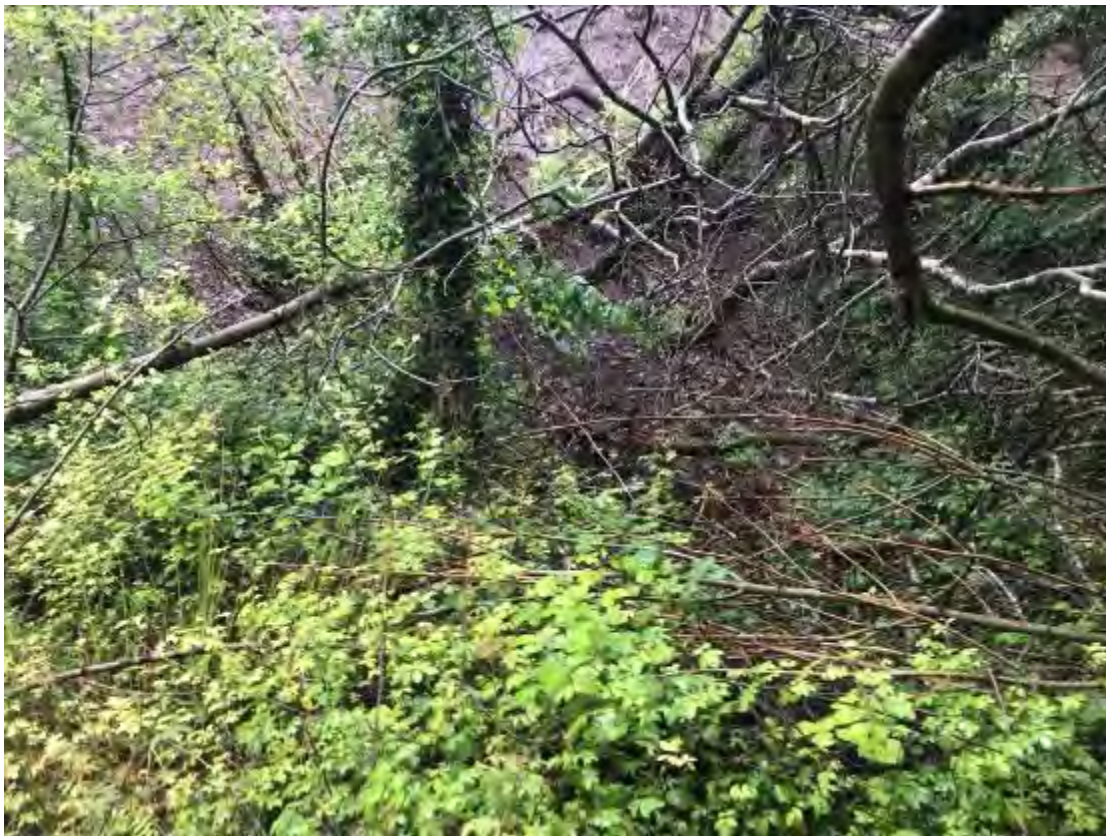
**Photograph 8 – Steep densely vegetated flanks of Site 1**

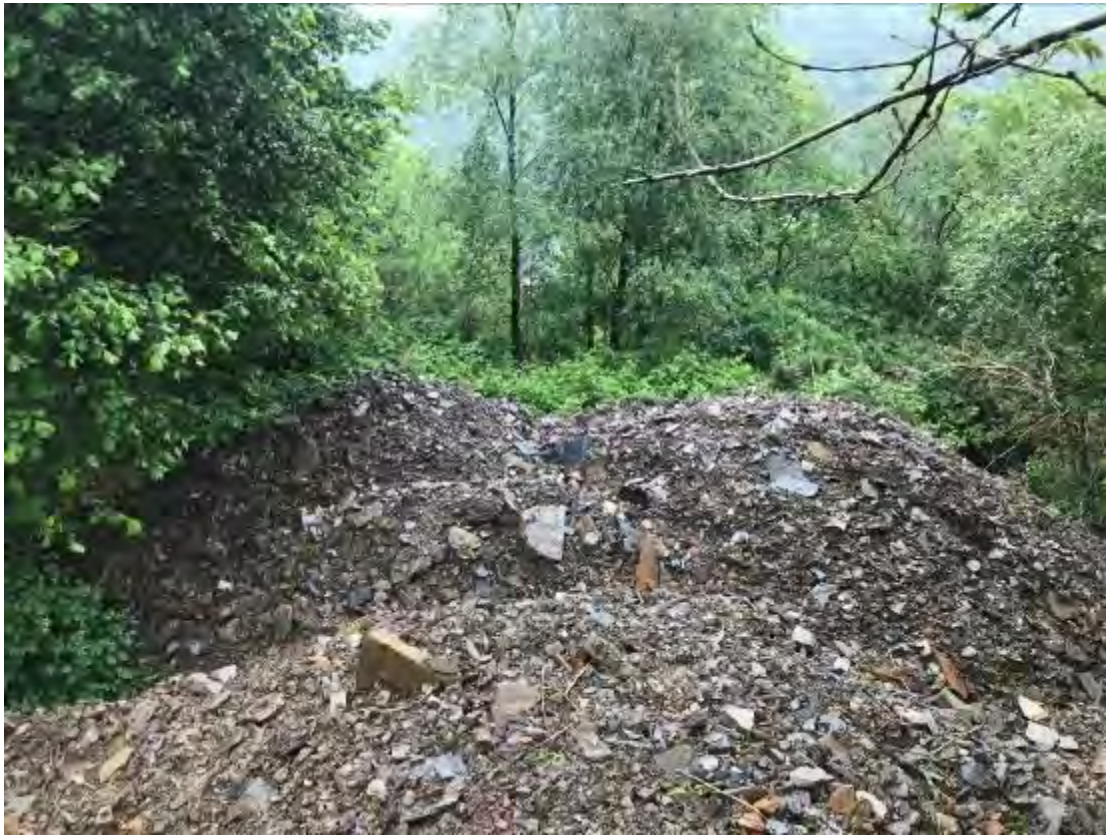
**Photograph 9 – Recent tipping of material at Site 1**

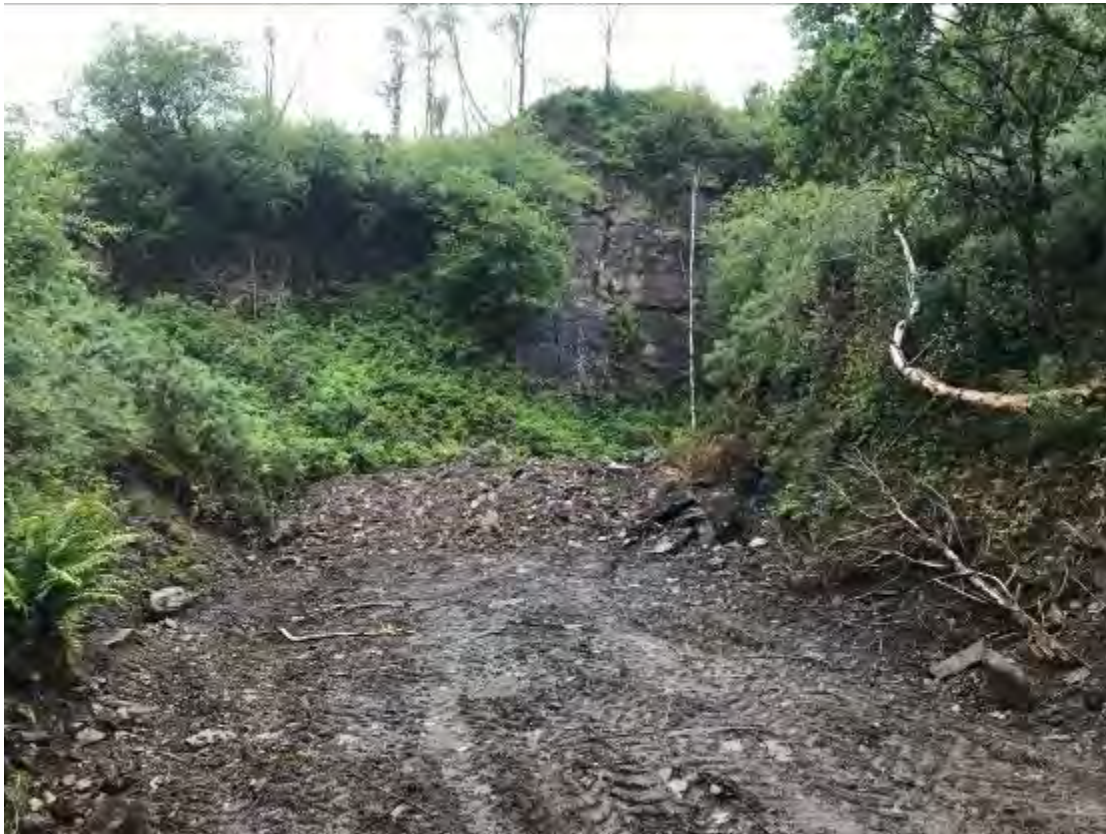
**Photograph 11 – High wall of Pentwyn Quarry showing recent tipping**

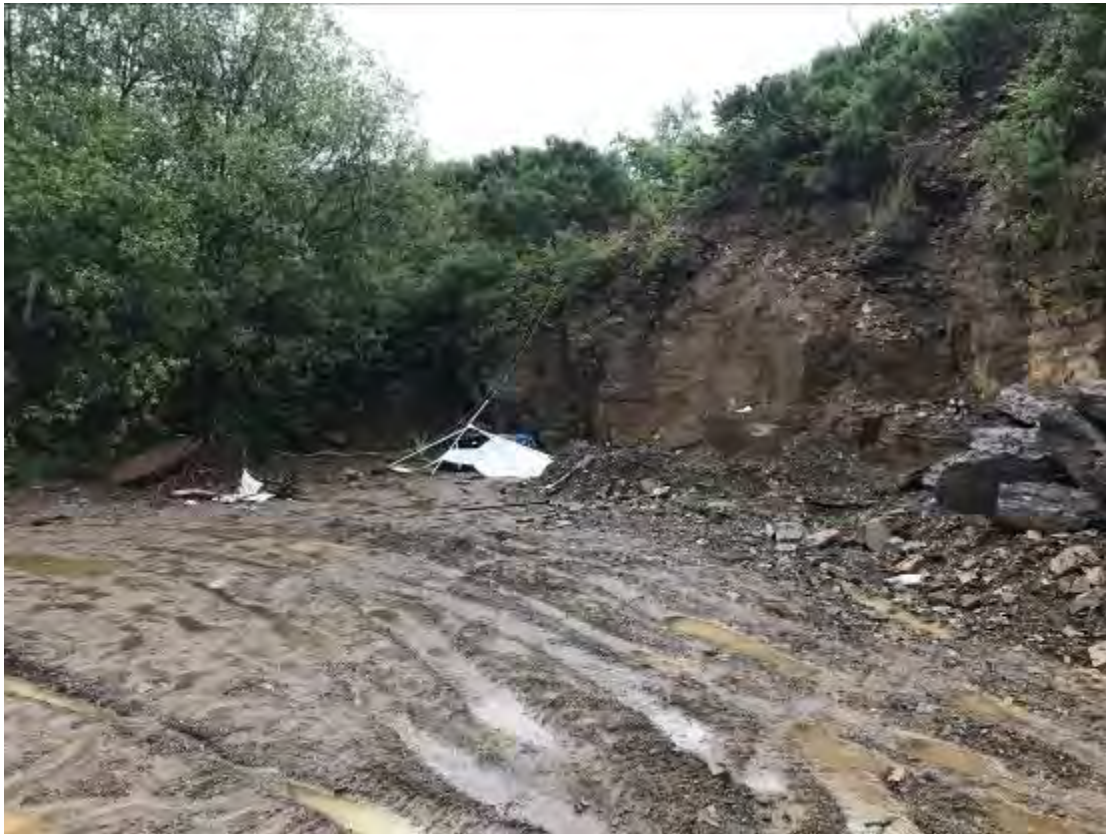
**Photograph 13 – Pentwyn Quarry recent excavations**

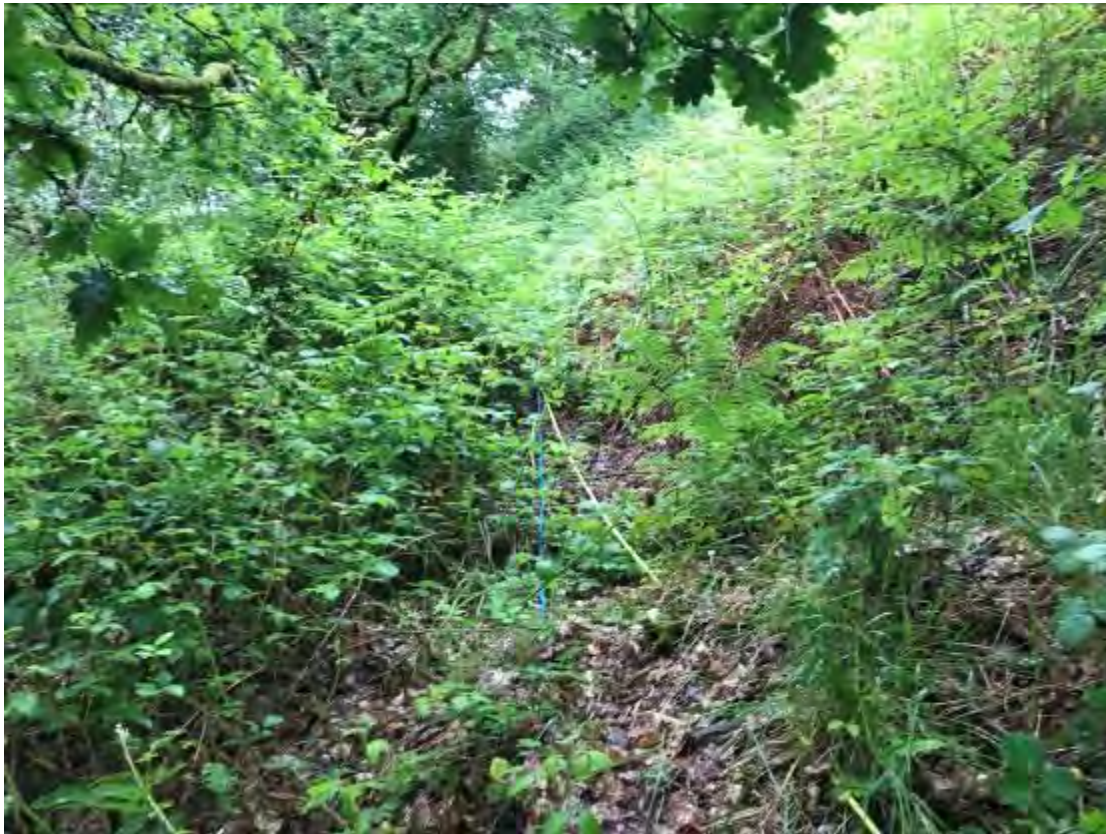
**Photograph 19 – Overgrown access path along toe of Site 1**

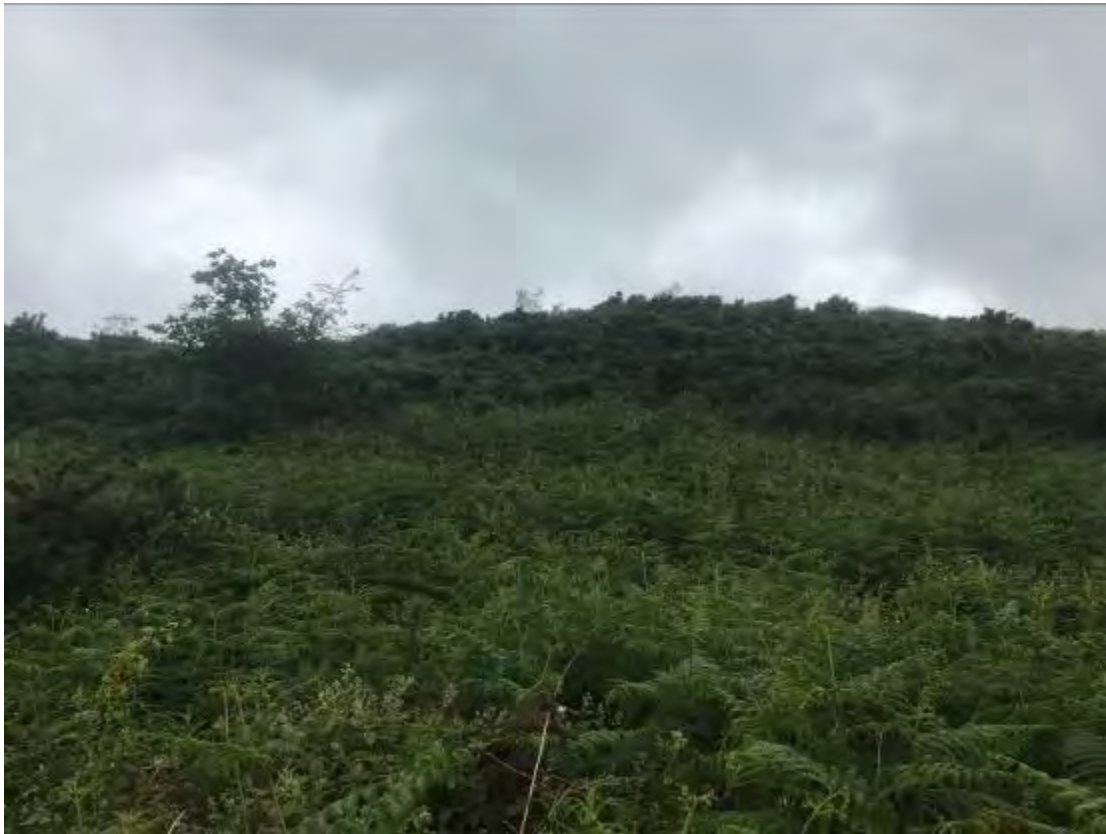
**Photograph 27 – View of Site 3 from toe**
