Site Inspection Report

Pen y Graig Arw Quarry, Ystalyfera

Client: Neath Port Talbot County Borough Council

Date: November 2017

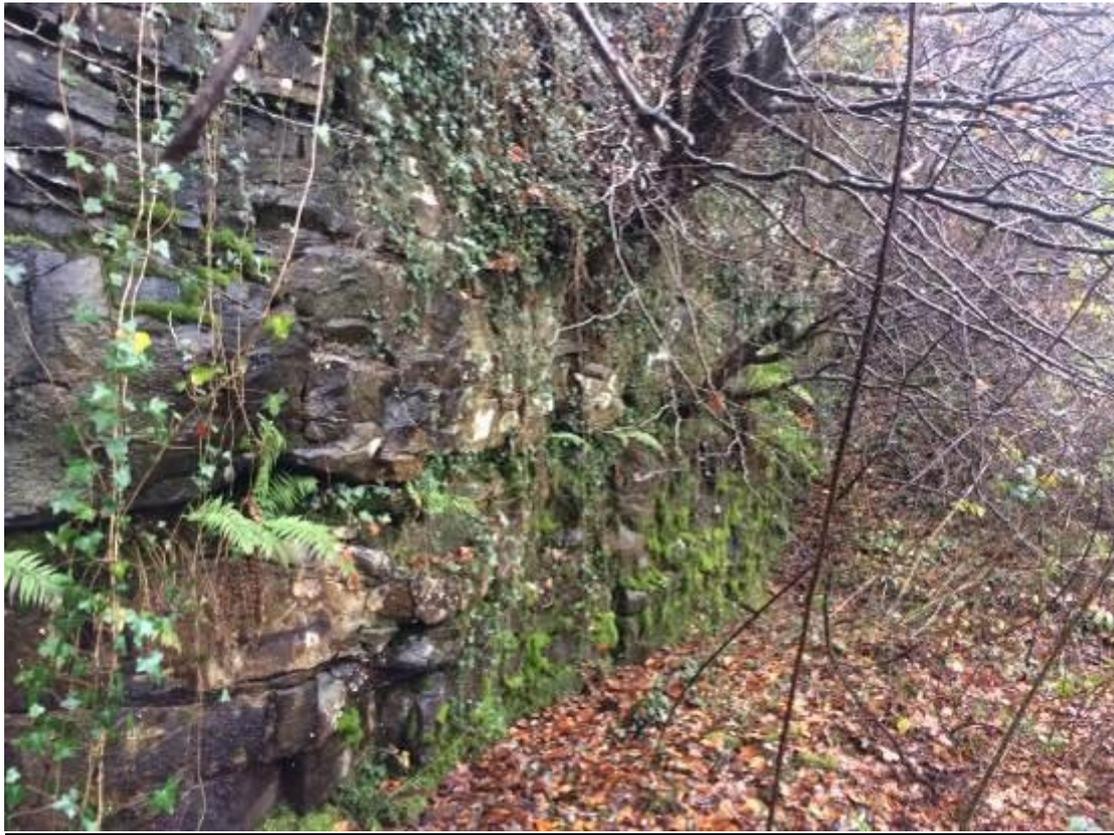
The quarry high wall is generally vertical, with the exposed strata comprising moderately weathered thin to thickly bedded sandstone units, with occasional subordinate siltstones (Photographs 1 to 6).

Photograph 1 – Quarry high wall location

Edge protection fencing and warning signs should be placed along the quarry high wall, and warning signs should be placed at the head of the Panteg landslide to warn the general public of the risk from falling rocks.

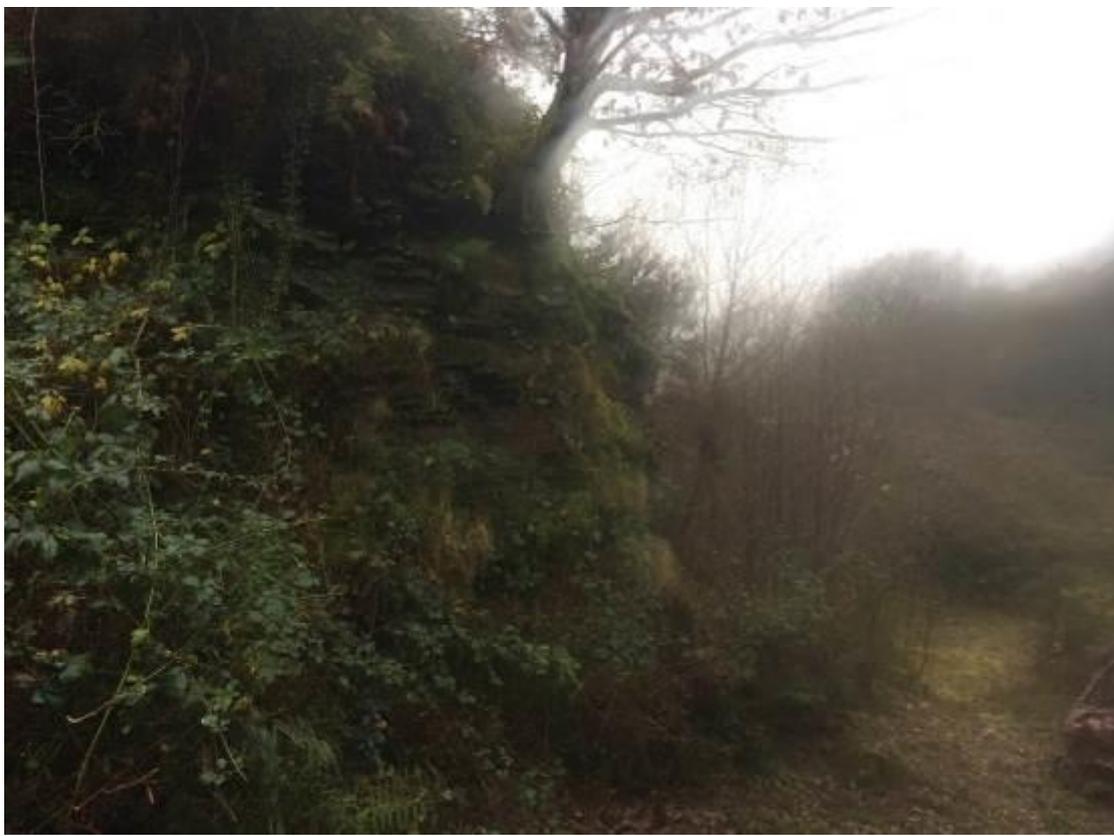
Photograph 2 – Quarry high wall location

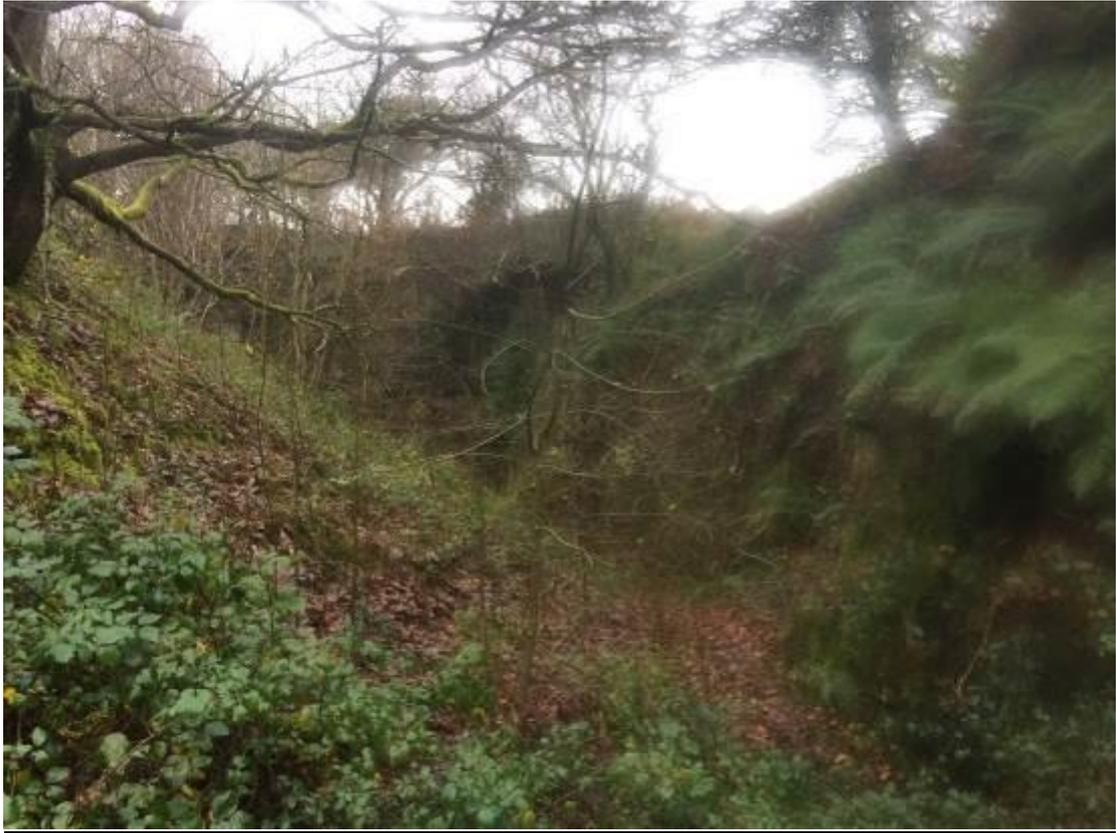
Photograph 3 – Quarry high wall location

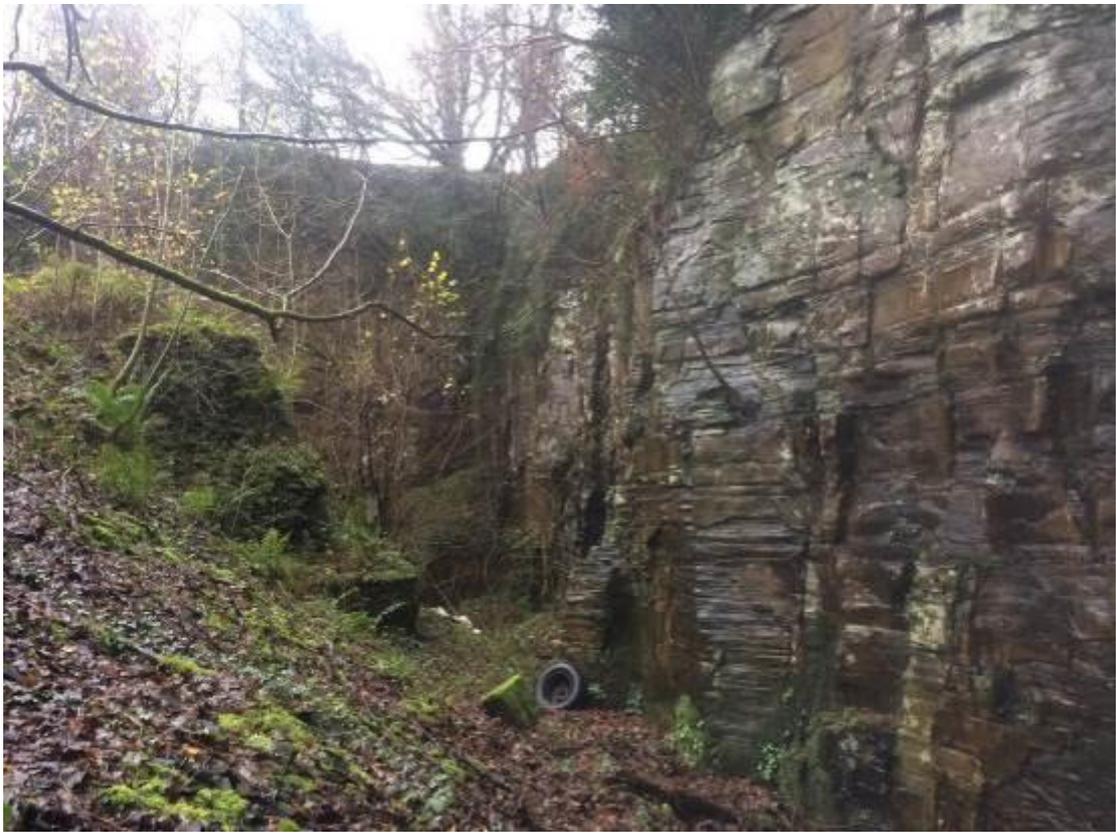
Photograph 4 – Quarry high wall location

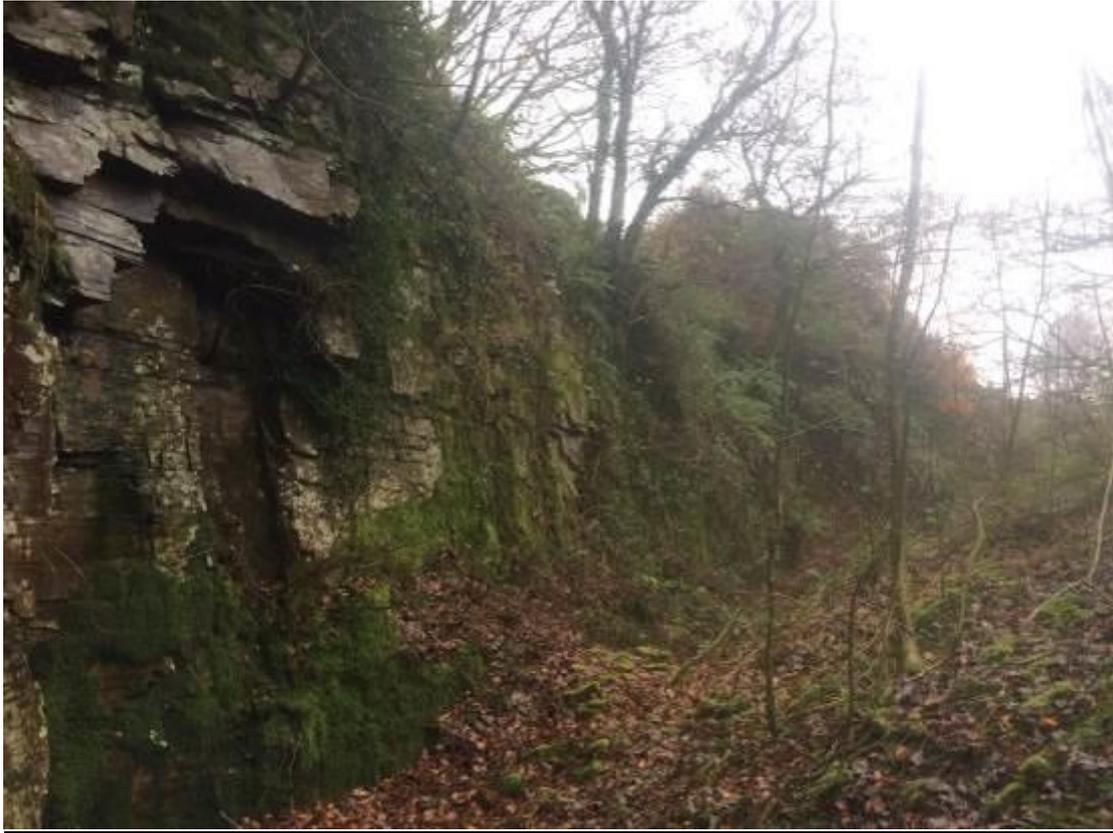
Photograph 5 – Quarry high wall location

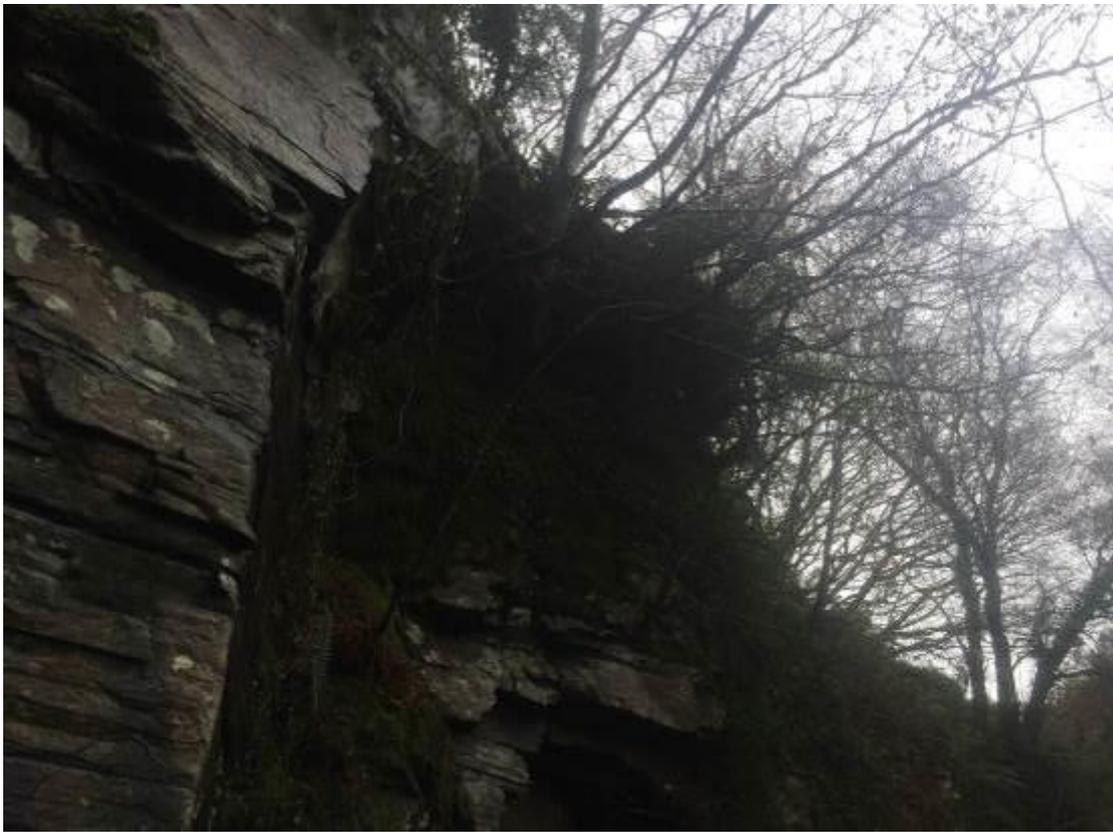
Occasional moderate groundwater seepages were observed from the face, generally at the interface of sandstone / siltstone units and at main joint sets. Several areas of loose overhanging blocks were observed, with occasional small rockfall areas noted (Photograph 6).

Photograph 6 – Quarry high wall showing overhanging block and trees

Selective removal of trees along the cliff edge may reduce the risk of instability along the cliff edge. The opinion of a specialist tree surgeon should be sought as access to the cliff edge presents a significant risk to operatives.

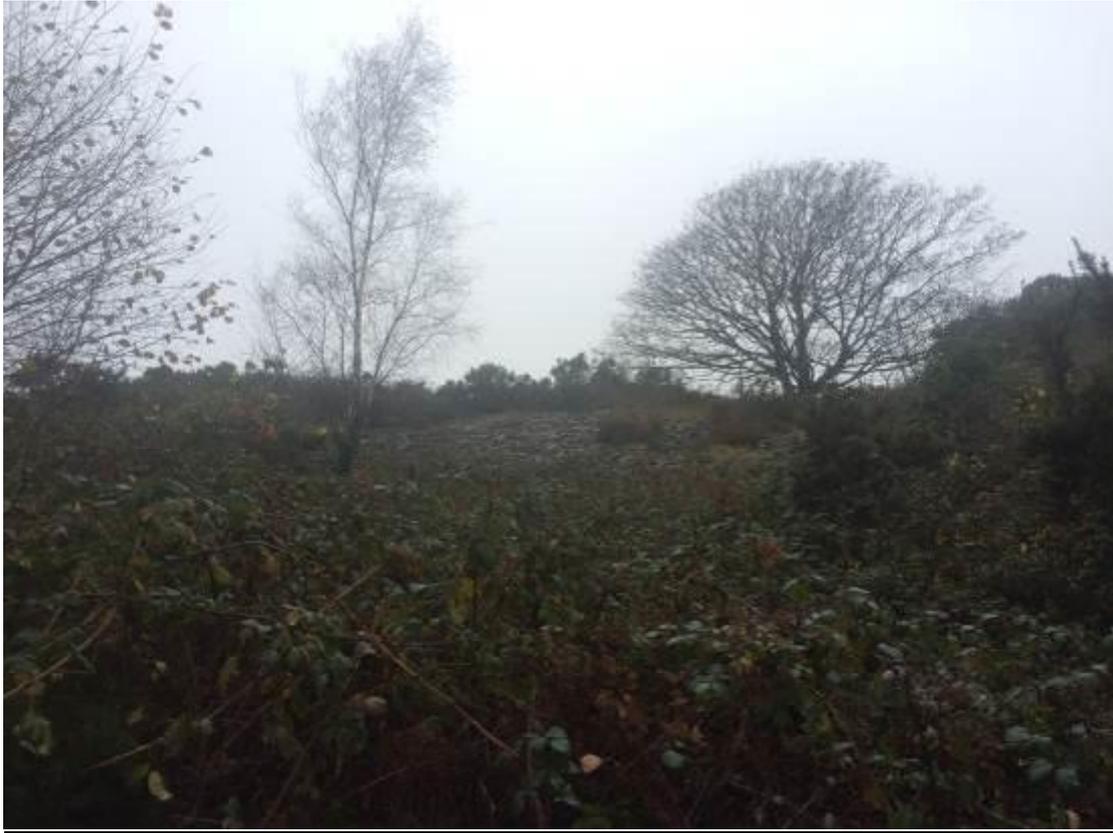
Access was limited to accessible areas and generally along routes cut through the dense vegetation by NPTCBC staff (Photographs 7 and 8).

Photograph 7 – Typical view of vegetation cover

It is recommended that a further inspection is undertaken when additional targeted vegetation clearance has been undertaken, in order to assess any unidentified areas of instability which could affect the quarry site.

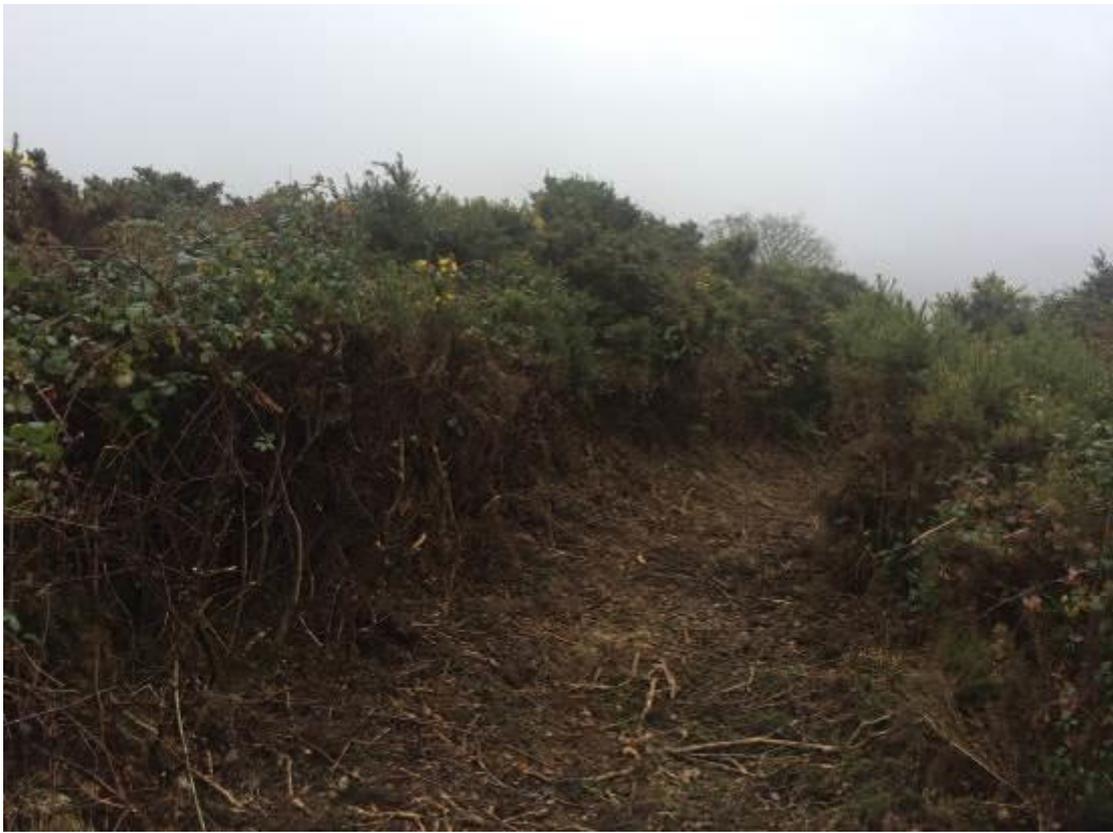
Photograph 8 – Access tracks cut through vegetation

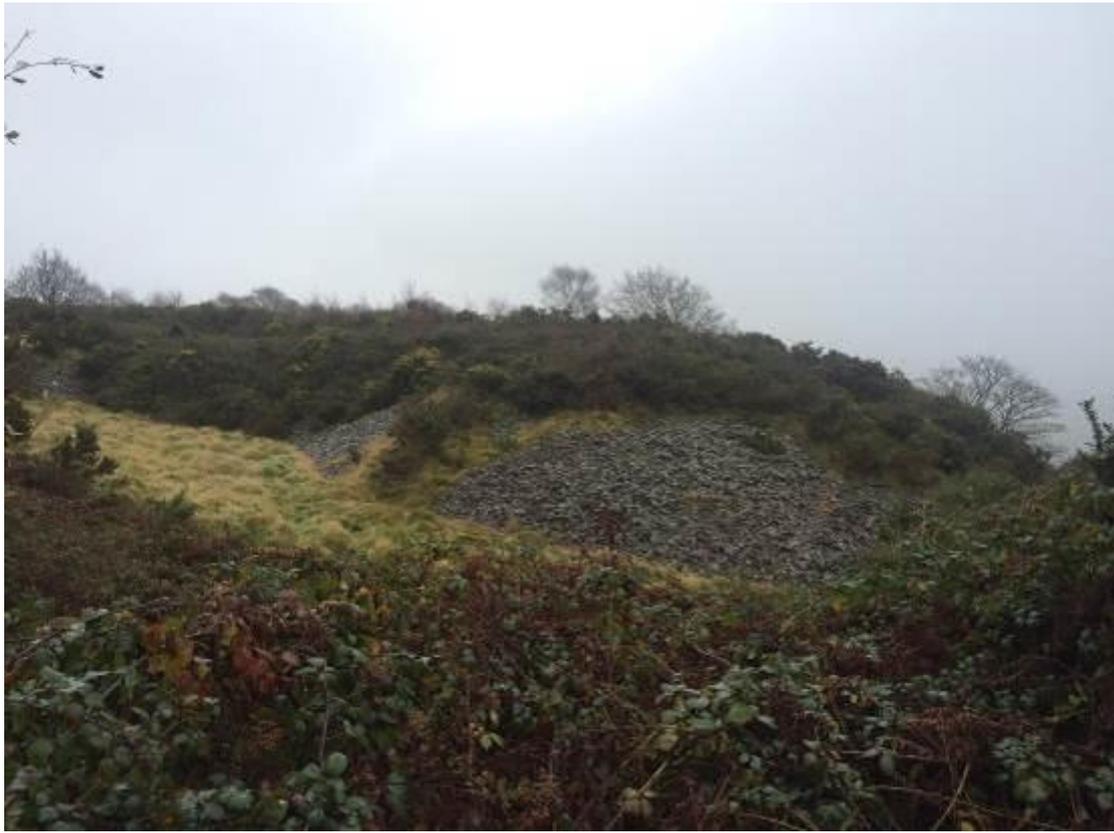
The inspection then viewed the various spoil mounds within the centre of the site. The mounds comprise quarry discard generally comprising flat sandstone within a matrix of finer material (Photographs 9 to 12).

The mounds are generally set at the maximum angle of repose, having been end tipped with little or no compaction. Where the spoil is un-vegetated, the materials appeared relatively loose.

There was no evidence of significant slope failures on any of the spoil mounds, with only localised scour and erosion, probably due to surface water erosion.

Photograph 9 – Quarry waste tip

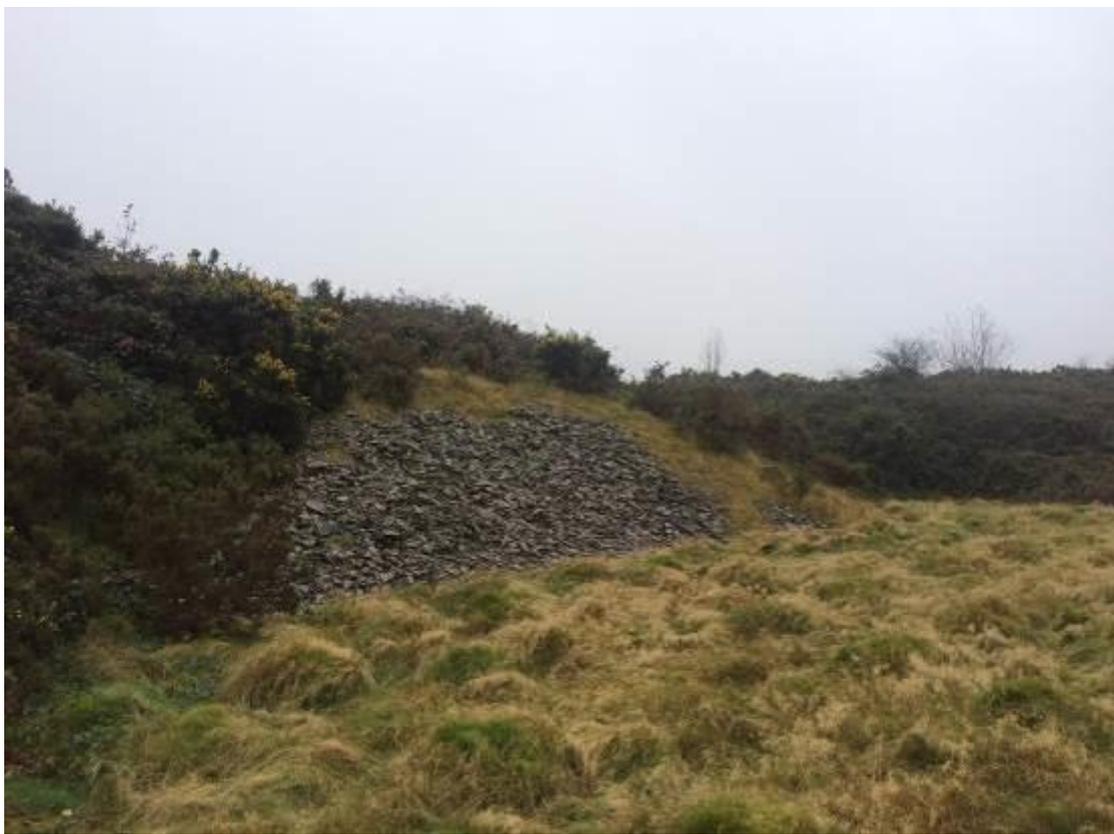
Photograph 10 – Quarry waste tip

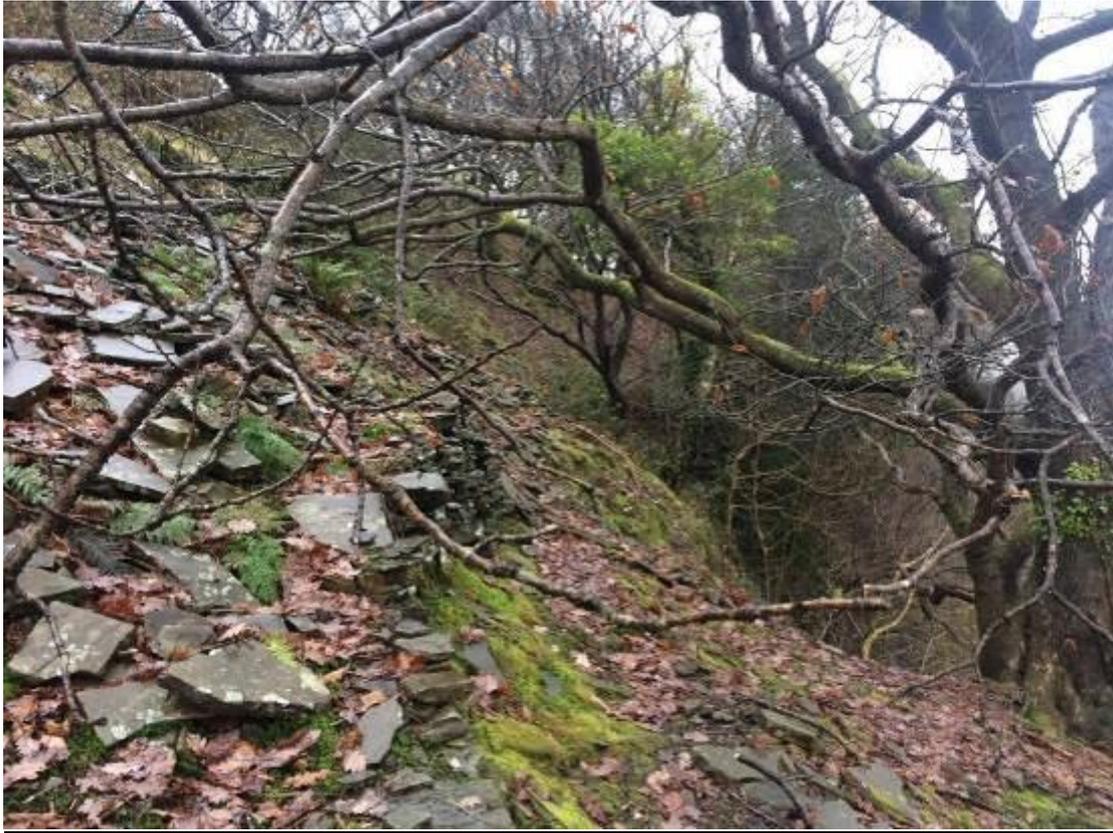
The inspection proceeded to the southern eastern perimeter, where a vertical cliff forms the site boundary. The spoil mounds in this area are in close proximity (<1m in places) to the cliff edge.

Localised spalling and surface erosion of the quarry waste mound sections adjacent the cliff edge may result in small amounts of spoil escaping over the cliff edge during extreme weather events. There was no visual evidence of significant spalling and erosion reaching the cliff edge, but the potential for this to occur presents a low to moderate risk. It is clear that in the past some quarry waste has spilled over the cliff edge, directly above the most recent (2012) Panteg landslide.

Photograph 11 – Quarry waste toe at crest of cliff

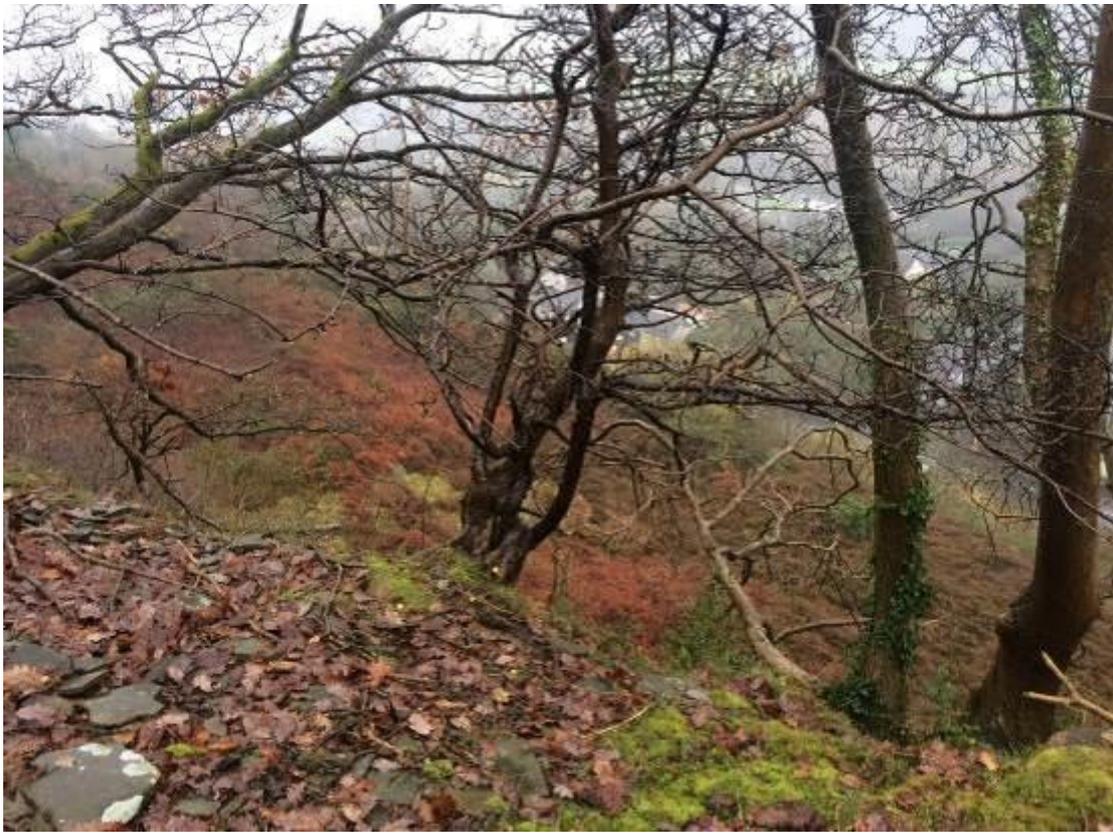
Photograph 12 – Quarry waste toe at crest of cliff

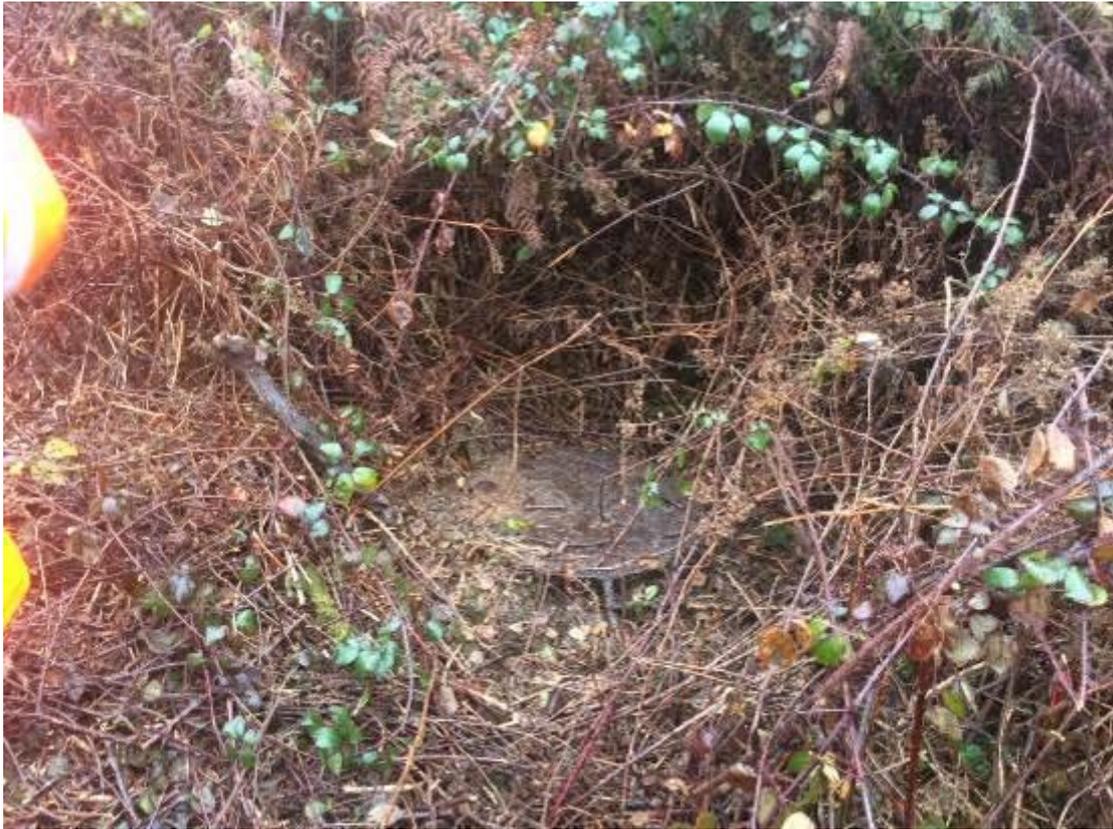
The inspection then followed a previously cleared route along the line of the drainage system. The drainage system appeared to be conveying water flows reasonably well although the chamber and pipes appeared visually to be in poor condition.

Photograph 13 – Manhole chamber along footpath

The condition of the surface water drainage system should be investigated. Dye testing could be utilised to determine flow routes and the ultimate discharge location.

Loose and missing manhole covers should be replaced.

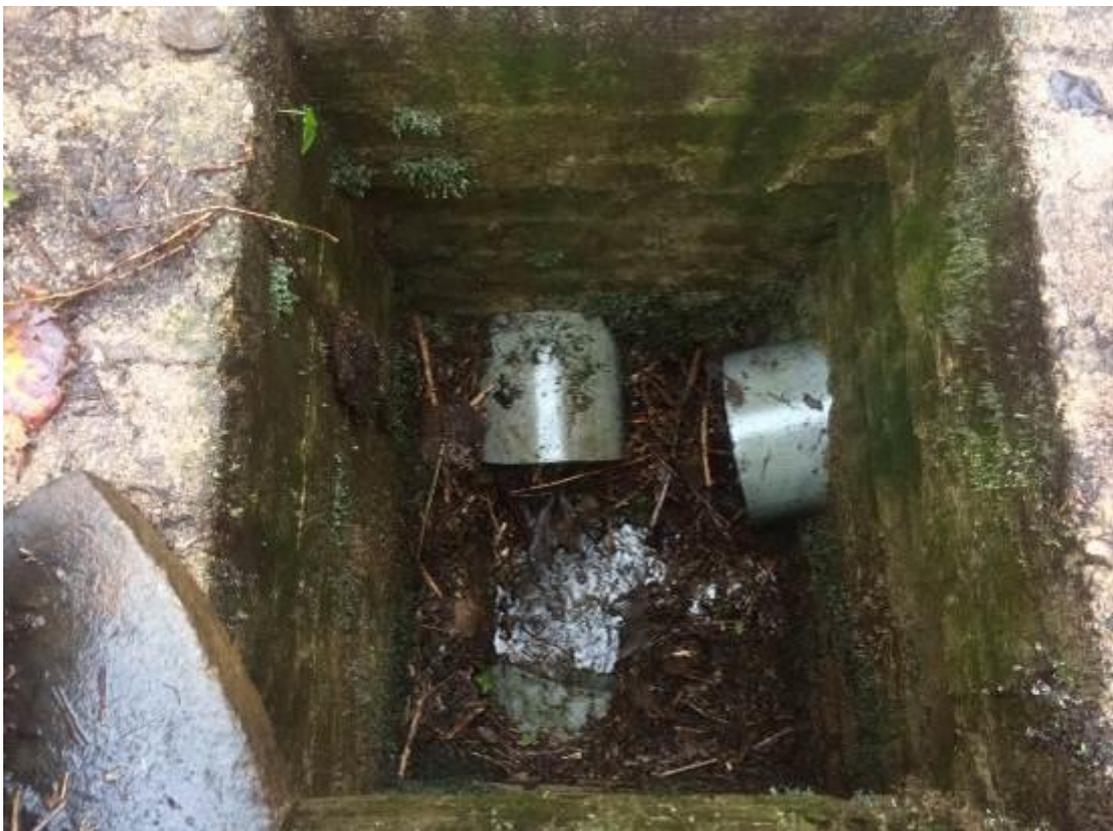
Photograph 14 – Internal view of manhole chamber

Under ideal conditions a CCTV survey of the drainage system should be carried out, however, access restrictions may preclude this exercise.

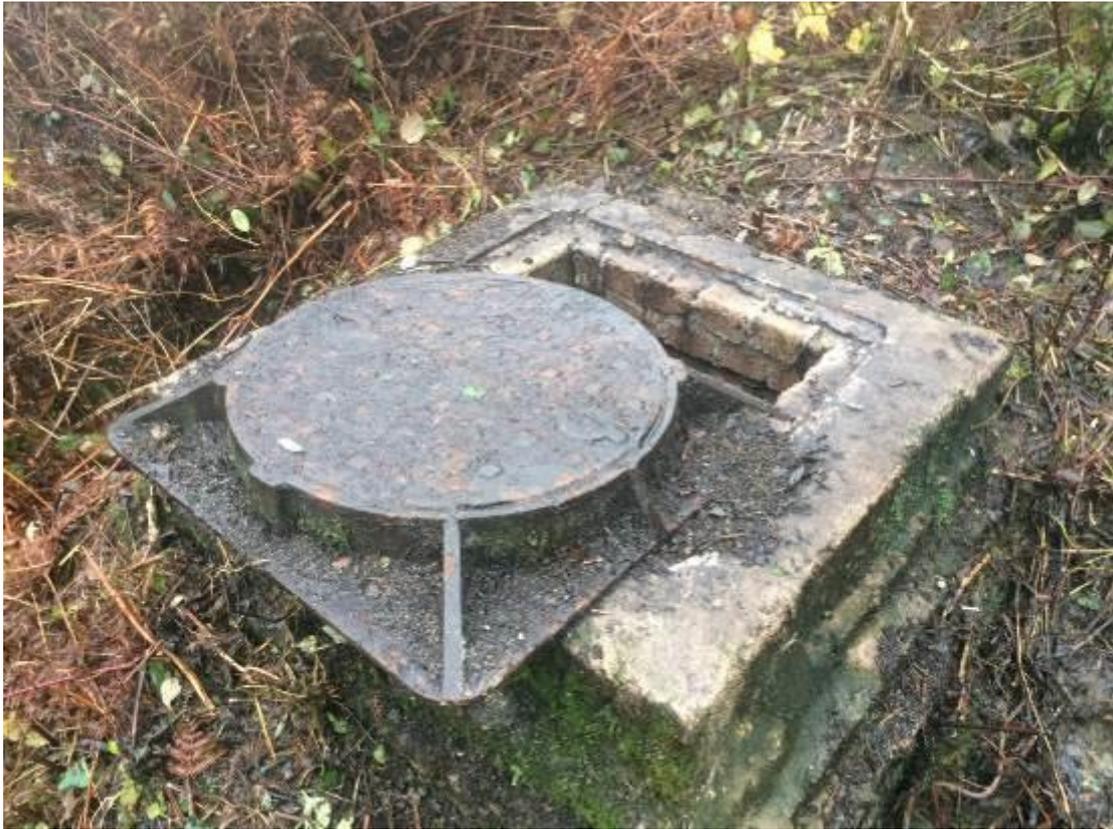
Photograph 15 – Manhole chamber along footpath

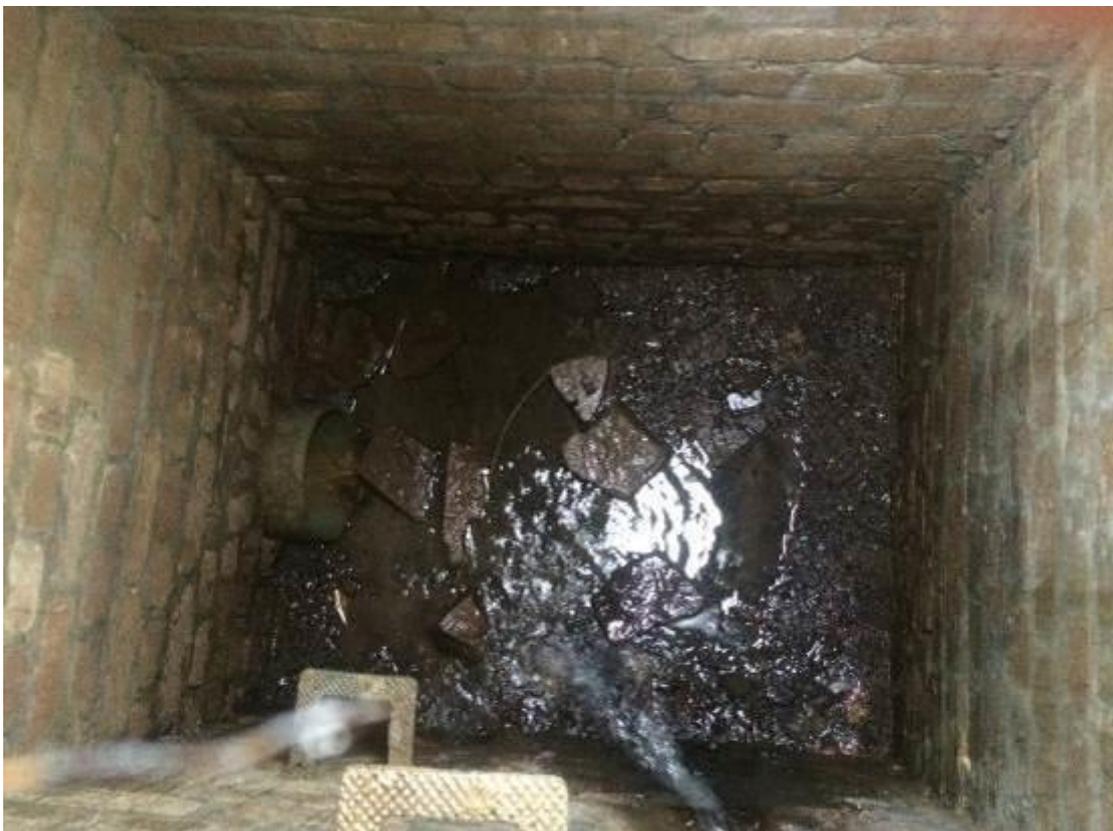
Photograph 16 – Internal view of manhole chamber

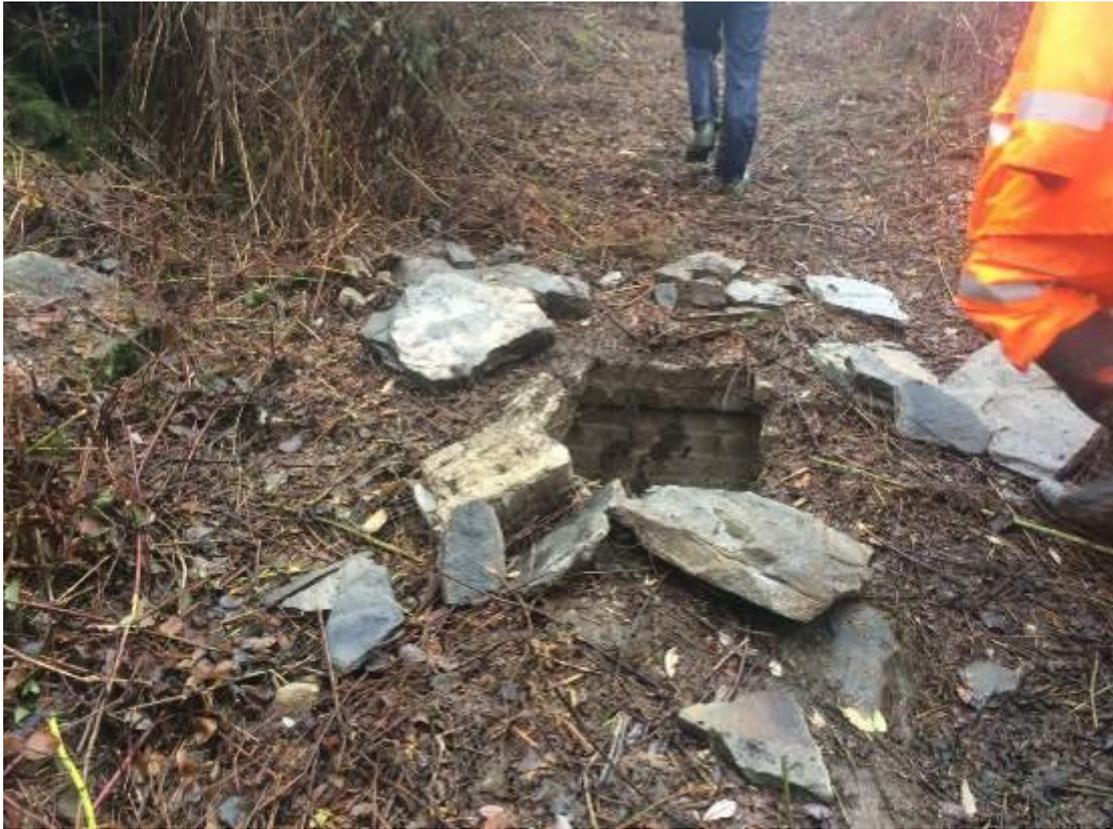
Photograph 17 – Manhole chamber along footpath

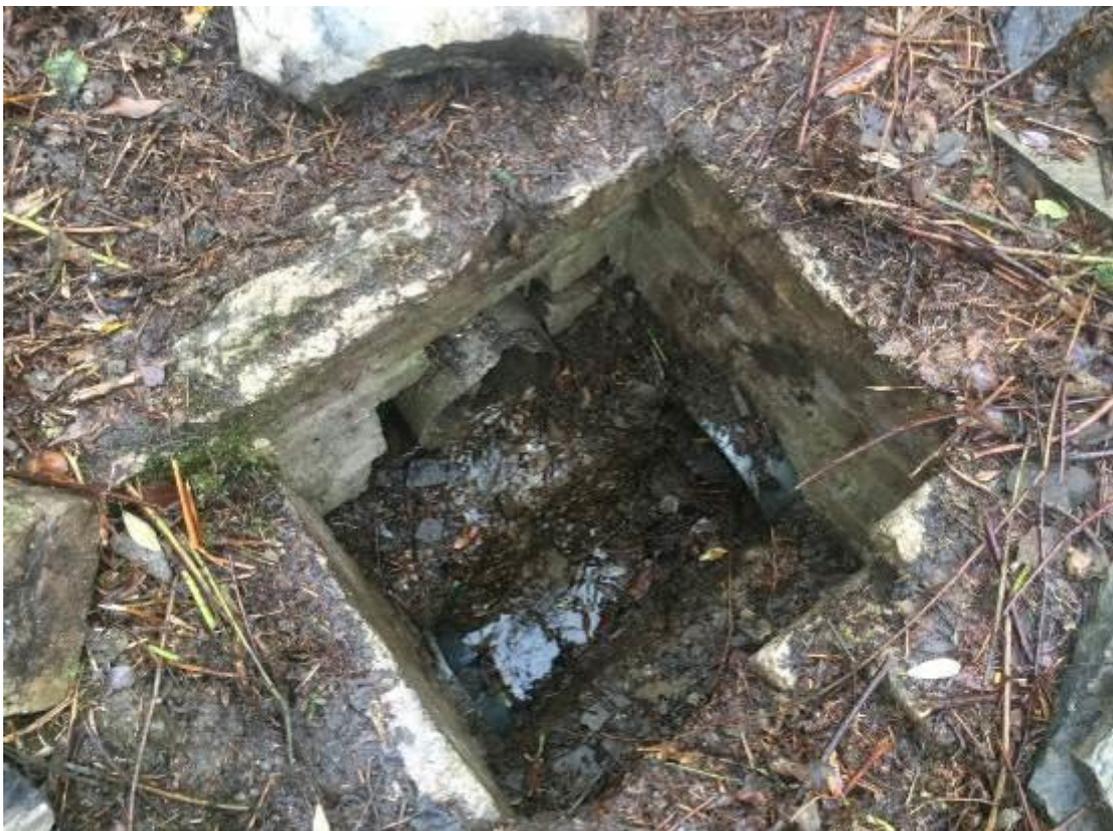
Photograph 18 – Internal view of manhole chamber

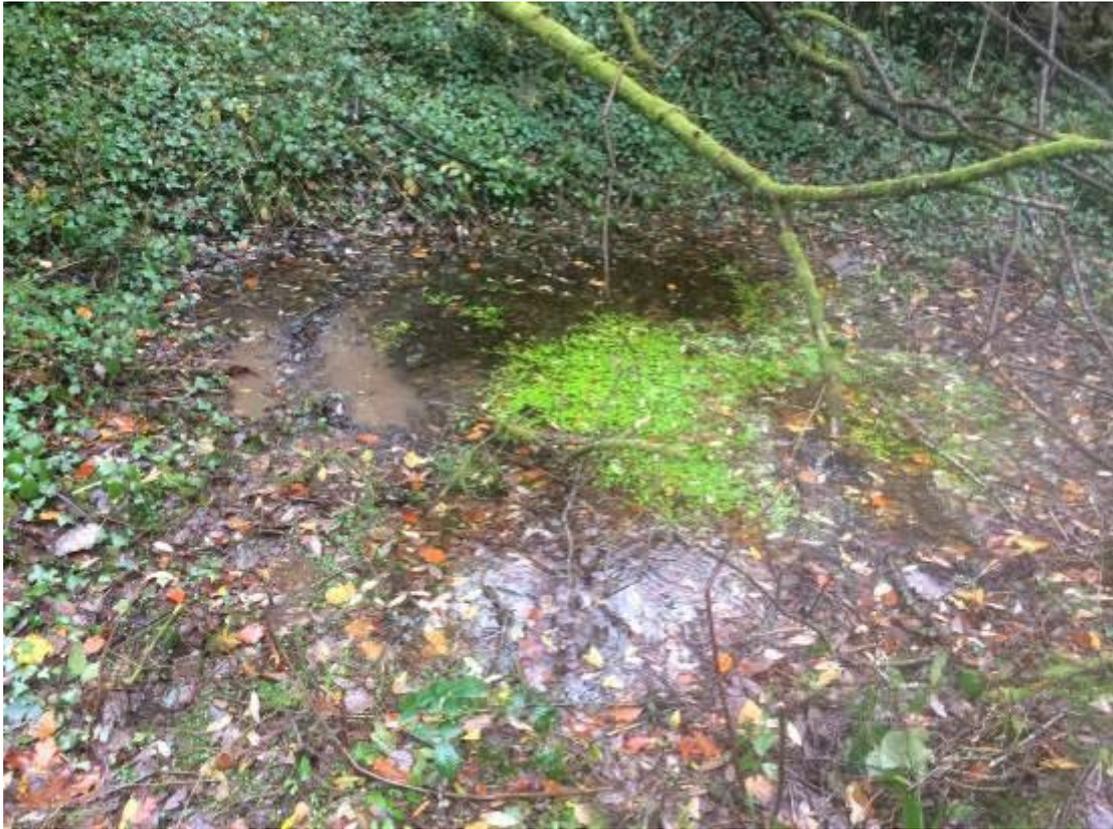
Localised areas of standing water were observed within the quarry floor (Photograph 19), suggesting that the drainage system is either not functioning or not present within this area. It is likely that water infiltrating the quarry floor will emerge at the base of the cliff to the eastern boundary, at the interface of the sandstone / mudstone strata and the position of the Lower Pinchin coal seam.

Photograph 19 – Area of ponding within quarry floor

It is suggested that if the existing drainage system has sufficient capacity, it could be extended to capture areas of ponding within the quarry floor.

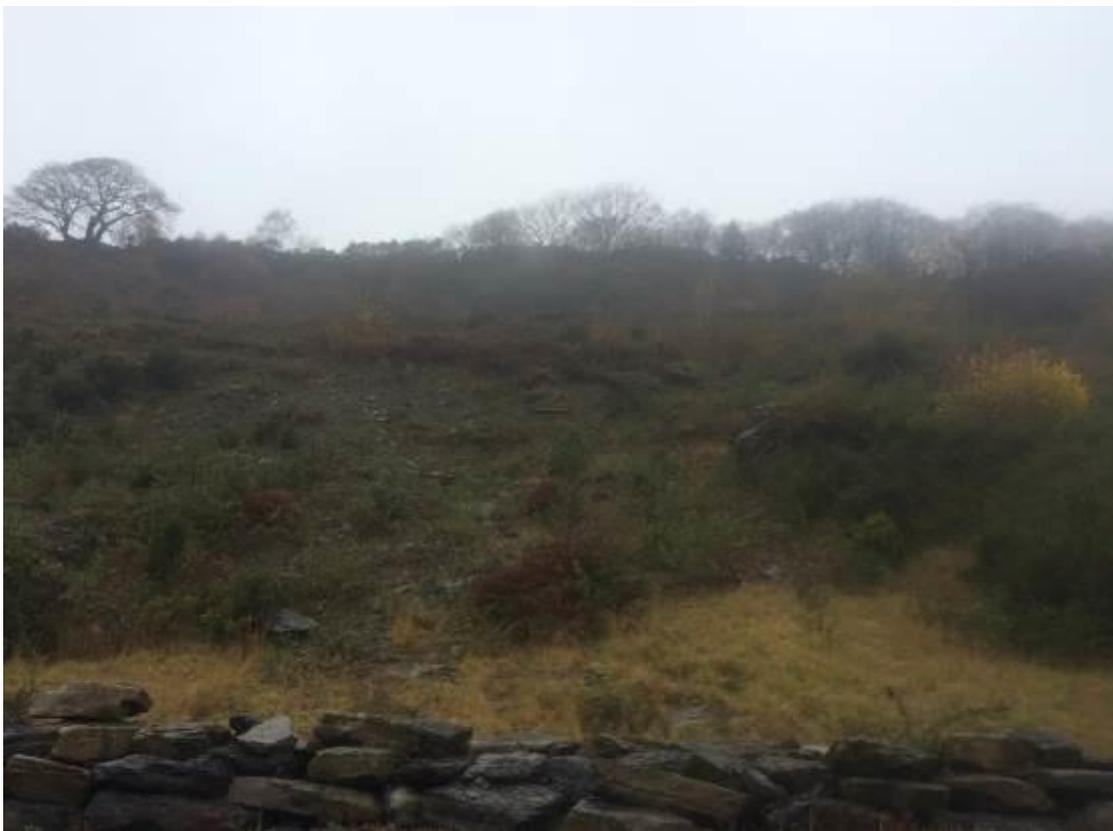
A significant failure of the eastern cliff edge would result in destabilising of the adjacent spoil mounds, leading to collapse and deposition onto the plateau area at the base of the cliff. Such a failure would surcharge the existing landside and would likely cause further downslope movement. Based on a visual assessment this scenario is considered to present a low to medium risk under current conditions. Due to access restrictions and dense vegetation cover, it was not possible to inspect the condition of the interface of the cliff base and head of the Panteg landslide.

Photograph 20 – View of Panteg landslip with quarry beyond crest
