**The Coal
Authority**

Site Inspection Report

Pen y Graig Arw Quarry, Ystalyfera

Date: May 2018

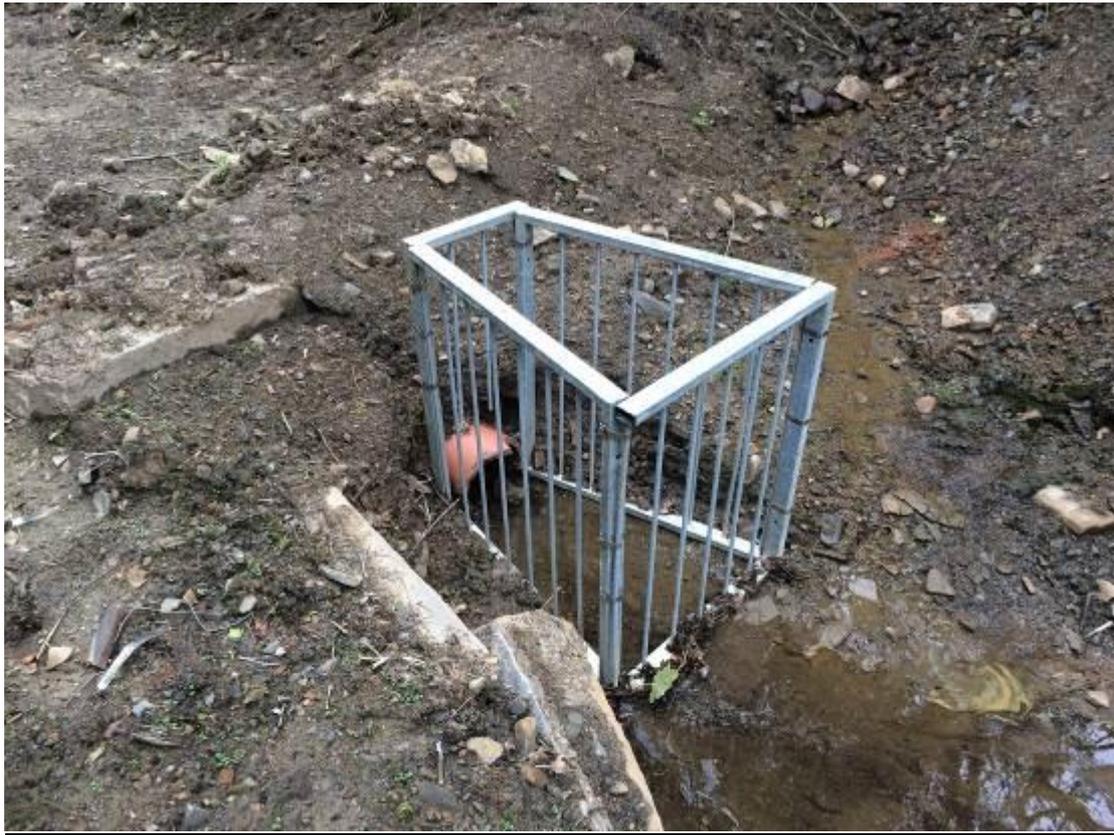
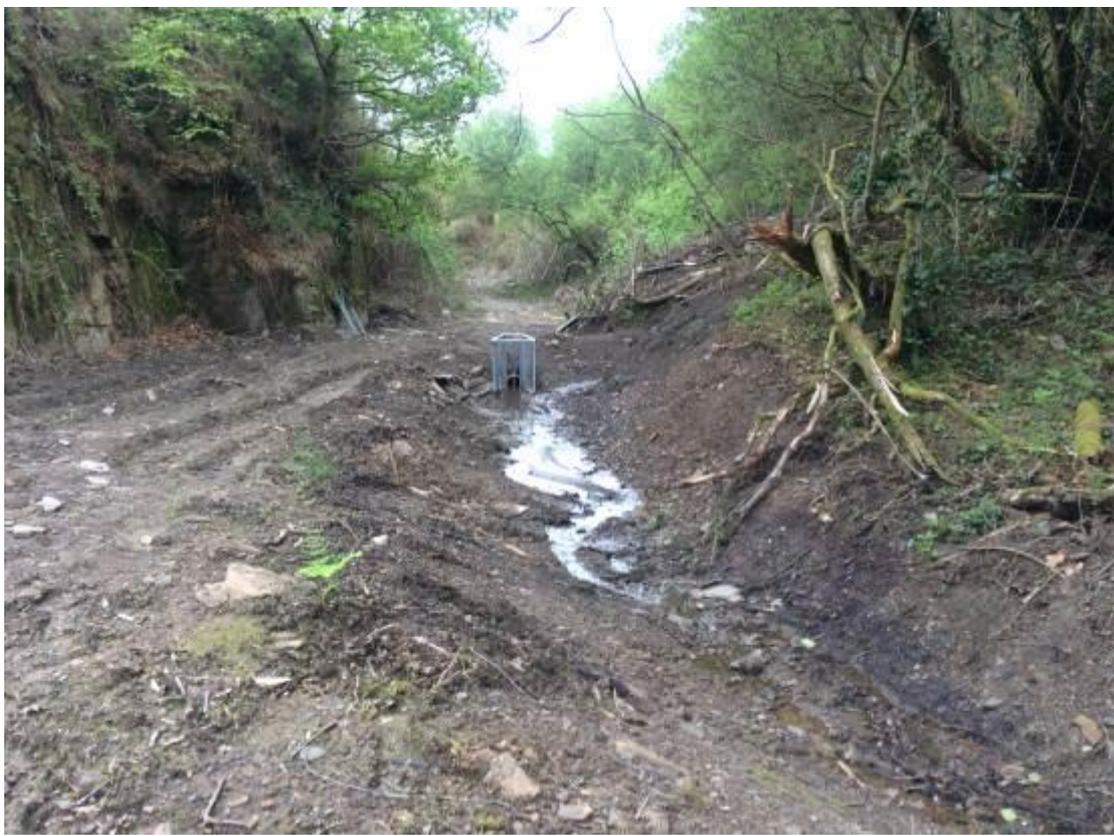
The area of ponding water within the quarry floor, identified in the previous report, has now been drained by the installation of a new pipe and headwall, with associated trash screen (Photographs 1 to 3). This feature connects to the existing Pen Y Graig drainage system and appeared to be functioning satisfactorily. The inlet headwall appeared incomplete and requires further work to formalise the structure.

Photograph 1 – Pipe inlet and screen within quarry floor

Photograph 2 – Pipe inlet and screen within quarry floor

The recently installed headwall and screen structure in the quarry floor should be inspected at regular intervals to ensure blockages do not occur.

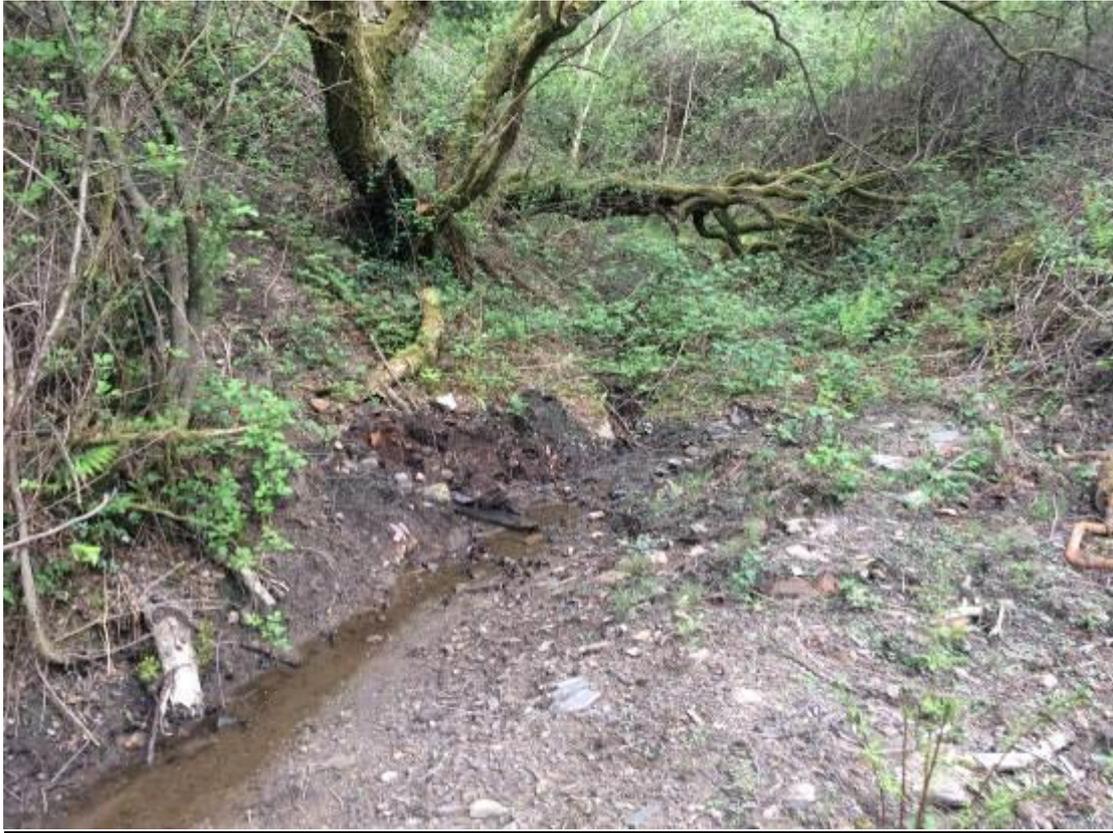
Photograph 3 – Water flows toward pipe inlet in quarry floor

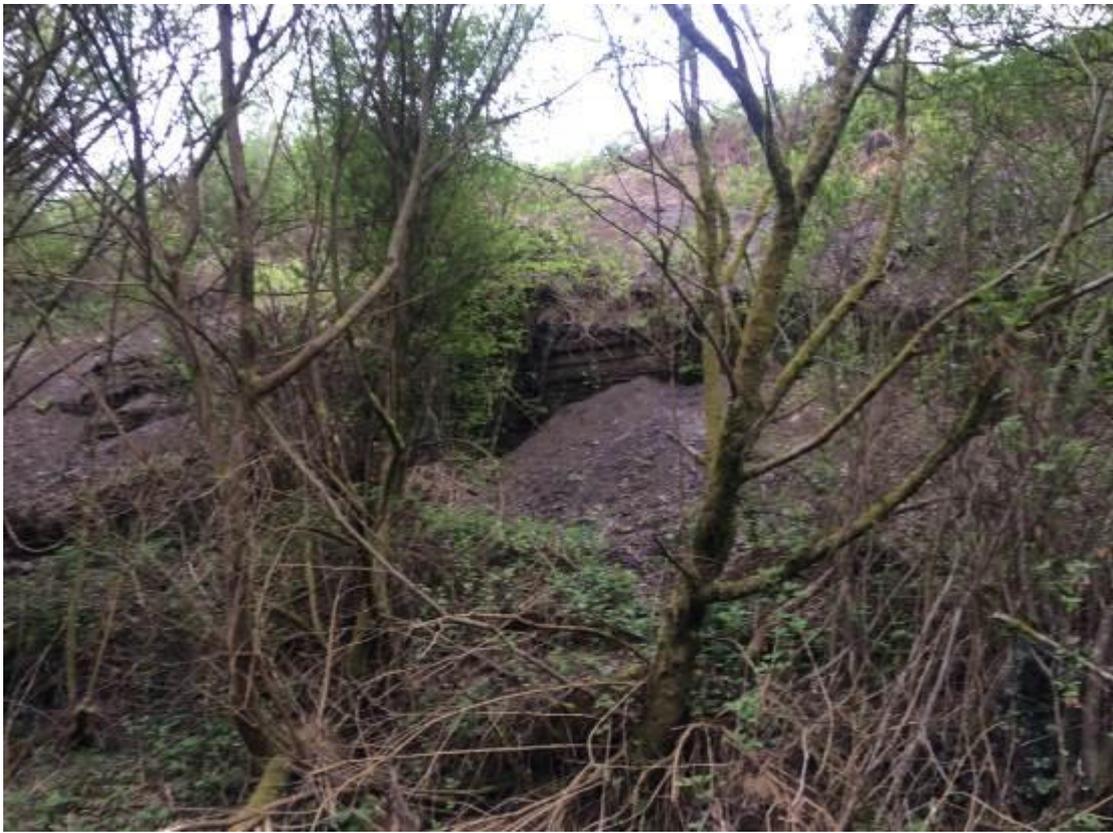
Occasional moderate groundwater seepages were observed from the face, generally at the interface of sandstone / siltstone units and at main joint sets. Several areas of loose overhanging blocks were observed, with occasional small rock-fall areas noted. Vegetation clearance permitted the inspection of scree slopes at the base of the high wall.

Photograph 4 – Cleared vegetation showing quarry face scree

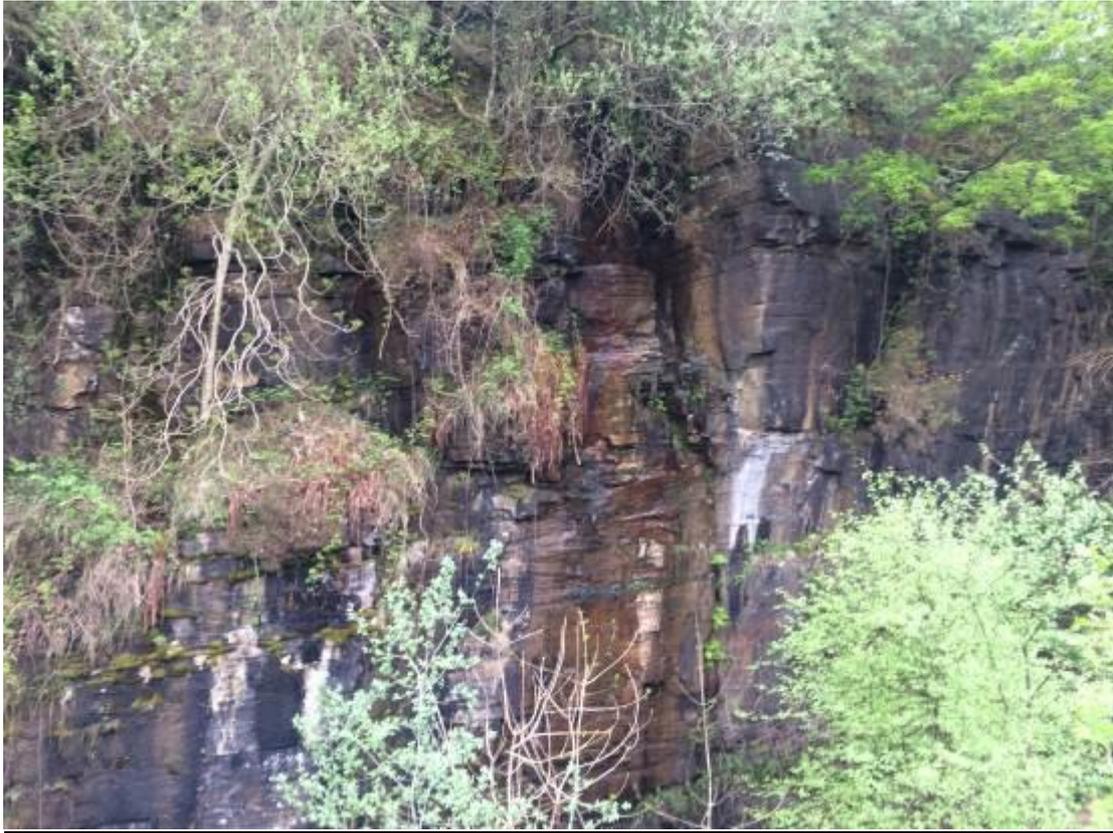
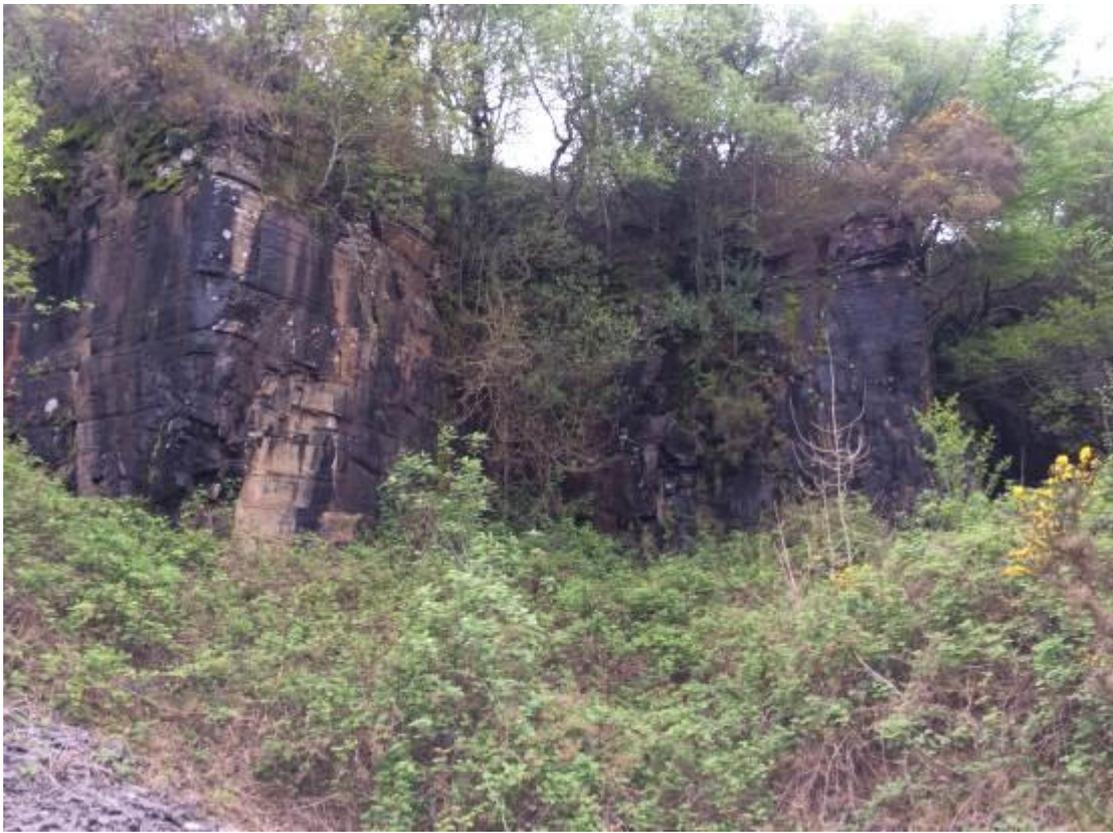
Photograph 5 – Quarry high wall showing seepages

Photograph 6 – Quarry high wall showing seepages

Edge protection fencing and warning signs should be placed along the quarry high wall, and warning signs should be placed at the head of the Panteg landslide to warn the general public of the risk from falling rocks.

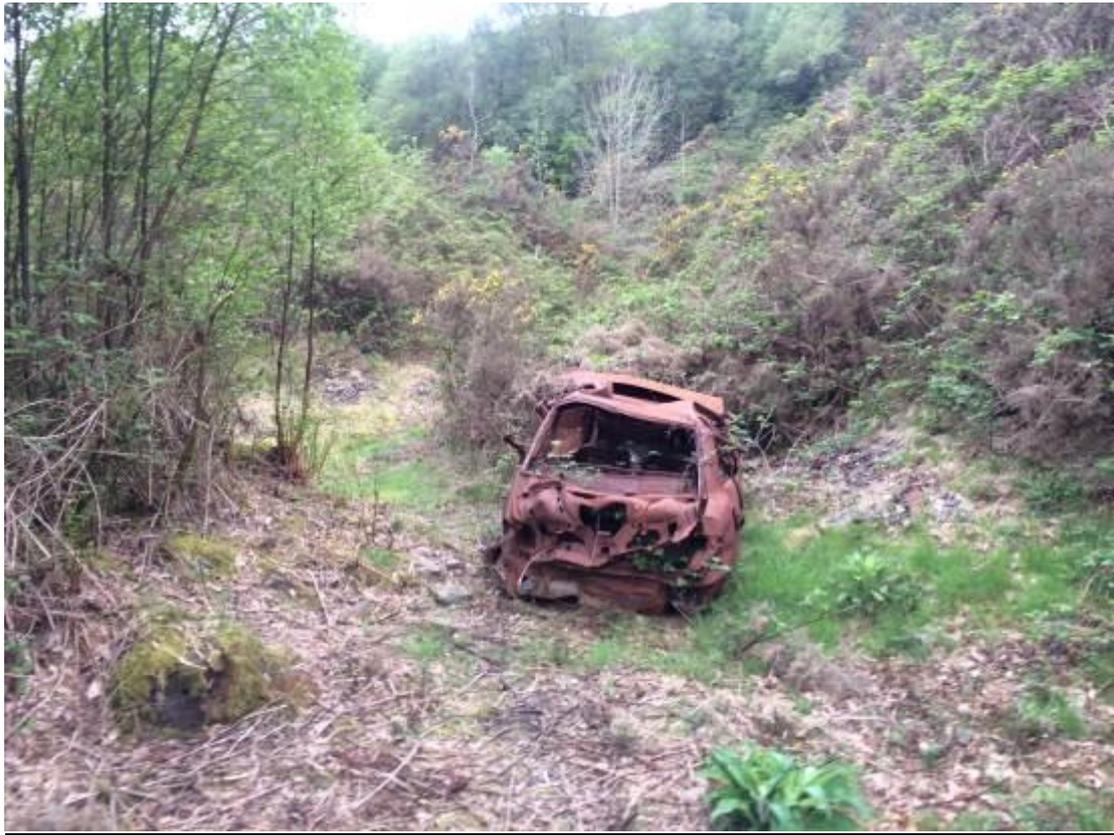
The high wall did not appear to have adequate fencing at the crest and no warning notices were present. As outlined in the previous inspection, areas of fly tipping, comprising gas bottles, corrugated steel sheets and a burnt out car were observed within the quarry floor.

Photograph 7 – Burnt out car in quarry floor

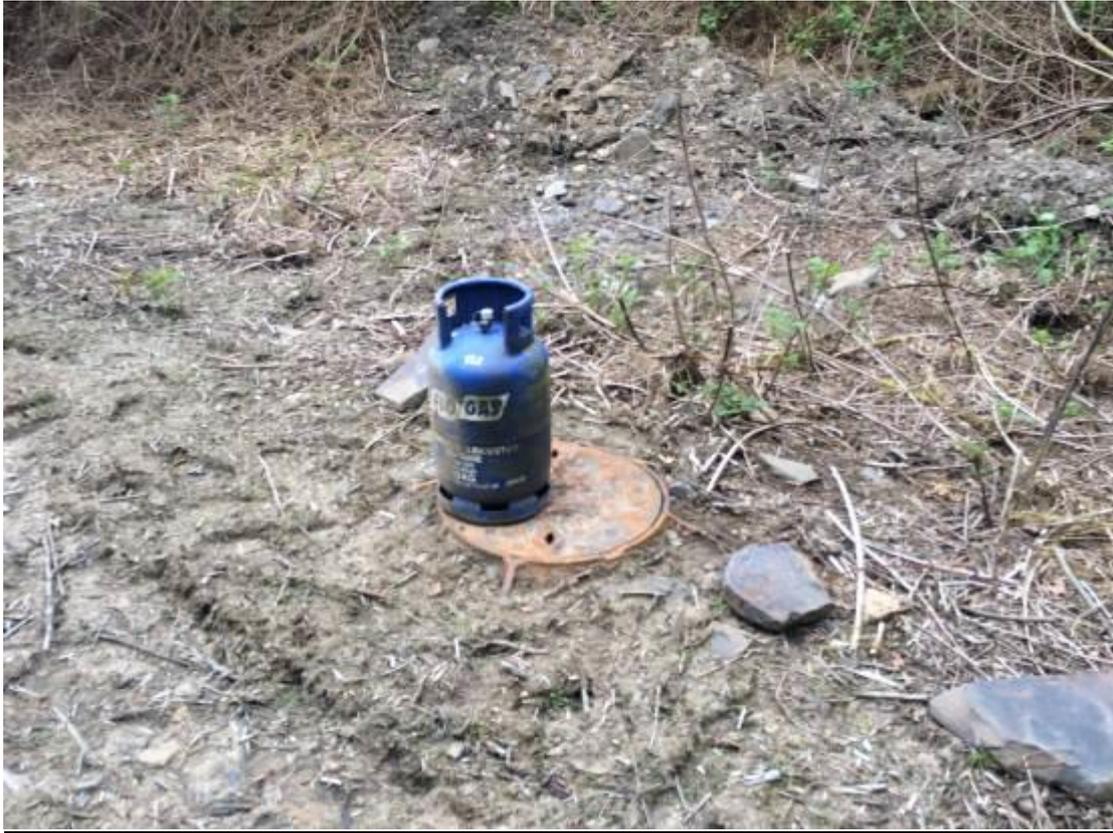
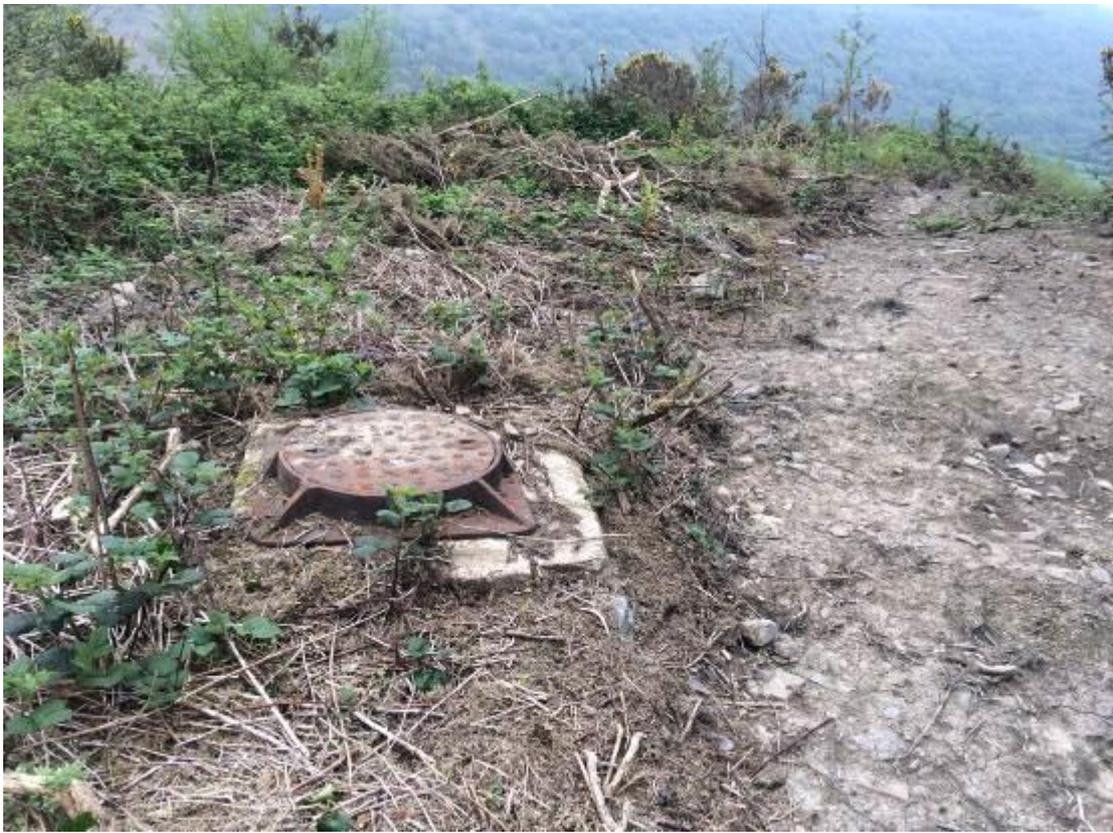
Photograph 9 – Exposed manhole cover following vegetation clearance

Photograph 10 – Exposed manhole cover following vegetation clearance

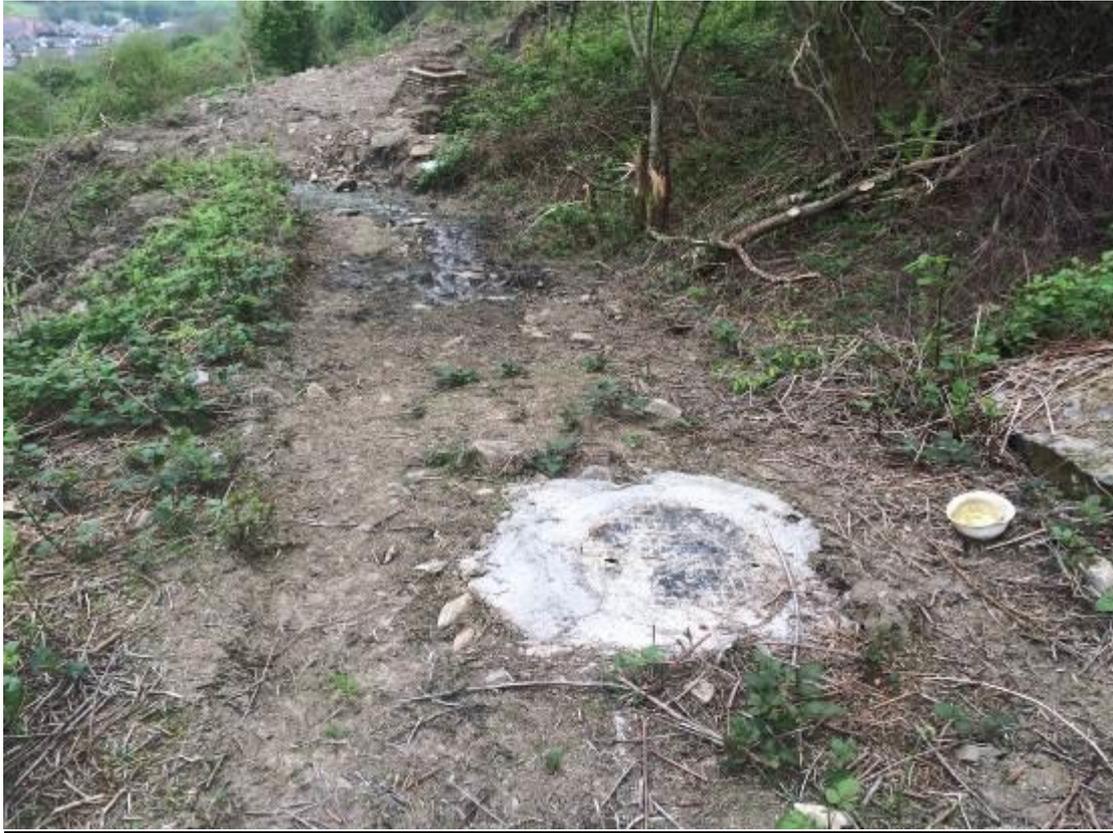
Photograph 11 – Seepage downstream of manhole cover

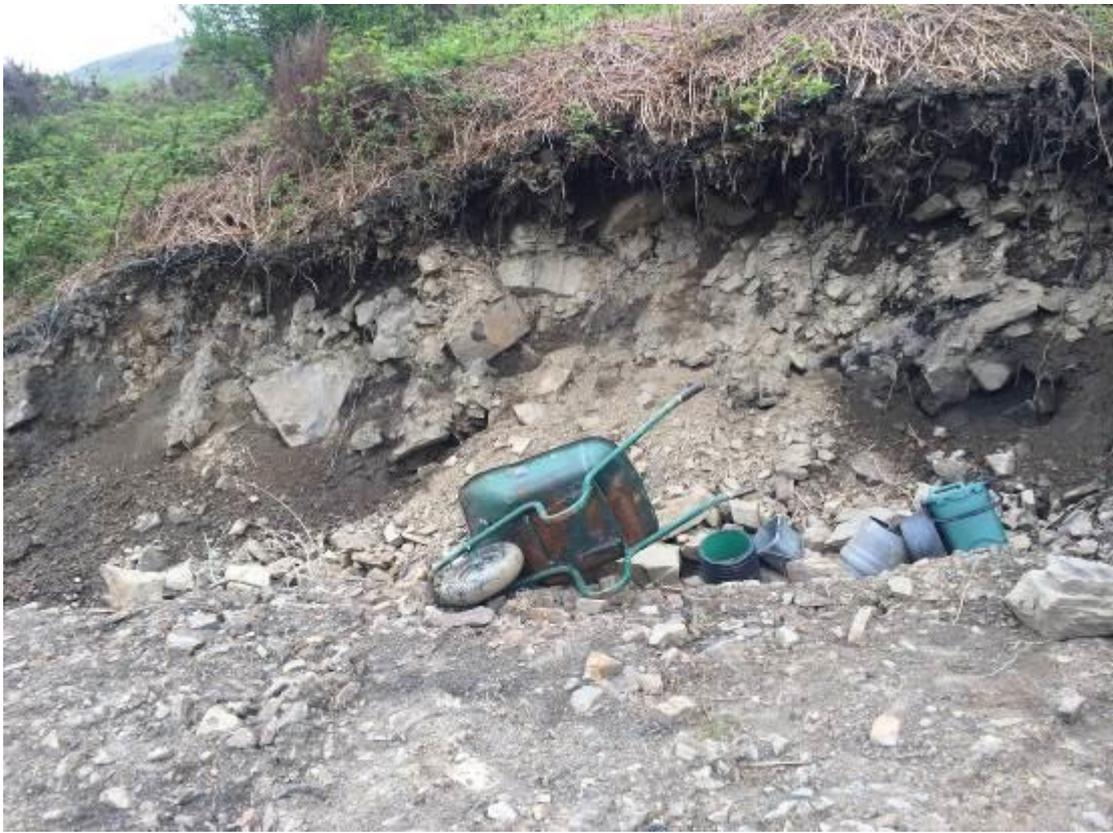
Photograph 12 – Excavation into bank with tools left on site

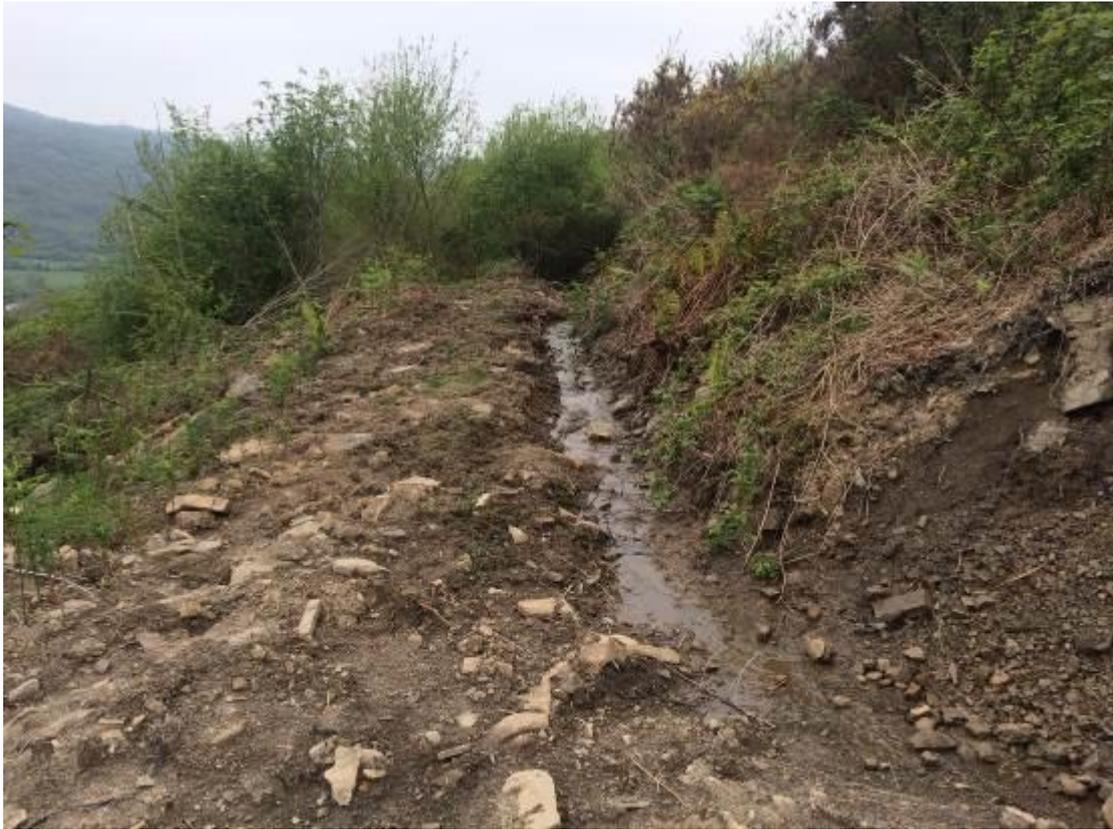
A new section of unlined ditch has been constructed, conveying flows to the collection chambers at the head of the elevated pipe drainage system. Flows within the ditch were seen to disappear at several locations into the underlying bedrock via small fractures within the rock. A section of pipe in this area requires backfilling, and investigation of a possible leak in the system should be carried out (Photographs 13 to 16).

Photograph 13 – New unlined drainage ditch

The recently excavated unlined ditch should be completed by providing an impermeable liner to ensure flows are conveyed along its length and do not disappear into underlying fractures within the bedrock.

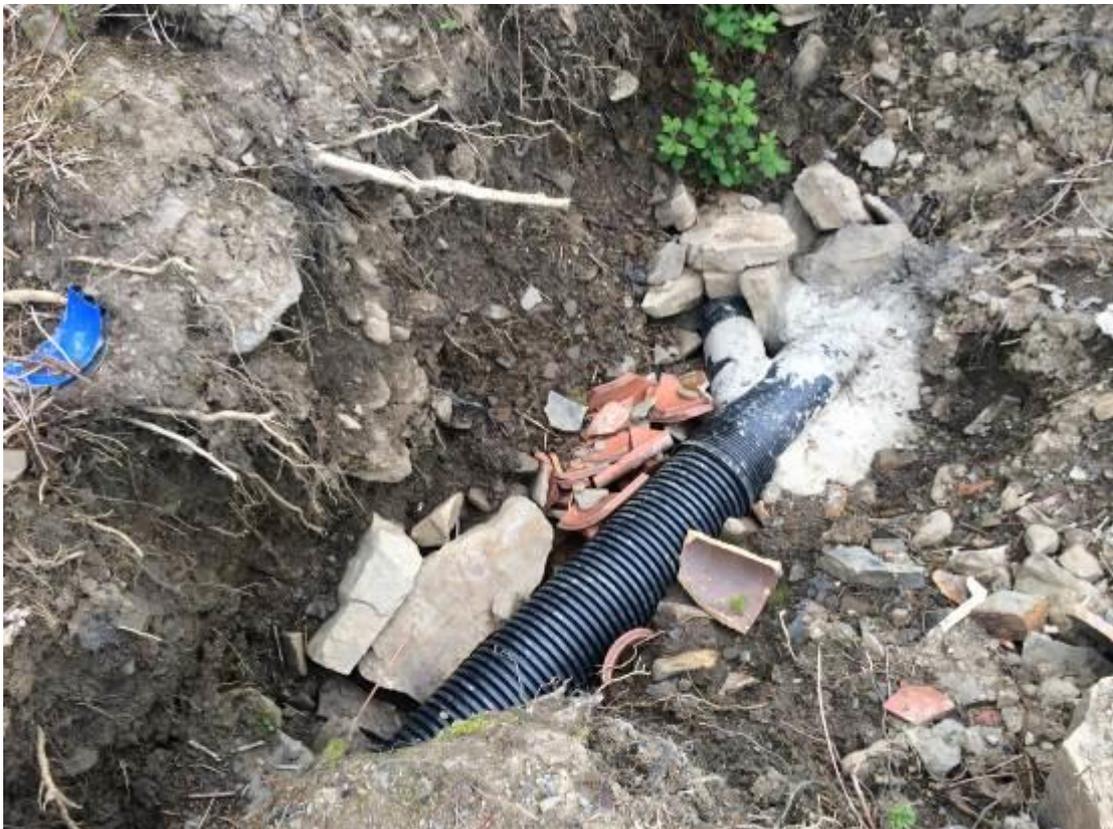
Photograph 14 – Exposed pipe requiring backfill

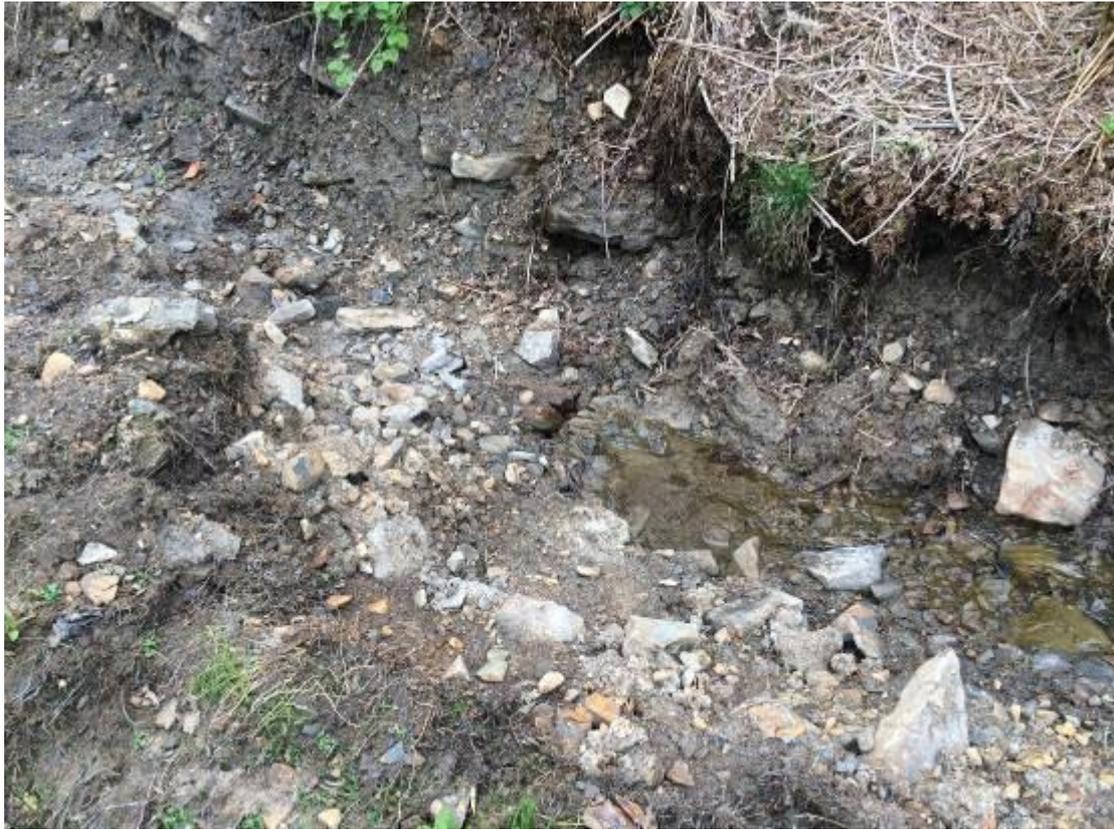
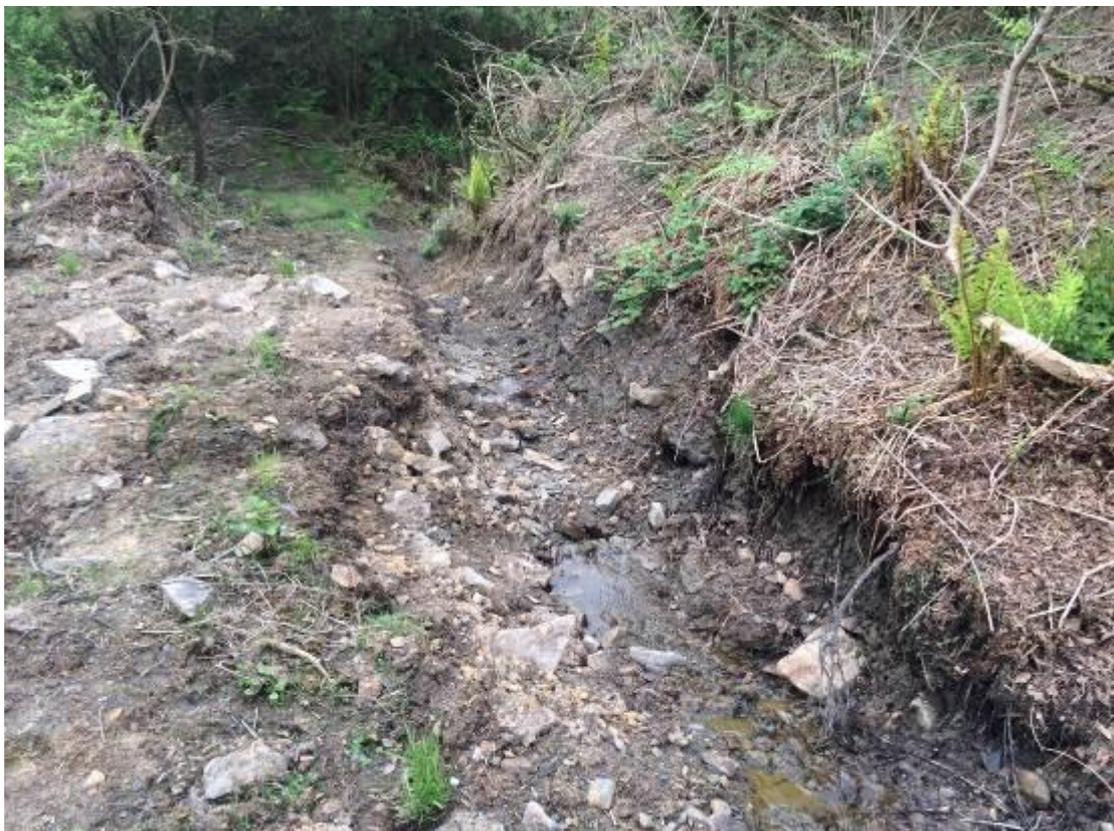
Photograph 15 – Flows disappearing into fractured rock at ditch invert

Photograph 16 – Flows disappearing into fractured rock at ditch invert

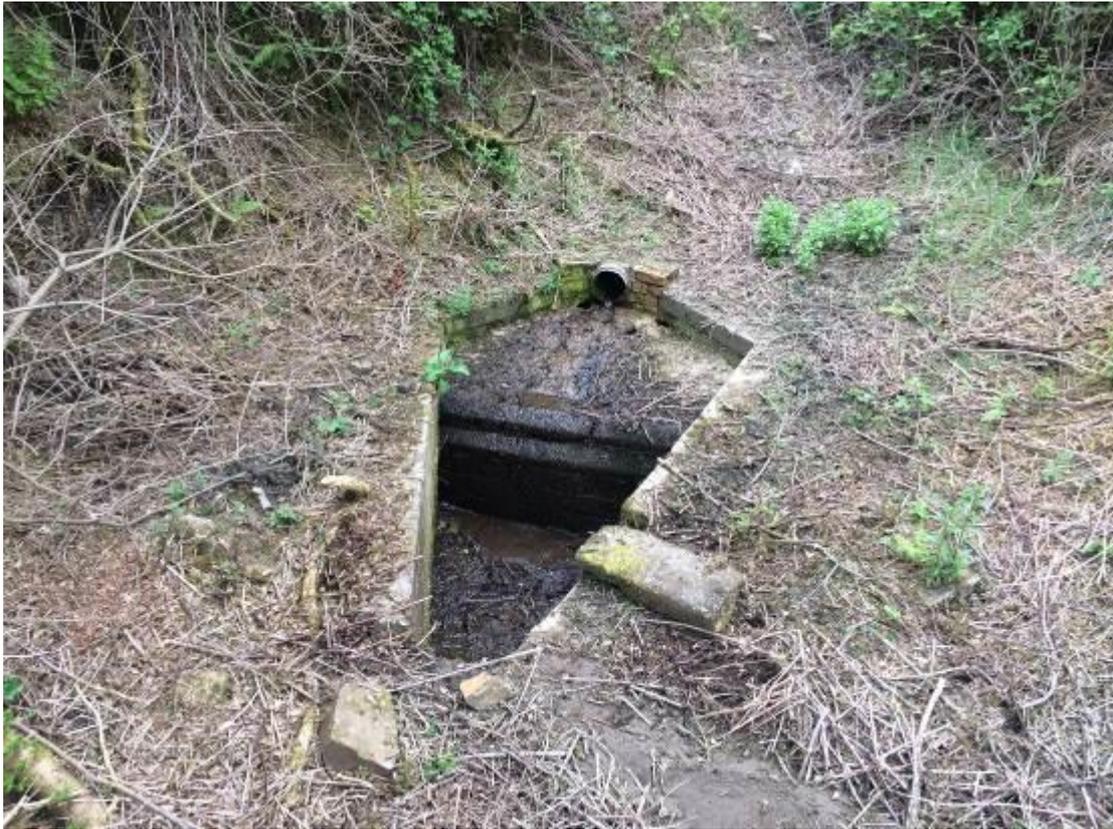
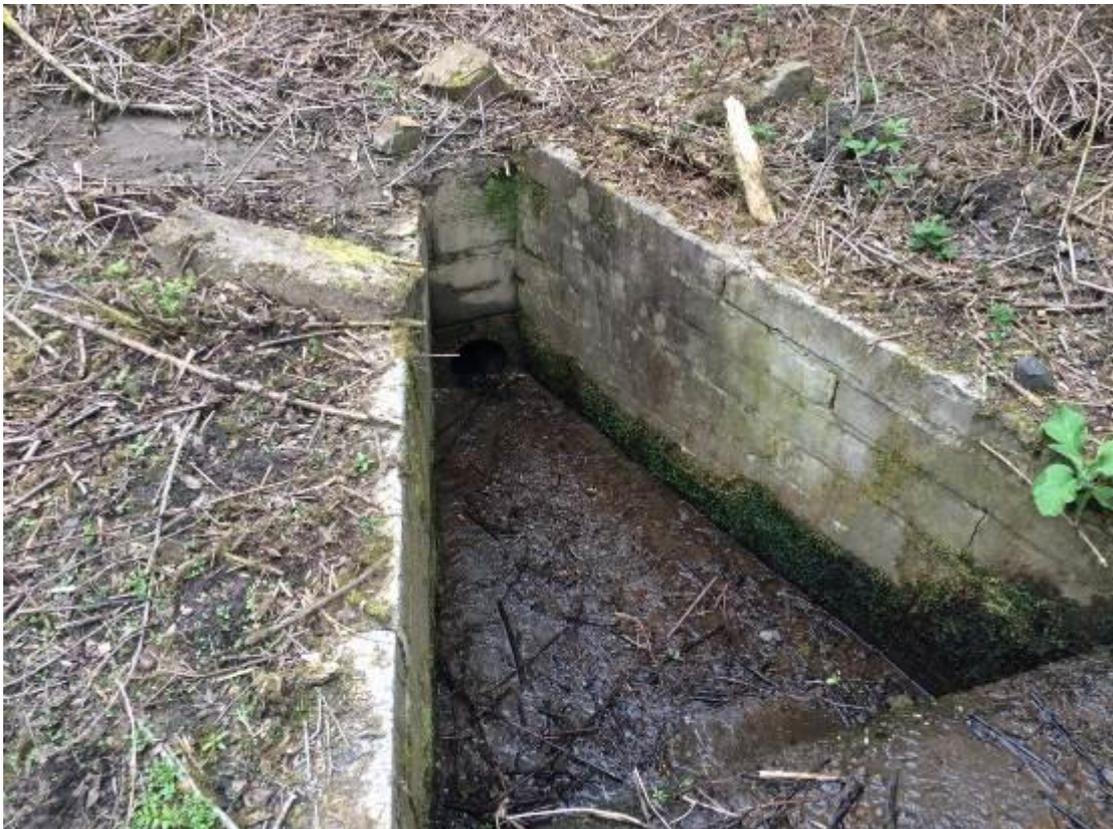
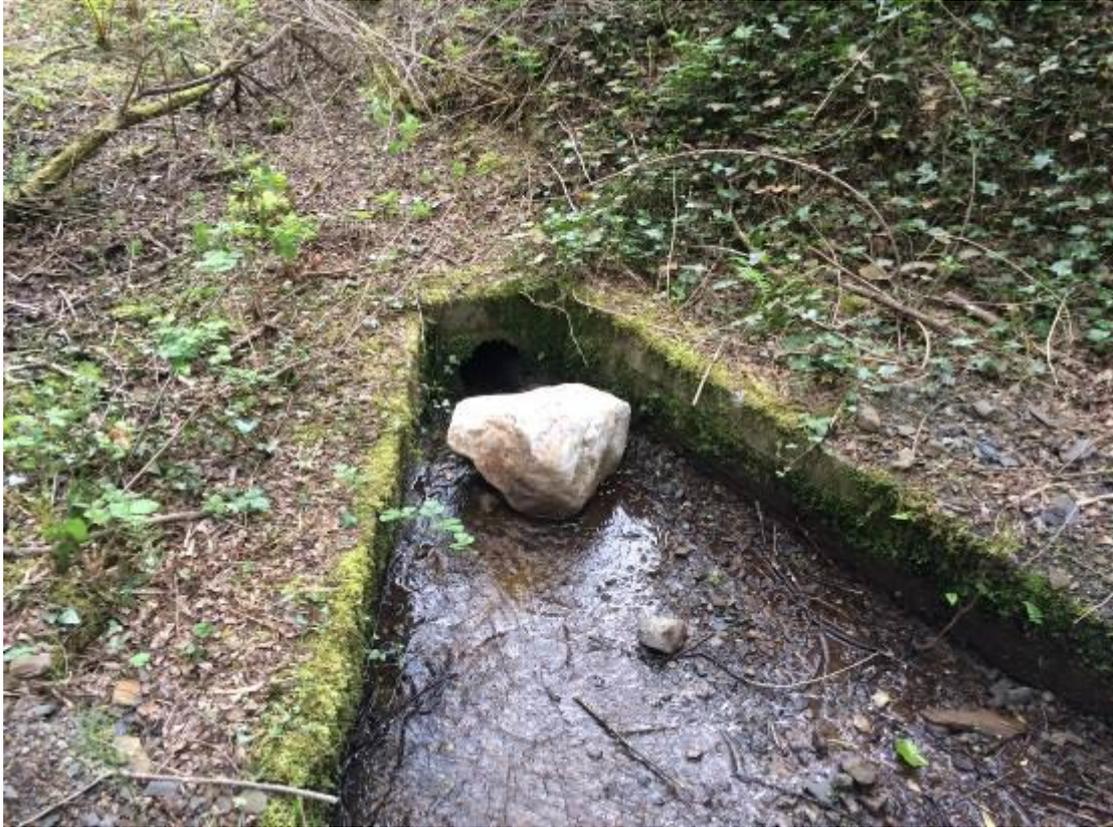
The collection chambers at the head of the elevated pipe drainage system were free of debris, but would benefit from protective fencing around the perimeter (Photographs 17 to 19).

Photograph 17 – Chamber at head of elevated pipe drainage system

Photograph 18 – Chamber at head of elevated pipe drainage system

Photograph 19 – Chamber at head of elevated pipe drainage system

Fencing to the collection chambers at the head of the elevated pipe drainage system should be considered.

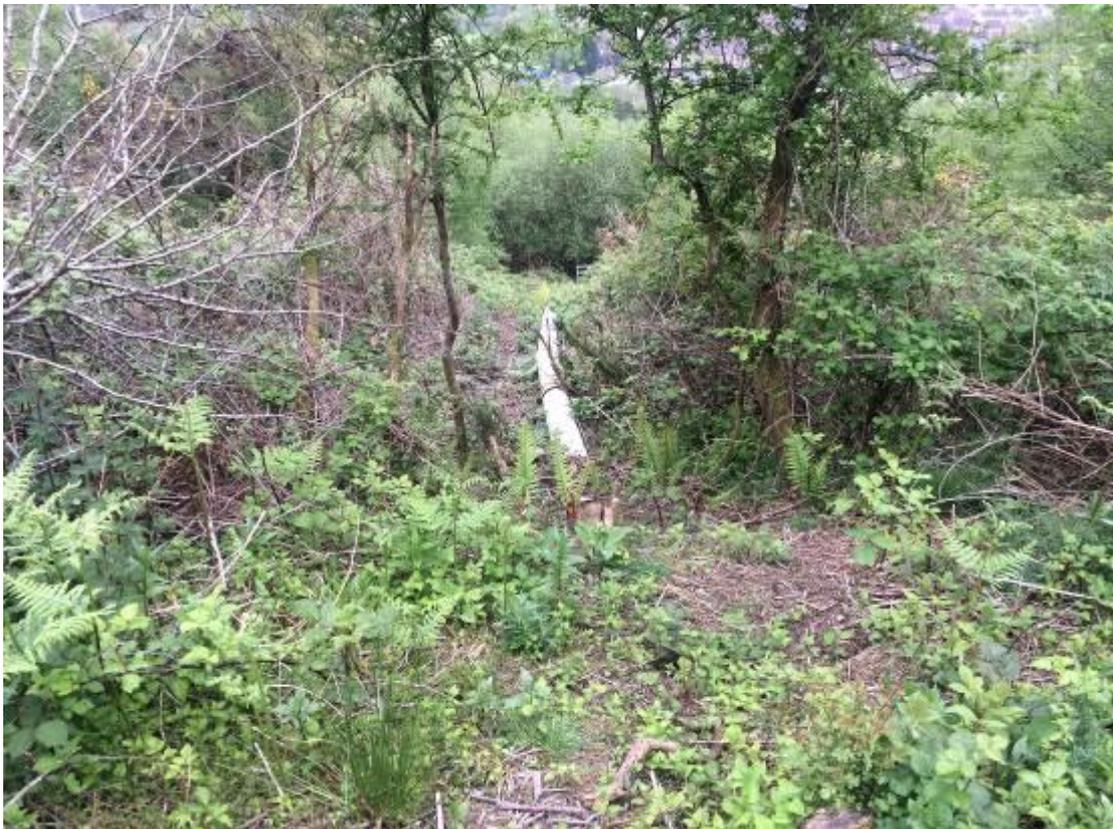
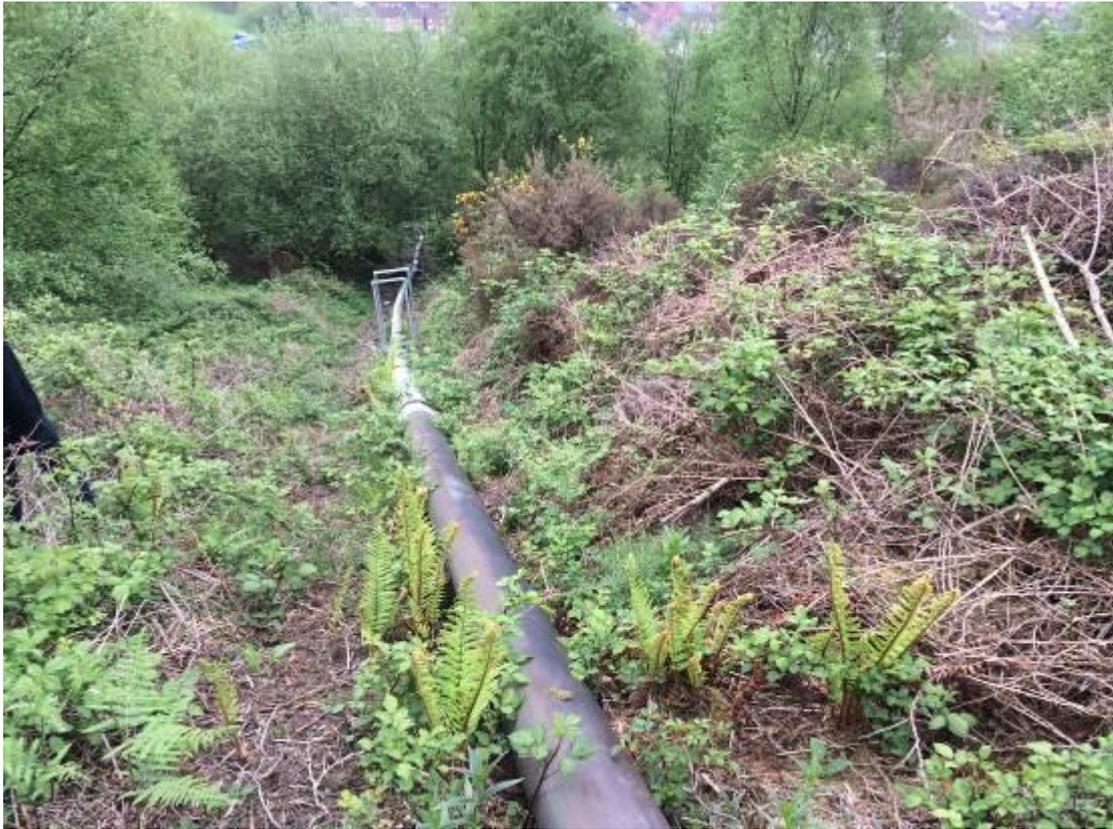
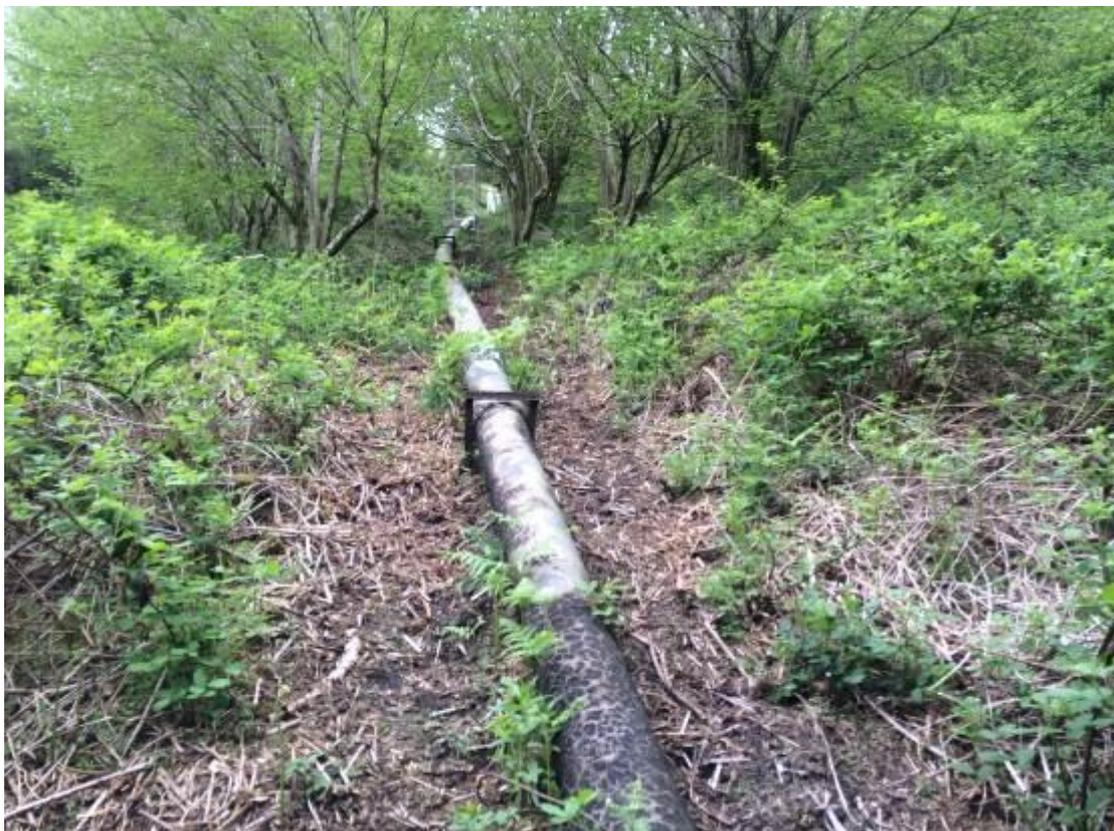
The route of the elevated pipe drainage system was inspected, with the pipe work and supports being in reasonable to poor condition. Attempts have been made to seal joints using waterproof tape in several areas, and some supports have been replaced or repaired. New side branch connections have been made at locations to capture groundwater seepages (Photographs 20 to 26).

Photograph 20 – Elevated pipe drainage system

Photograph 21 – Elevated pipe drainage system

Photograph 26 – Elevated pipe drainage system

Consideration should be given to a scheme for upgrading / replacing the elevated pipe drainage system in order to ensure continued functionality. Attempts have been made to seal leaking joints using waterproof tape - this should be seen as a temporary, short term solution.

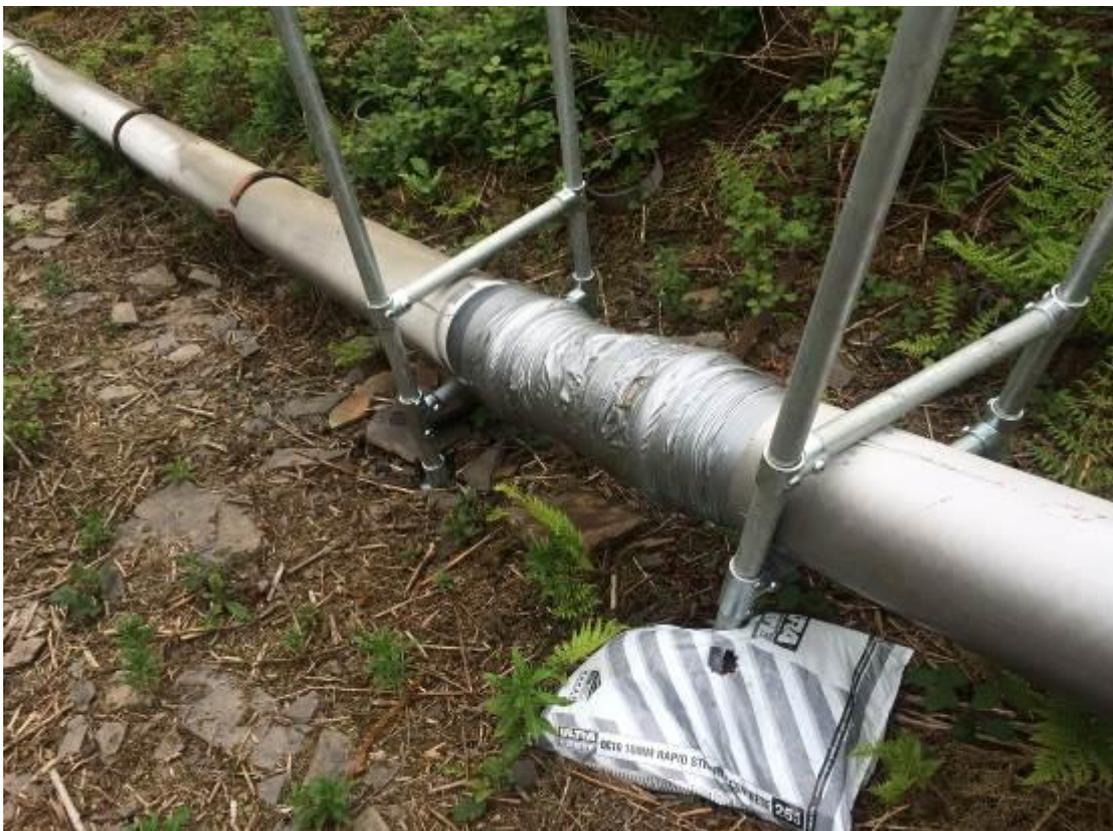
Photograph 22 – Joints recently sealed with waterproof tape
