**The Coal
Authority**

Site Inspection Report

Pen y Graig Arw Quarry, Ystalyfera

Date: May 2018

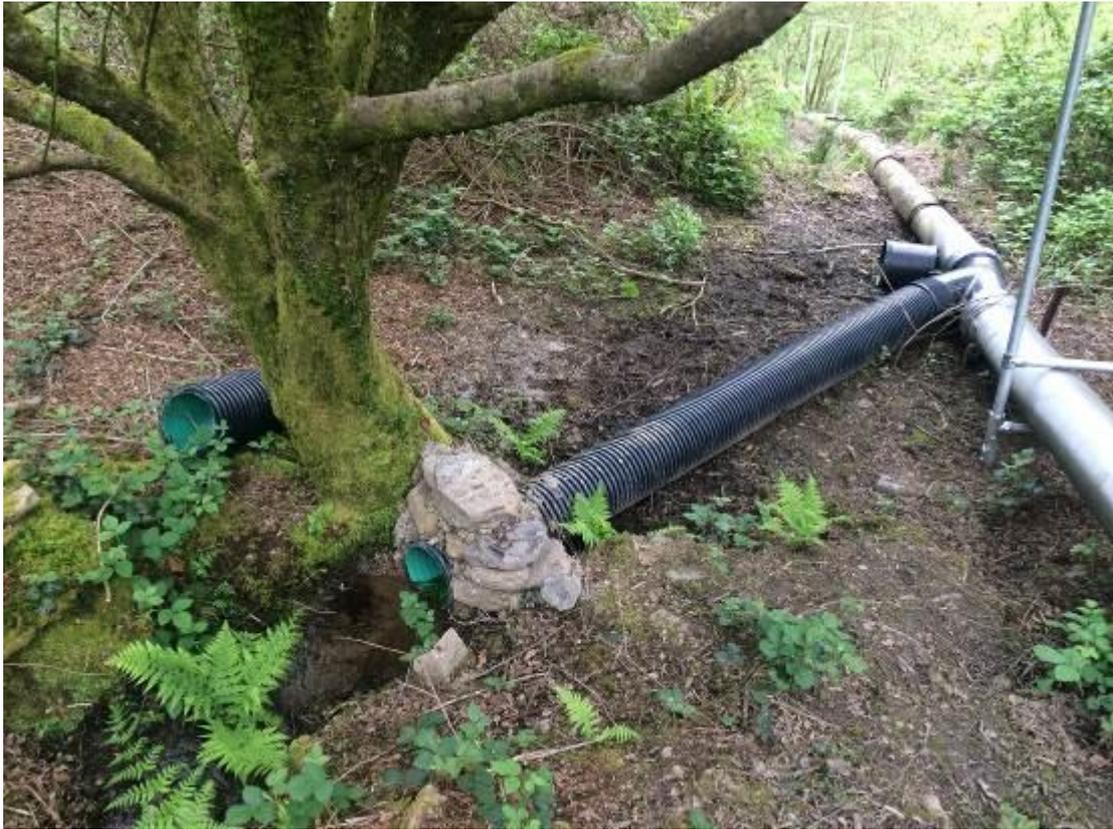
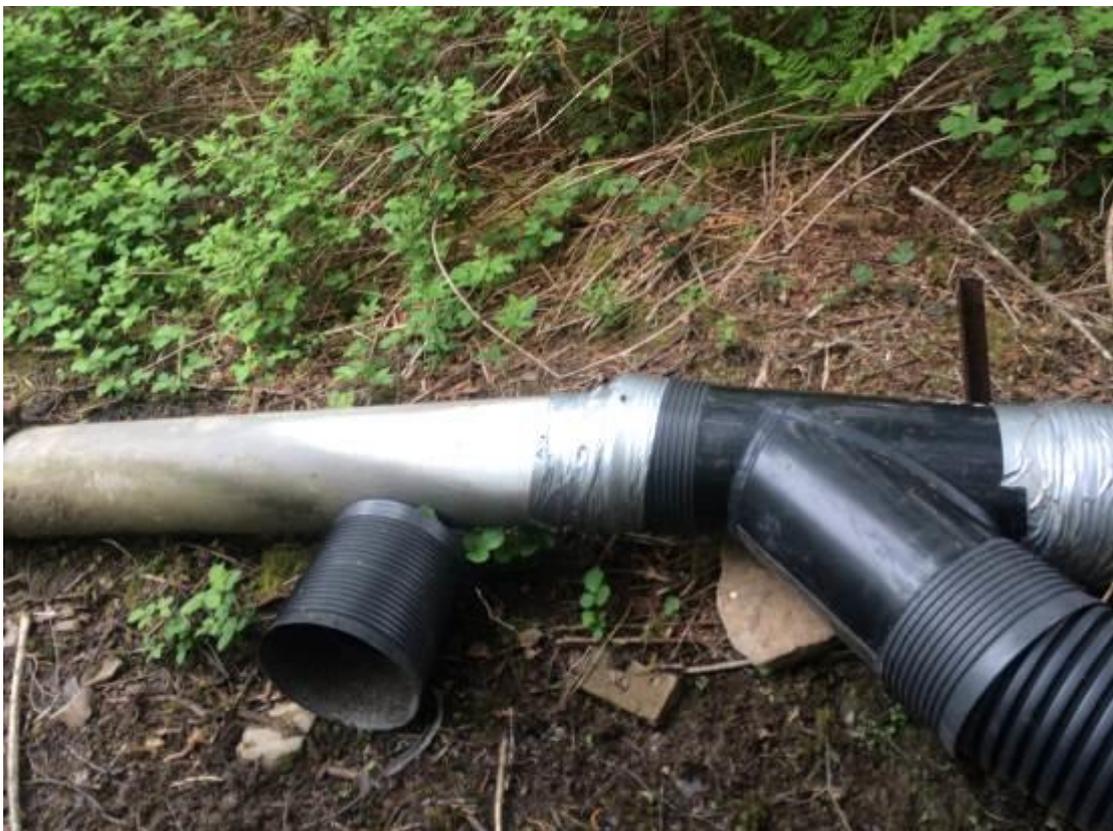
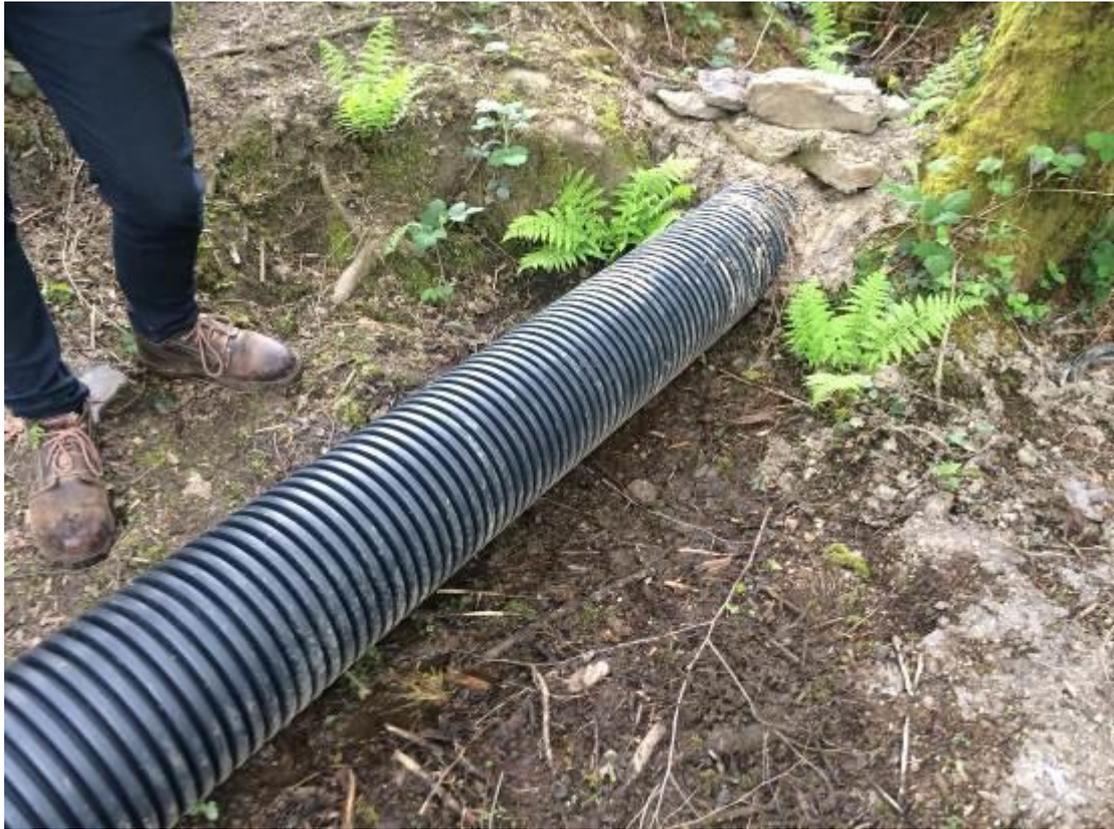
The route of the elevated pipe drainage system was inspected, with the pipe work and supports being in reasonable to poor condition. Attempts have been made to seal joints using waterproof tape in several areas, and some supports have been replaced or repaired. New side branch connections have been made at locations to capture groundwater seepages (Photographs 20 to 26).

Photograph 23 – Side connection to elevated pipe drainage system

Photograph 24 – Close up of connections

Photograph 25 – Side connection to elevated pipe drainage system

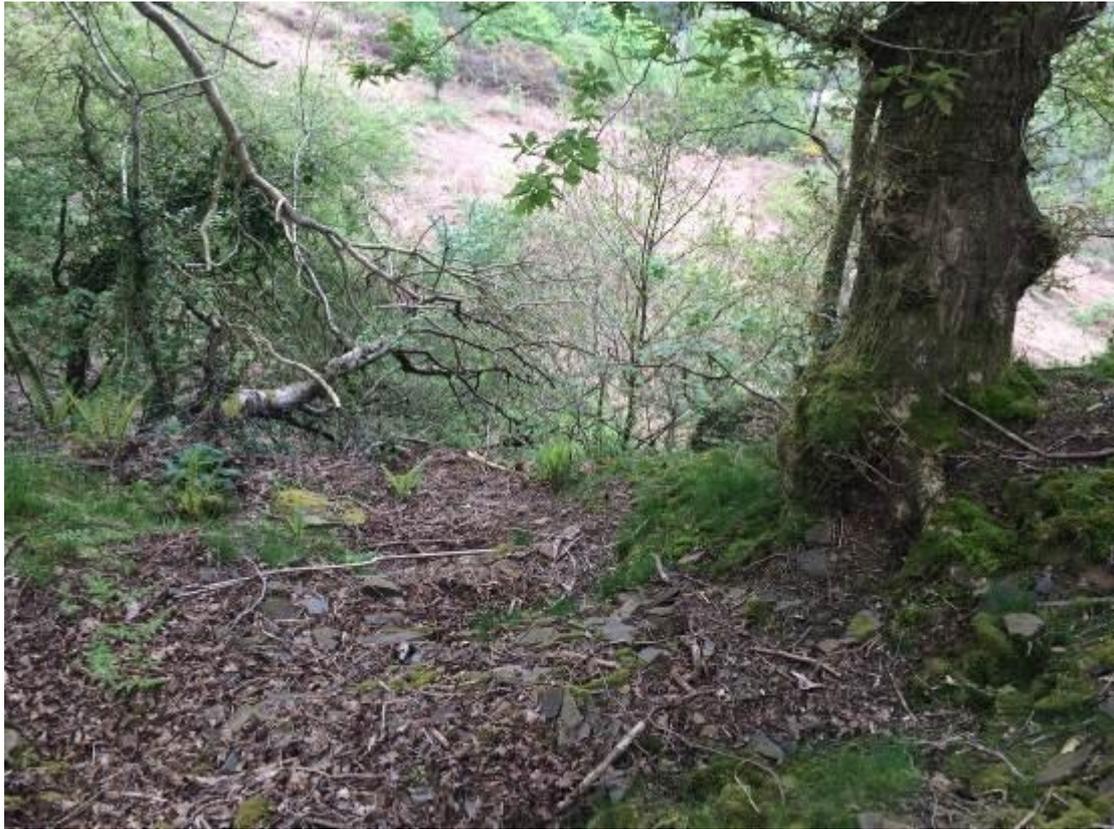
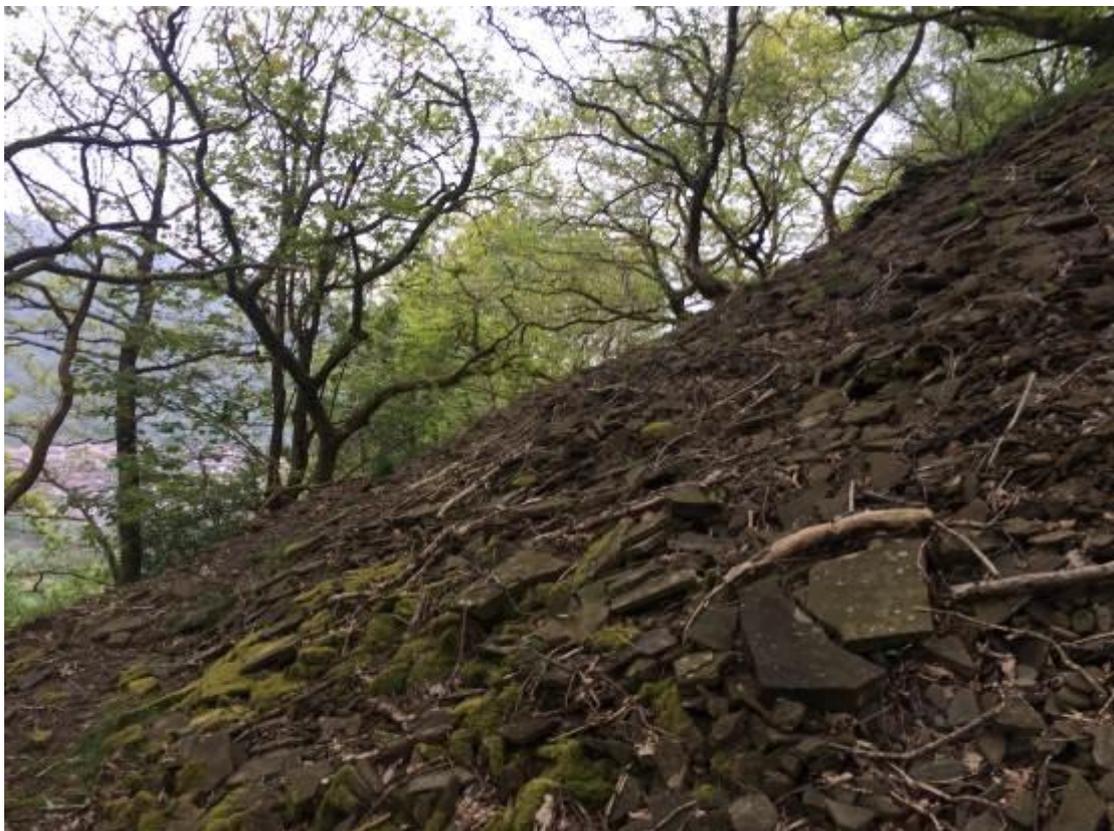
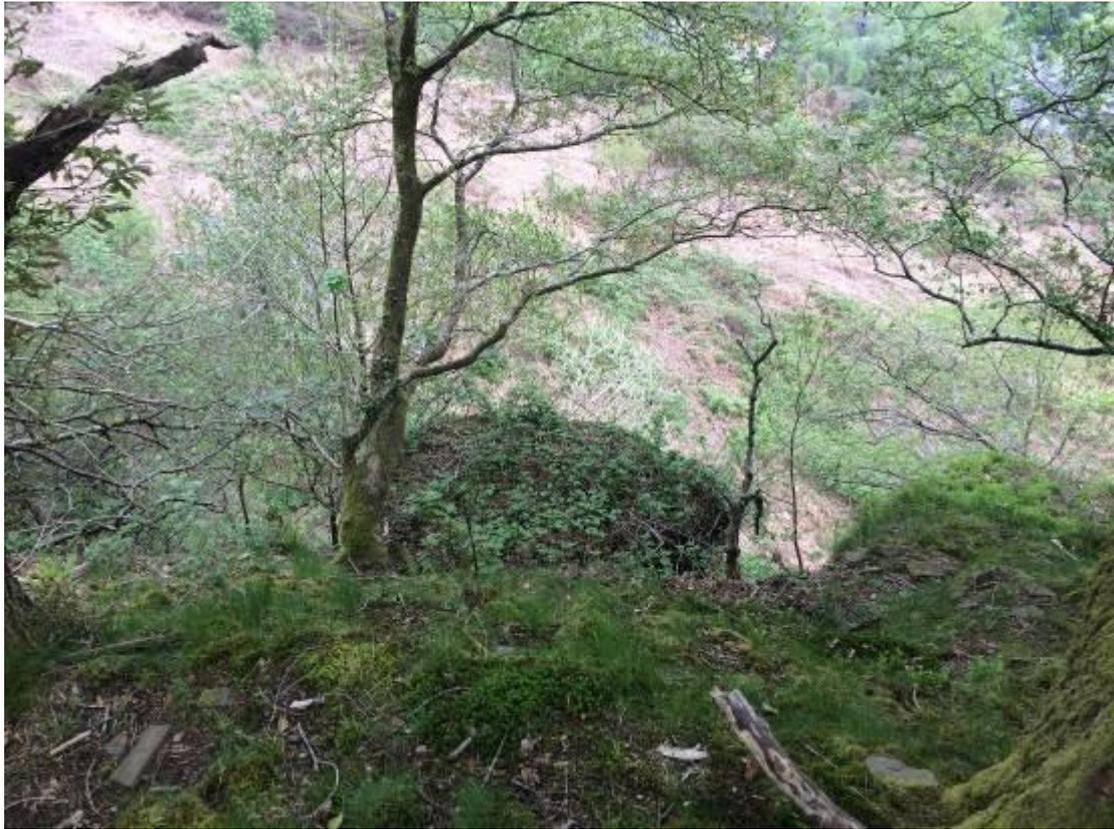
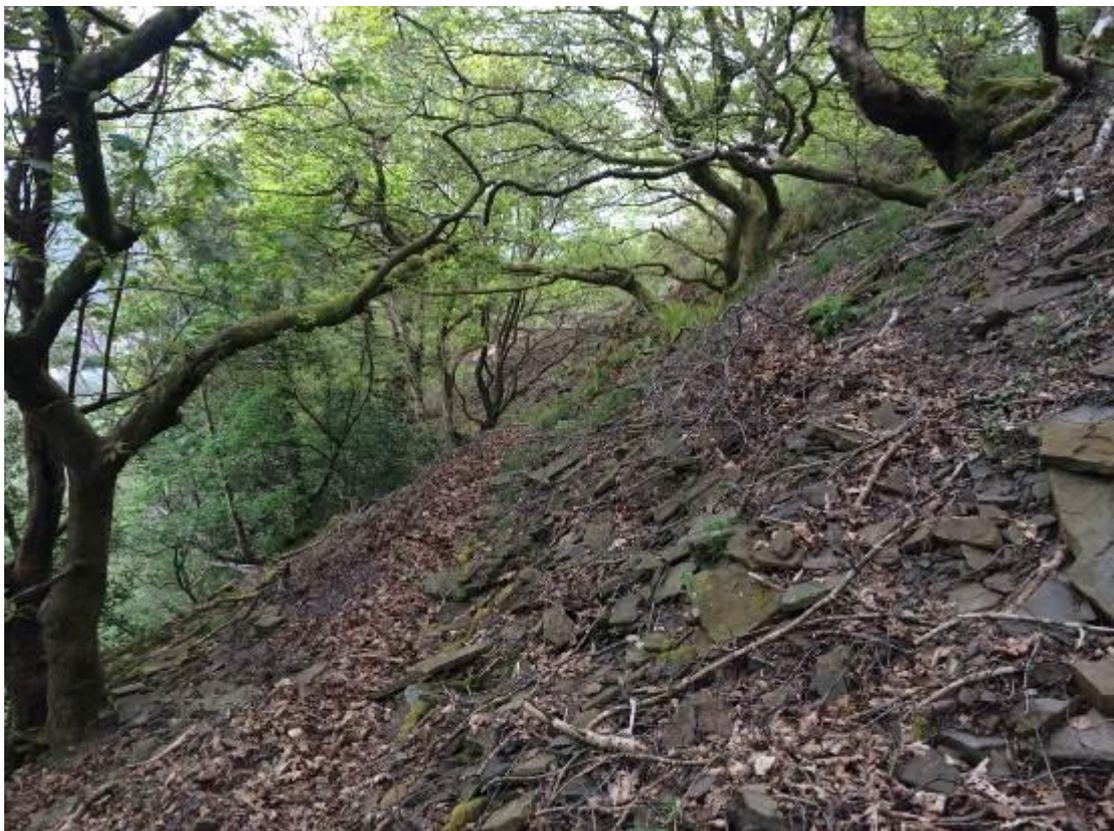
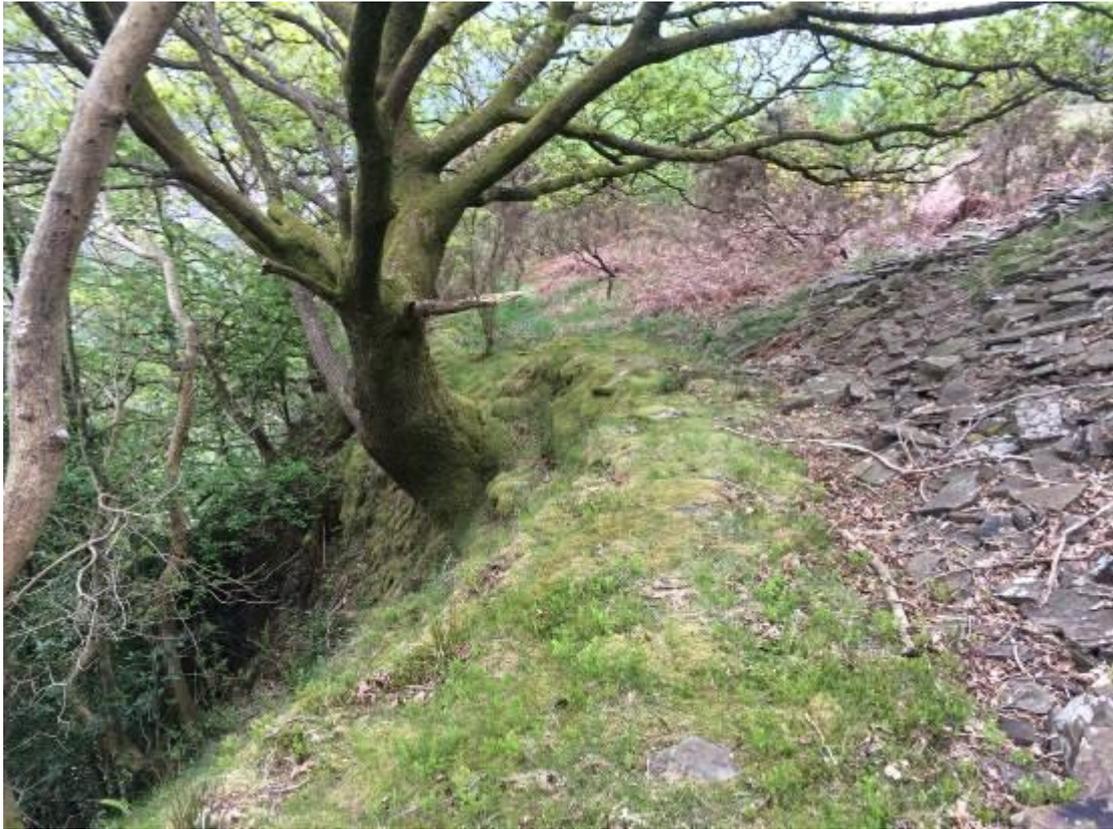
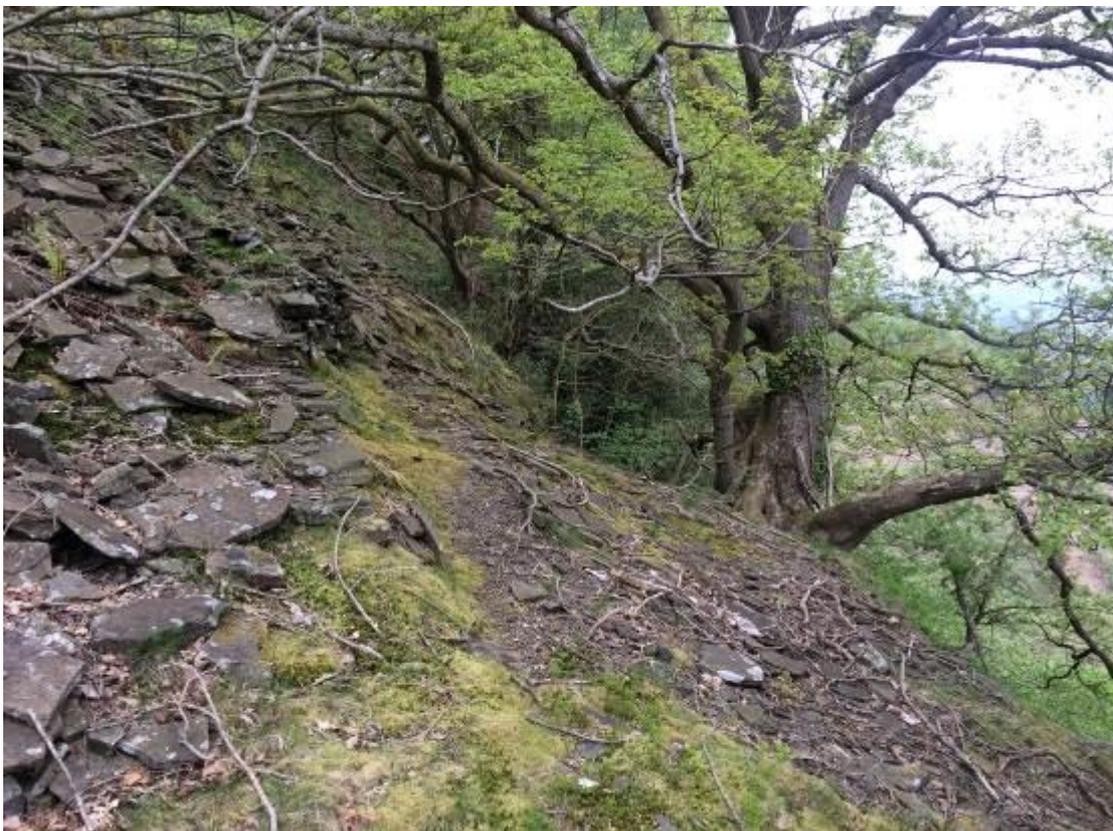
The inspection then proceeded to the south eastern area, where a vertical cliff forms the site boundary. The spoil mounds in this area are in close proximity (<1m in places) to the cliff edge (Photographs 27 to 32).

Numerous mature trees are located along the cliff edge. The root systems of these trees are likely to have penetrated the weathered bedrock and will likely destabilise the cliff edge in the future.

Localised spalling and surface erosion of the quarry waste mound sections adjacent the cliff edge may result in small amounts of spoil escaping over the cliff edge during extreme weather events. There was no visual evidence of significant spalling and erosion reaching the cliff edge, but the potential for this to occur presents a low to moderate risk. It is clear that in the past some quarry waste has spilled over the cliff edge, directly above the most recent (2012) Panteg landslide.

A significant failure of the eastern cliff edge would result in destabilising of the adjacent spoil mounds, leading to collapse and deposition onto the plateau area at the base of the cliff. Such a failure would surcharge the existing landside and would likely cause further downslope movement. Based on a visual assessment this scenario is considered to present a low to medium risk under current conditions. Due to access restrictions and dense vegetation cover, it was not possible to inspect the condition of the interface of the cliff base and head of the Panteg landslide.

Photograph 27 – Quarry spoil mound at edge of cliff face

Photograph 28 – Quarry spoil mound at edge of cliff face

Photograph 29 – Quarry spoil mound at edge of cliff face

Photograph 30 – Quarry spoil mound at edge of cliff face

Photograph 31 – Quarry spoil mound at edge of cliff face

Photograph 32 – Quarry spoil mound at edge of cliff face

Selective removal of trees along the cliff edge may reduce the risk of instability along the cliff edge. The opinion of a specialist tree surgeon should be sought as access to the cliff edge presents a significant risk to operatives.

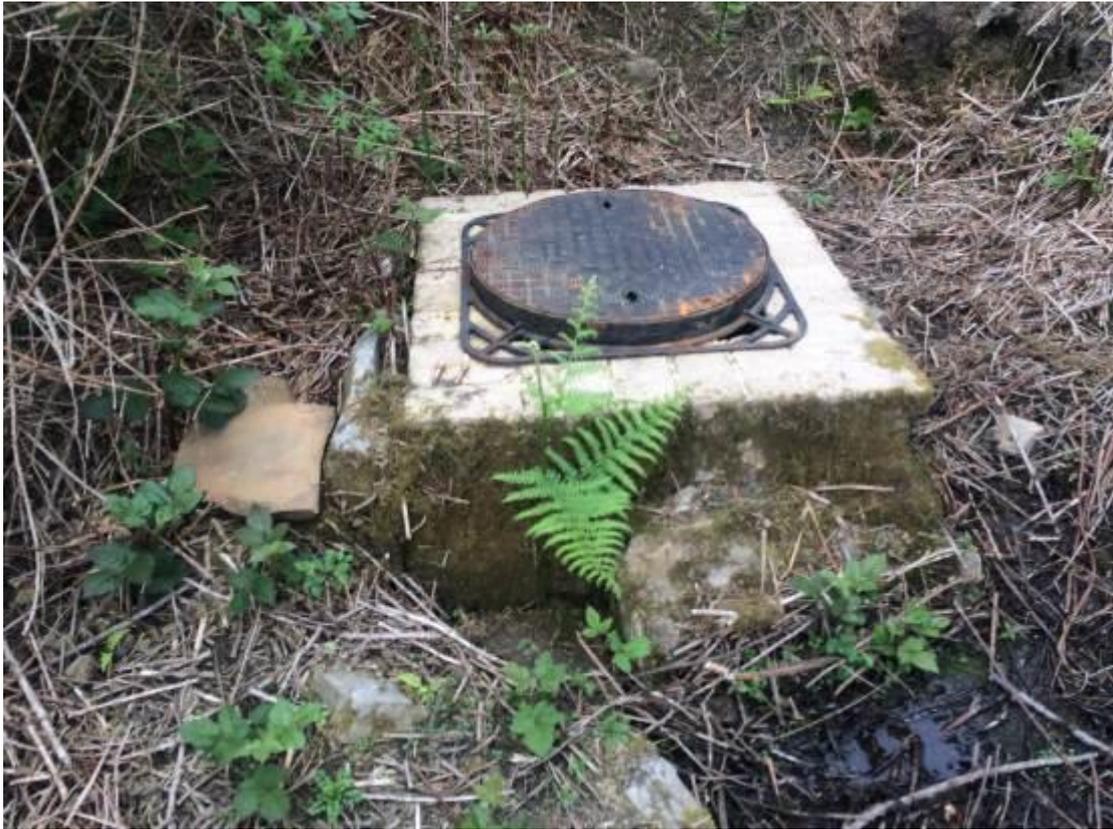
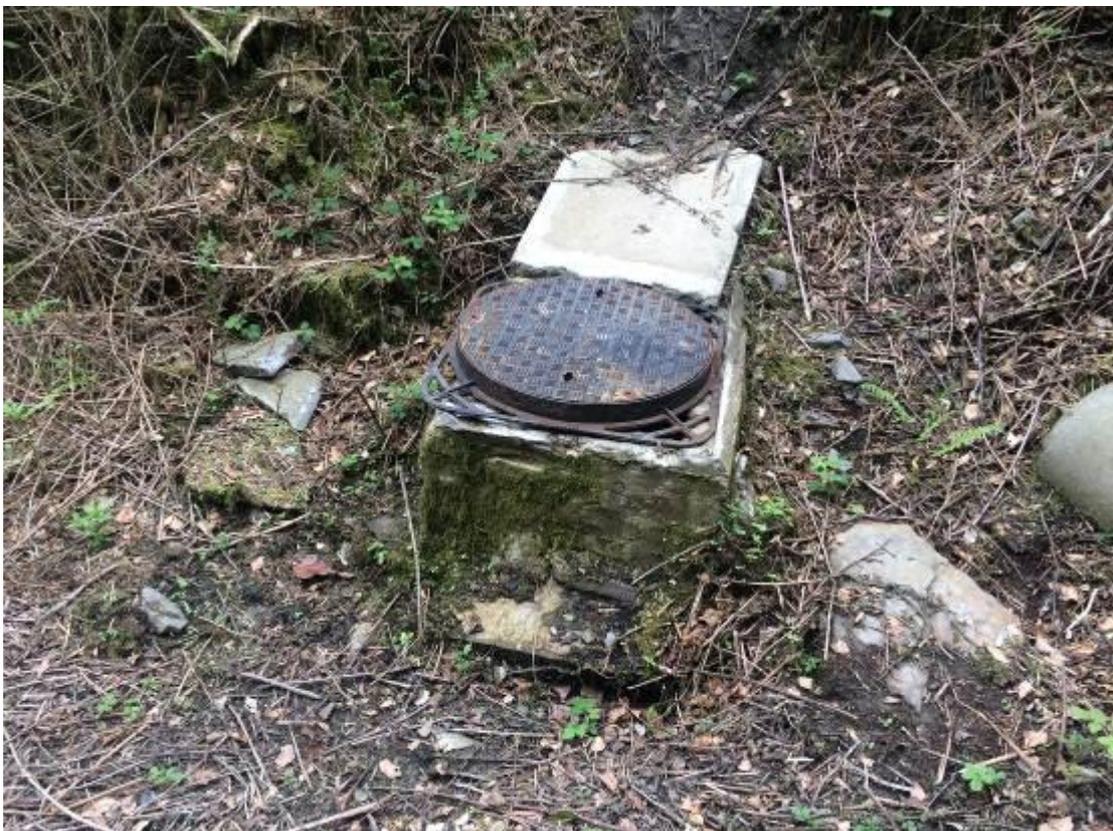
The inspection then followed recently cleared routes along the line of the drainage system. The drainage system generally appeared to be conveying water flows reasonably well. The previously observed manhole chambers have now had covers fitted, although not all are complete and require setting in mortar bedding (Photographs 33 and 34).

Photograph 33 – New manhole cover requiring bedding

Photograph 34 – New manhole cover requiring bedding

Newly installed manhole covers require bedding in mortar.

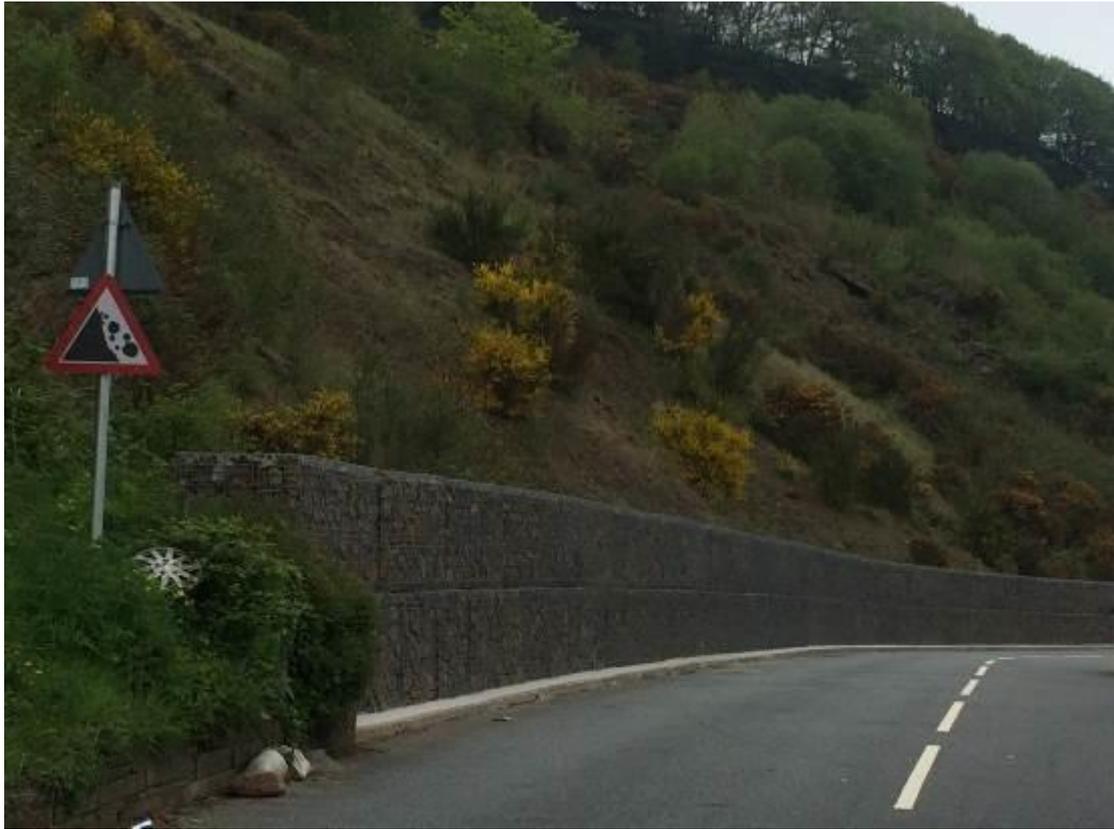
On leaving site, it was noted that a new gabion basket wall has been constructed at the carriageway edge at the toe of the most recent Panteg landslide (Photograph 35).

Photograph 35 – New gabion basket wall at toe of Panteg landslide
