Pantteg Landslide, Pantteg Executive Summary; Hazard and Risk Assessment

Neath Port Talbot County Borough Council

Report Reference: **ESP.5859e.09.2930 Volume 3**

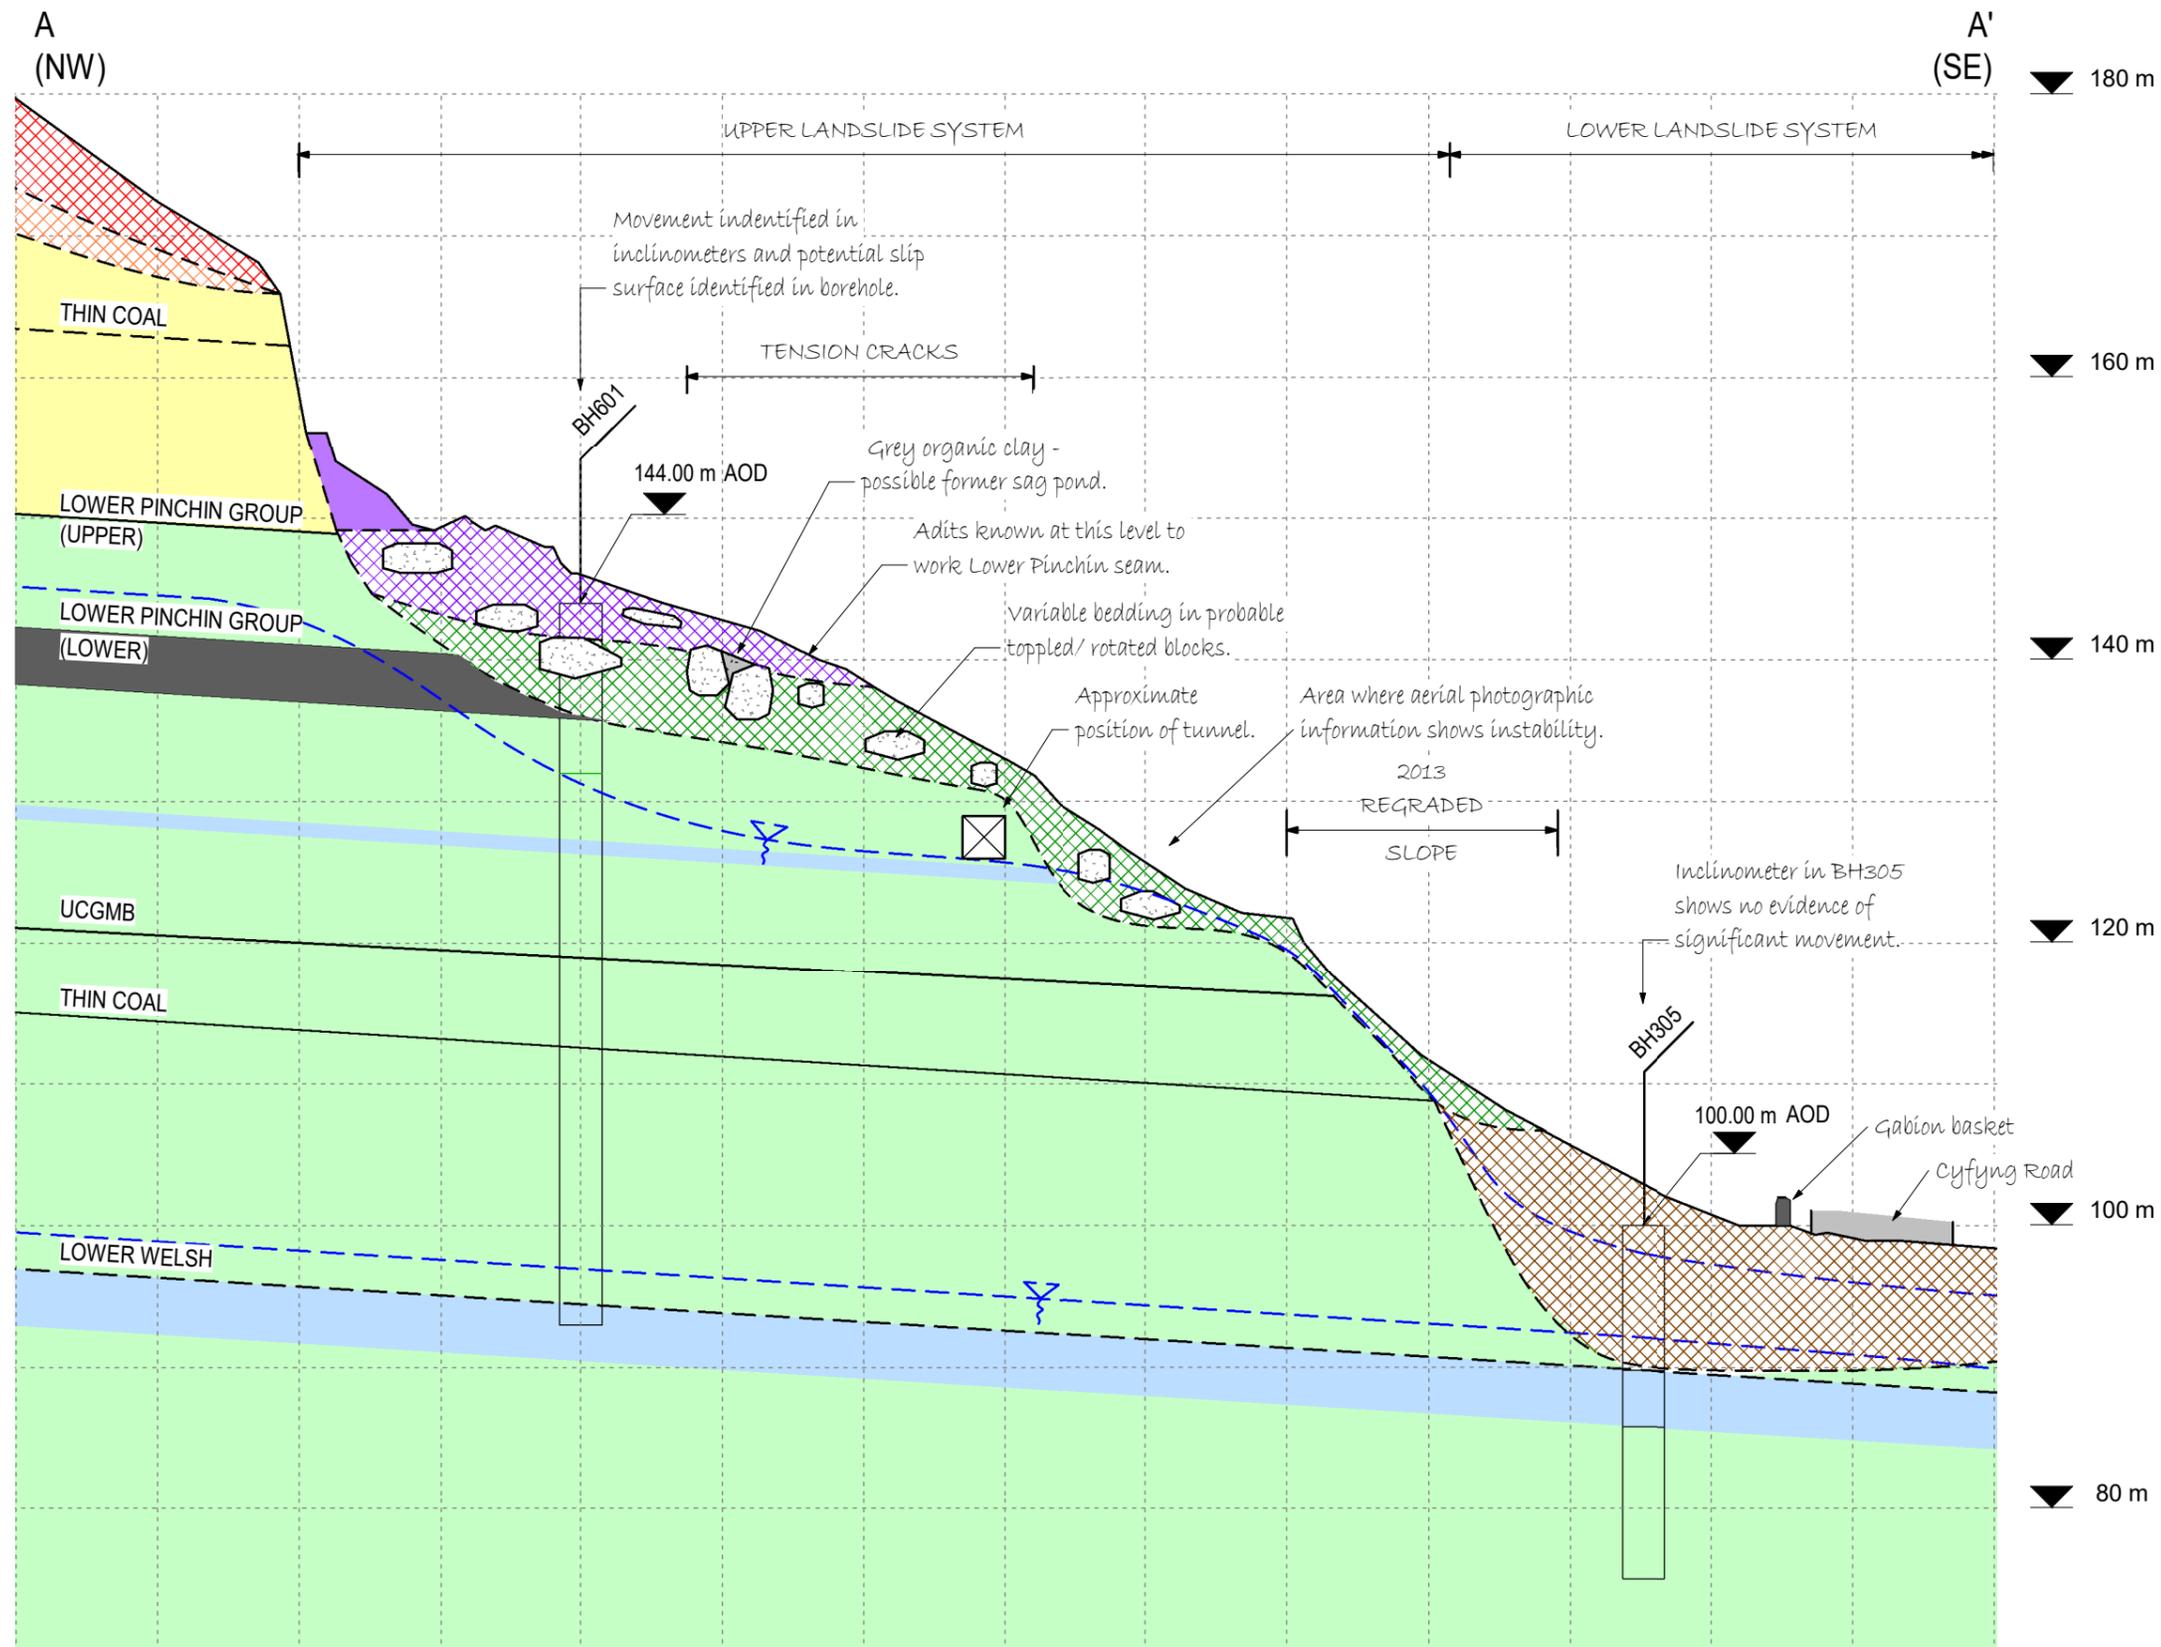
FIGURE 1: CONCEPTUAL GROUND MODEL

The instability at Pantteg and the wider landslide system is considered to have three main components. Two of these components are within the Upper Landslide System and are considered to be 'active'; the third is within the Lower Landslide system and is considered to be inactive and ancient.

The Lower system generally represents the first failure to occur at Pantteg and evidence of this is the thick 10-20m of Colluvium in the valley base. Inclinometers and other evidence generally demonstrate little or no movement in this material and confirms the view that this is generally inactive.

Investigation has shown the instability in the Pen-y-Graig area can be attributed to a slip surface that is thought to be the lowest expression of the Lower Pinchin Coal Group. The slip surface comprised extremely weak weathered rock and a thin clayey silt layer, which is interpreted as being the base of the landslide materials. Inclinometer monitoring shows the material above the Lower Pinchin slip surface to be moving down slope.

Aerial photographic interpretation has shown a second area of instability which is broadly delineated by a convex break in slope in the west and a lower bench in the east. Numerous translational landslides have occurred along this bench and it is likely to receive material slowly moving from the plateau area, and periodically over-steepening the second area until failure reduces the slope angle.

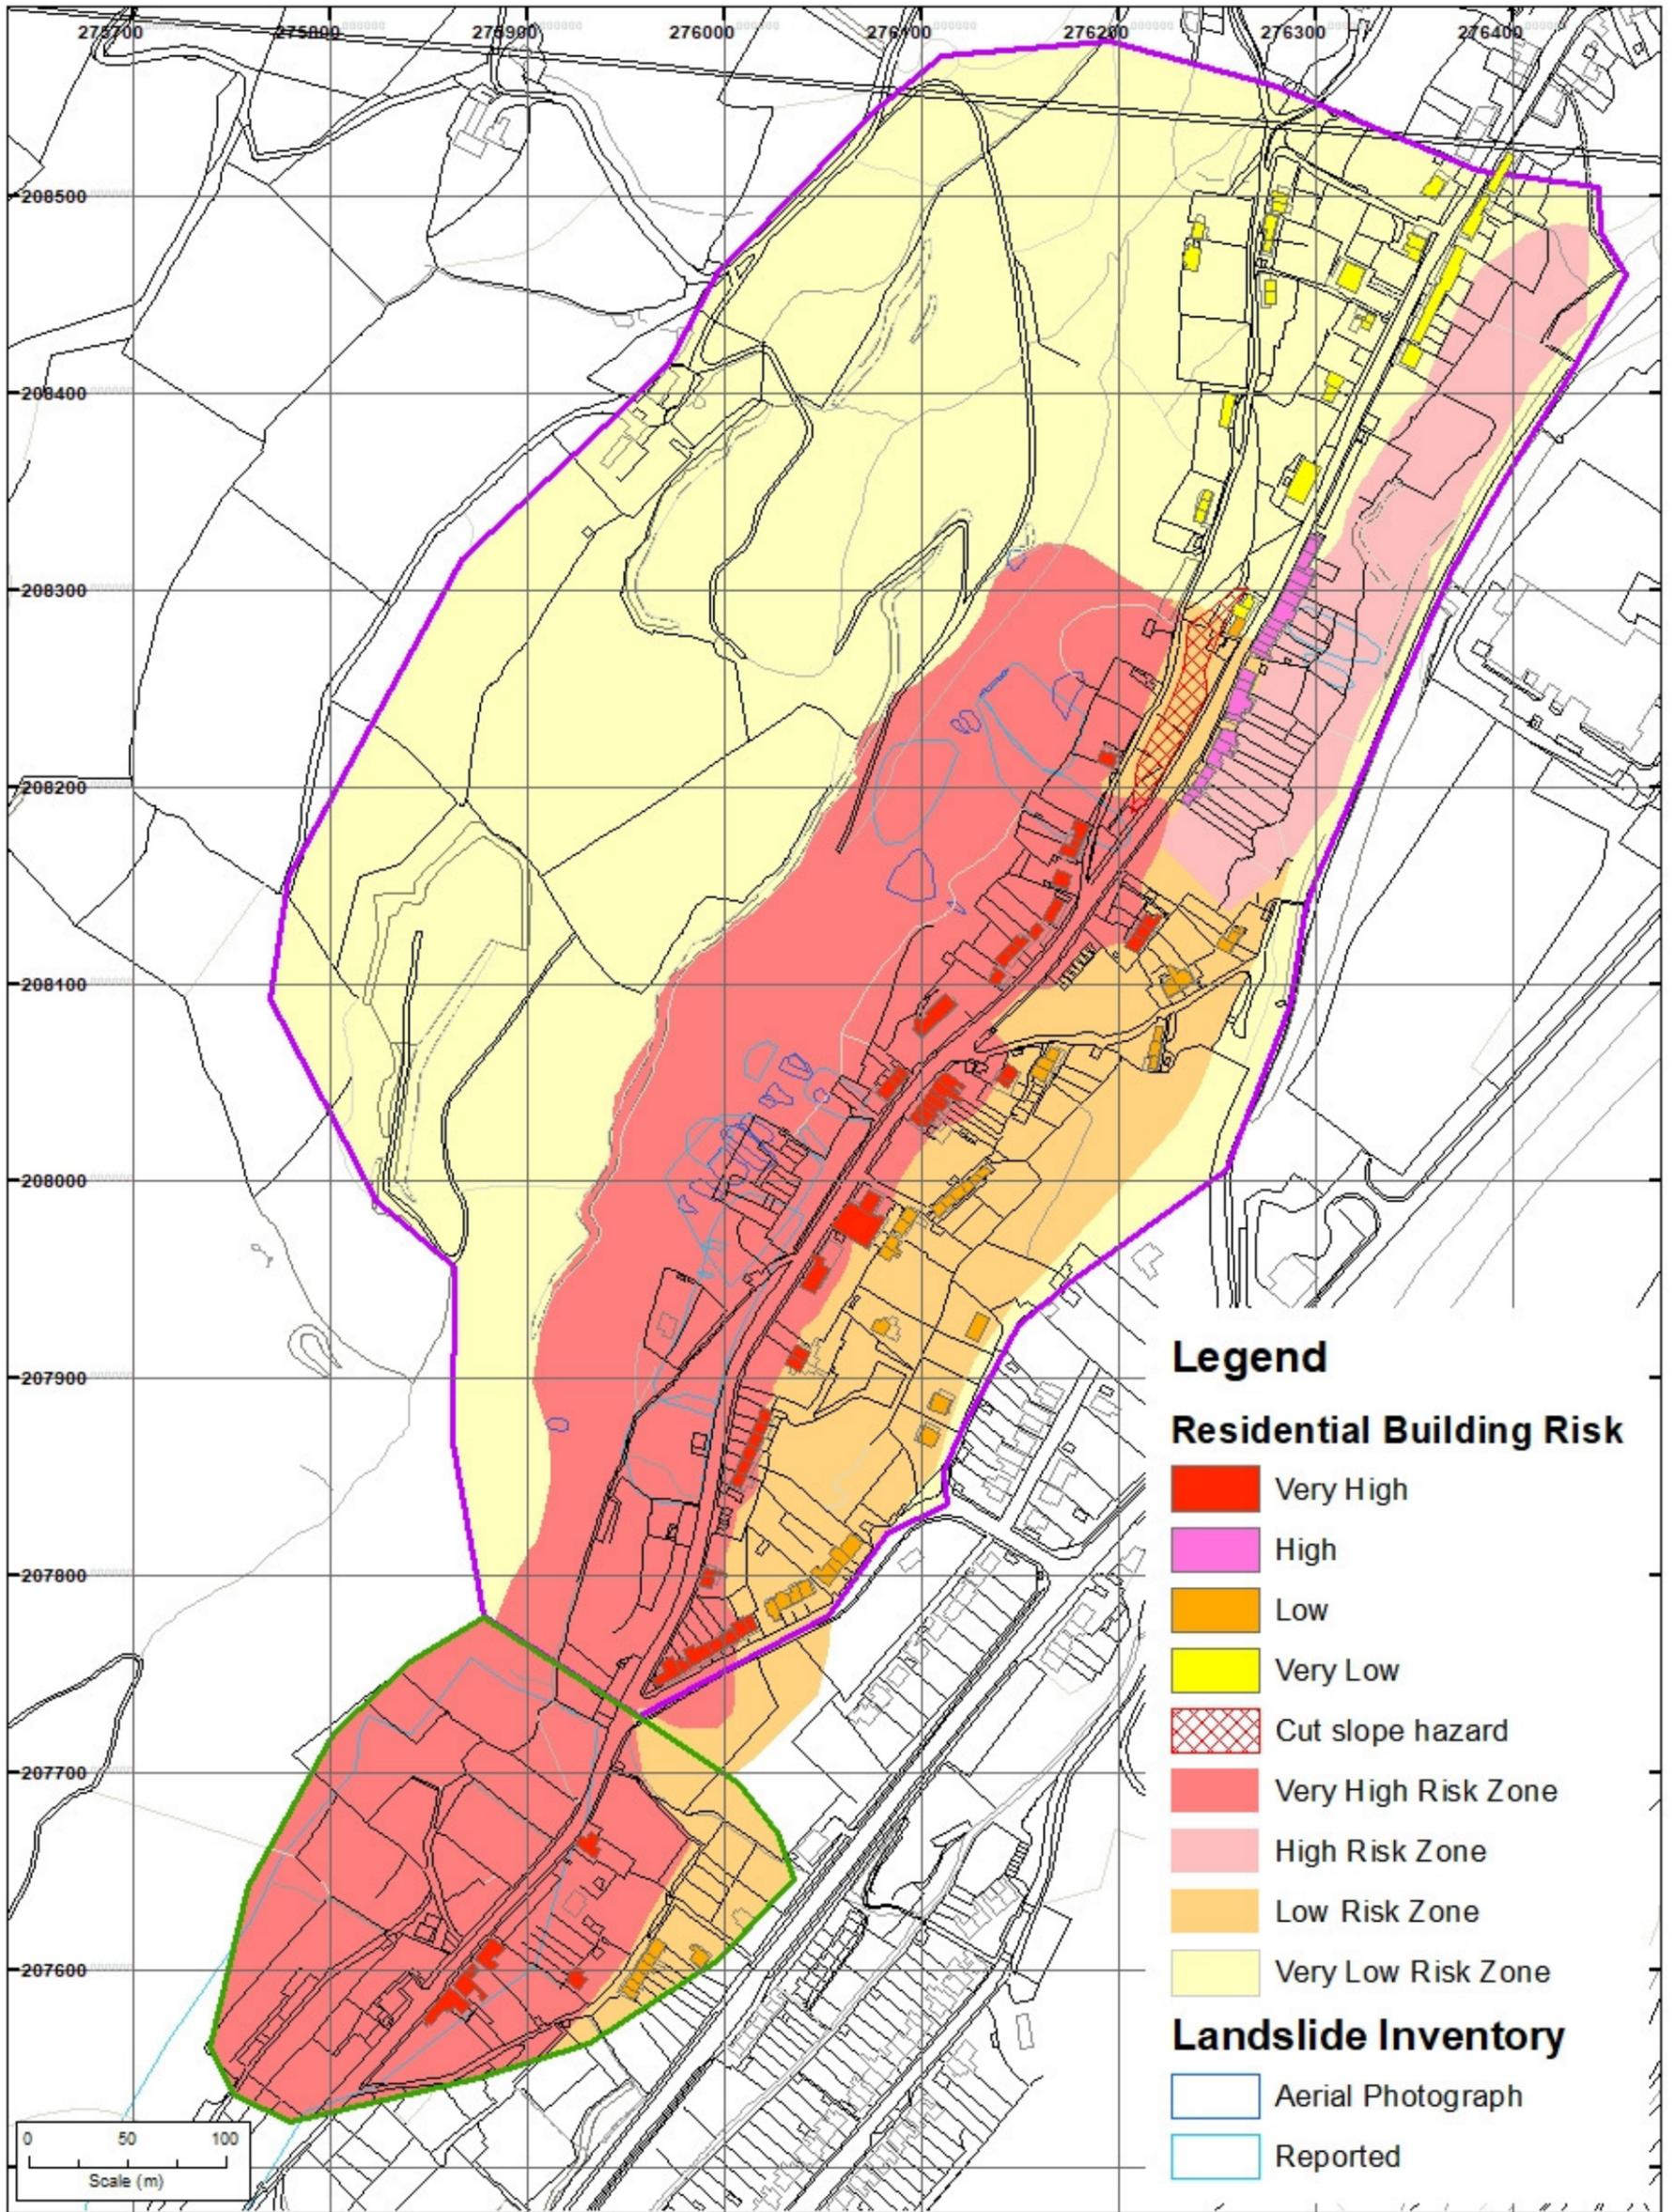
FIGURE 2 - RESIDENTIAL PROPERTY RISK

The outcome of the assessment allowed an to update the Hazard and Risk Map for Pantteg based upon current engineering geology practice, to develop an understanding of where instability is likely to occur in the future and give us a better understanding of likely impacts on roads, land and properties in the area. The subsequent updated Hazard and Risk map, which amalgamated all the hazard types onto one plan, is provided as Figure 2.

The three houses and garages south of the Graig-y-Merched junction are linked to the very high-risk area are in the very high-risk polygon; the properties are denoted as 'very high risk' to explain the risk to the residential properties. Mitigation from upslope properties plays a role here; a conservative adopted position has been for landslides >500m³ volume that may engulf the upslope properties and continue downslope.

The high risk zone below Cyfyng Road encompasses the whole housing-terrace. The interconnectivity of the structures is an important factor here.

The risk zonings for Pantteg and their extent is shown in Figure 2.

Hazard Awareness Notices have been issued by NPTCBC to residents within the 'very high risk' and 'high risk' areas as defined on the Residential Property Risk plan presented as Figure 2.

Occupation of houses within the highest risk zones is not preferable due to the unacceptable risks presented. Residents should consider moving themselves out or be encouraged to move out of the very high and high risk zones at the earliest point (despite that they are privately owned for the majority of cases). This approach is in addition to 'warning and informing' in terms of a 'Hierarchy of Controls' approach (e.g. Management of Health and Safety at Work Regulations, 1999).
