Investigation Report into Flooding Incident of 16th February 2020 Canal Side, Aberdulais

Highways and Drainage Services
Environment and Regeneration Directorate
Neath Port Talbot County Borough Council

Version	Prepared by	Reviewed by	Approved by	Date
4.0	Richard Colman (Drainage Officer)	James Davies (Drainage Engineer)	Michael Roberts (Head of Streetcare)	13/07/2020

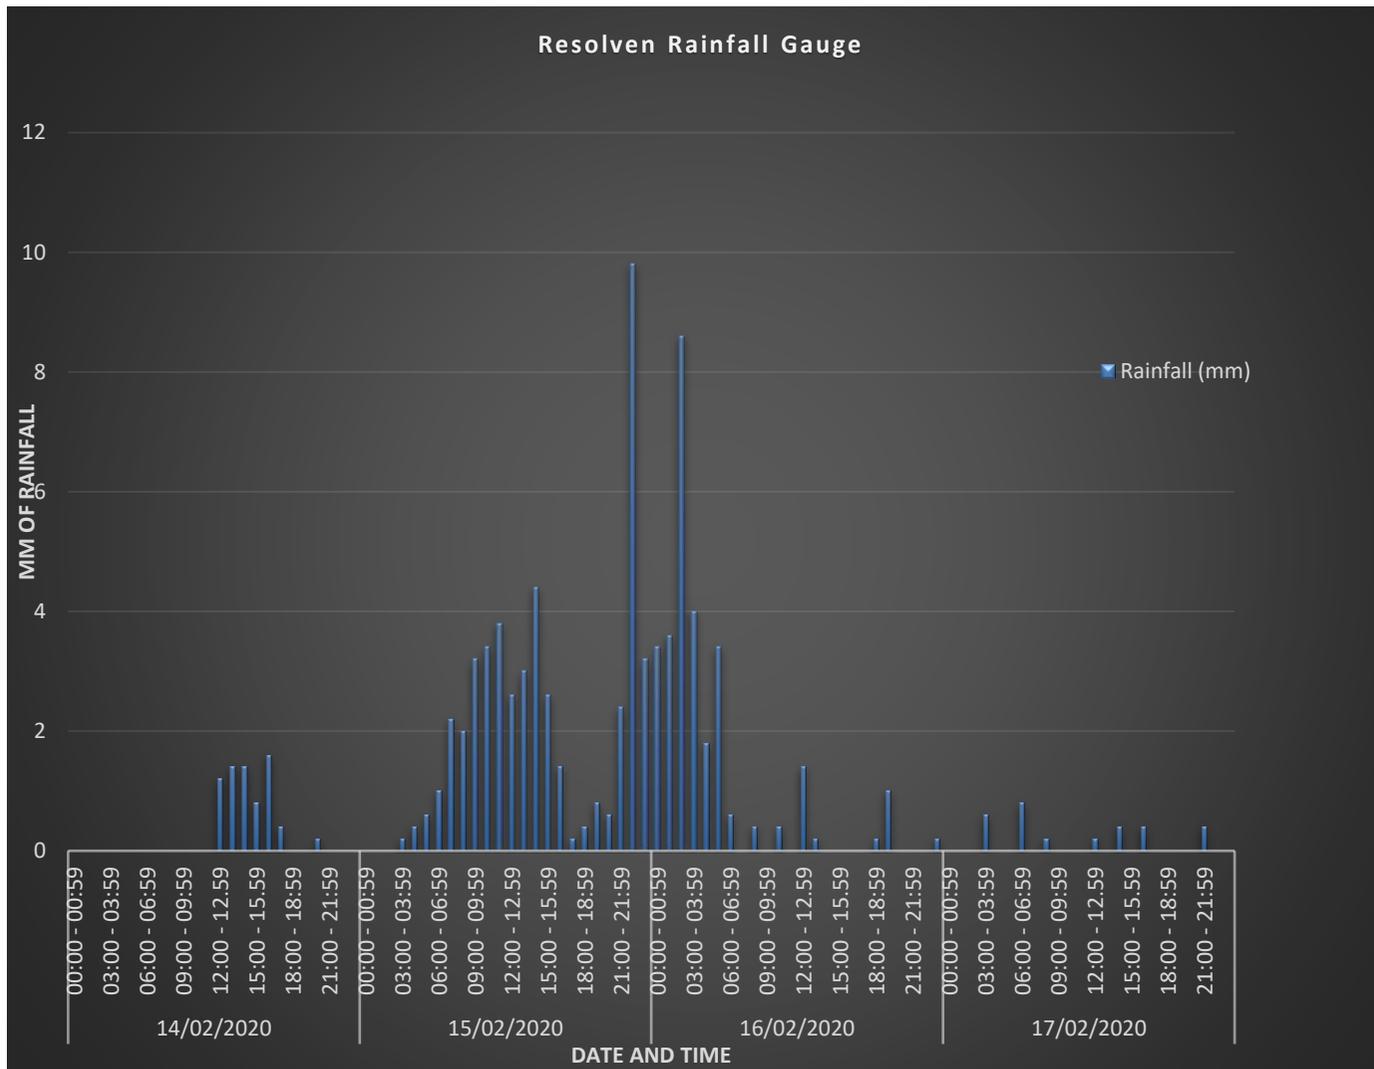
Figure 4 – Rainfall Hydrograph at Resolven, Shootill Gauge Map 2020.

Figure 4 & 5 illustrates the magnitude of the rainfall event with the river level exceeding the highest on record on Sunday morning. The rainfall hydrograph data from Resolven along with the river level records show how the river level reacted to the rainfall peak times.

- Rainfall peaked at 4.4mm per hour at 15:00 hrs on the Saturday with the river levels reacting 4.30 hrs after, peaking at 18:30 hrs.
- Rainfall again peaked at 9.8mm per hour at 23:00 hrs Saturday and again at 8.6mm per hour at 03:00 hrs on Sunday morning leading to the river level rising to the highest on record at 05:15 hrs.

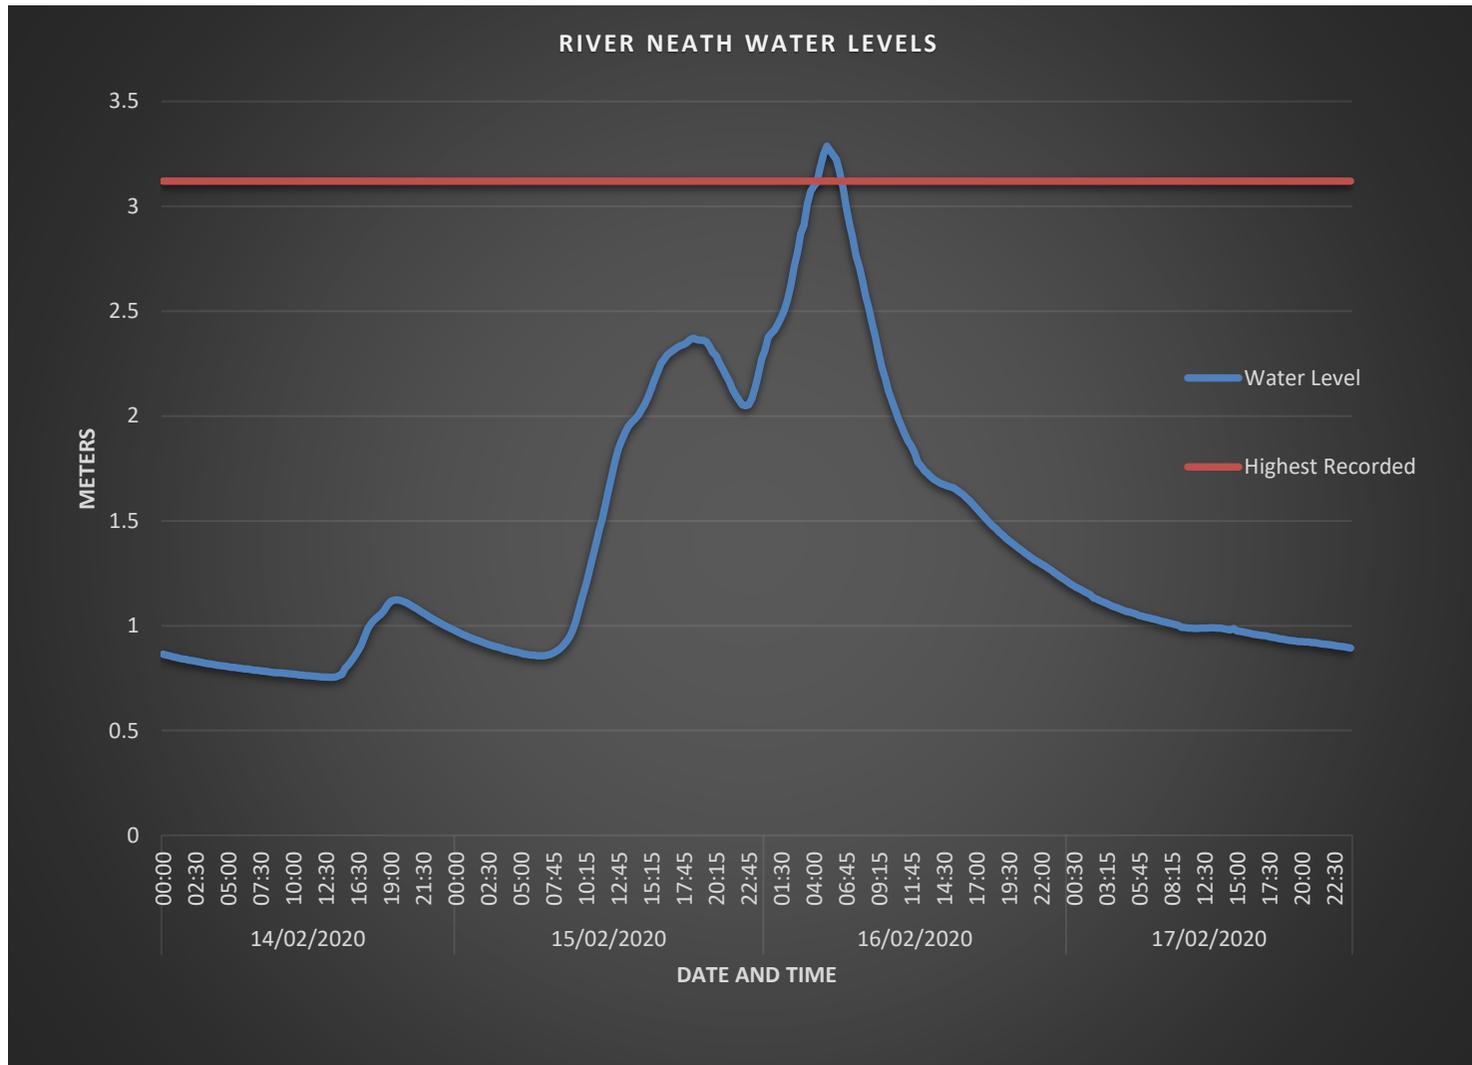
Figure 5 – River Level records at Resolven, Shootill Gauge Map 2020

It is noted from the river Neath gauging station records at Resolven (6 miles upstream from Canal Side) that during the storm the river level peaked twice, once on Saturday 18:30 at 2.371m and then again on Sunday 05:15 at 3.29m.

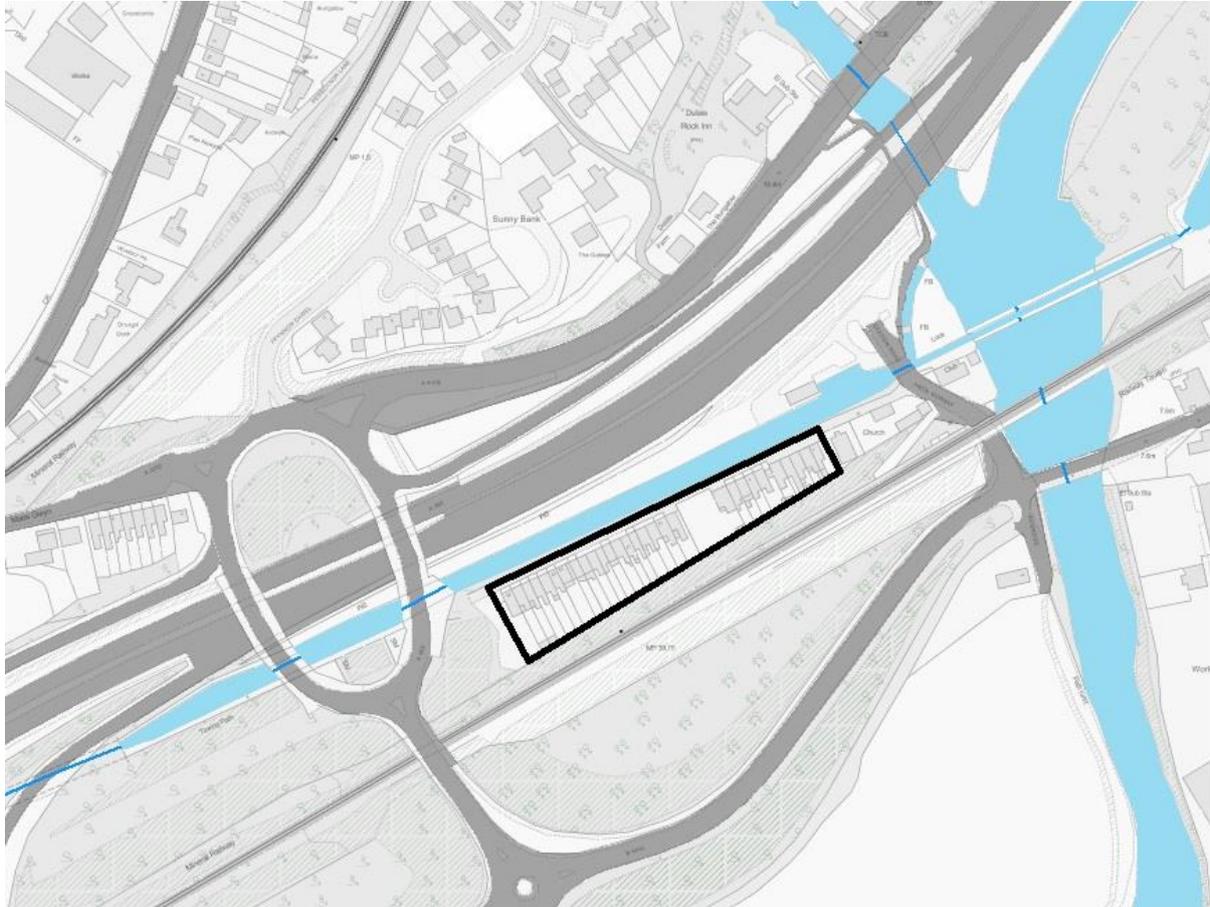
Figure 6 - Location of properties affected by the flood event on 16th February 2020

A number of properties suffered internal flooding on Sunday 16th February at Canal Side; Figure 6 illustrates the general location of the properties that were affected.

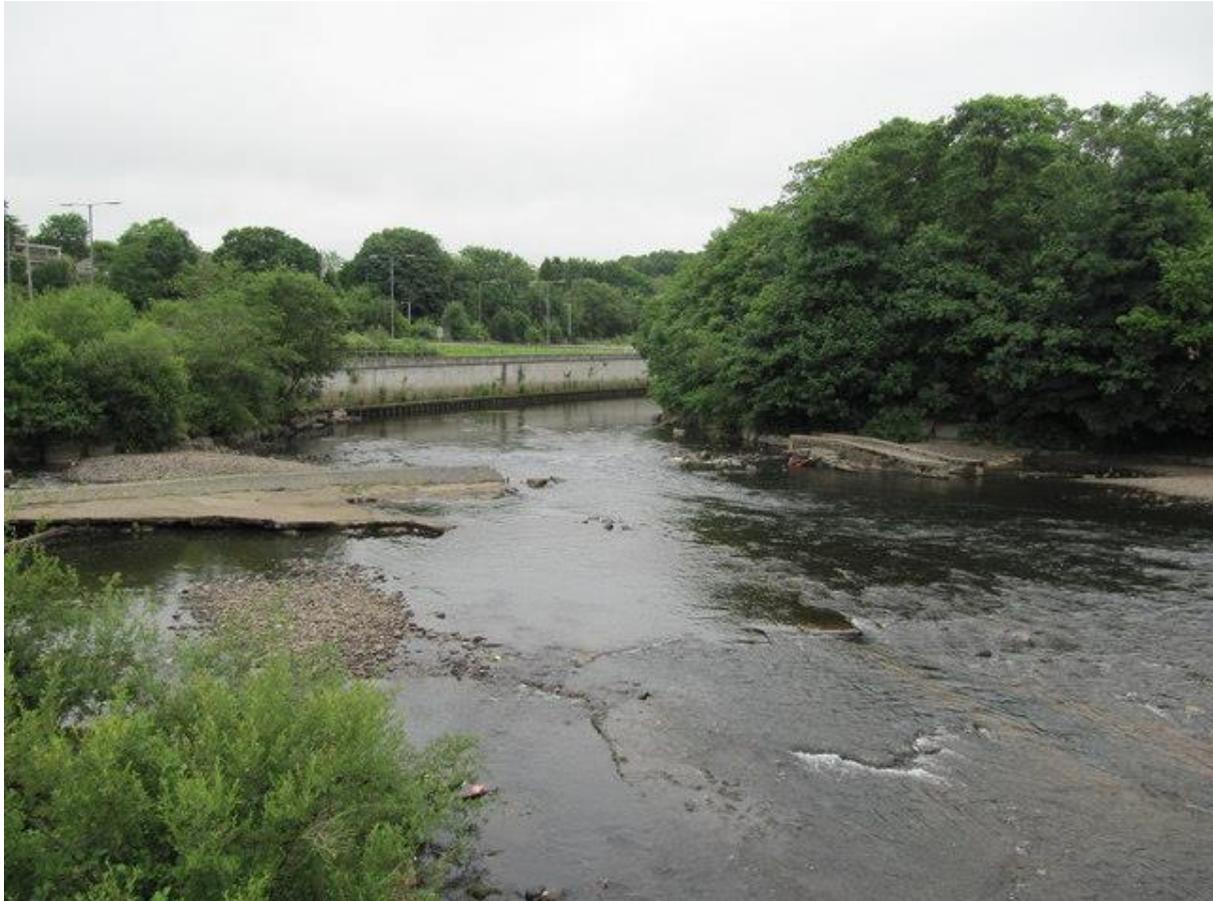
This structure is a reminder of historical manmade alterations made to the river in order to harness its resource. Built in circa 1887, the weir is a low dam constructed across both the river Dulais and river Neath in order to regulate the flow of the river. It alters and diverts the natural current of the rivers to distribute the flow evenly through all of the aqueduct arches, though its primary

Image 1 – Weir structure at Canal Side.

It is important to note that the Canal Side weir also marks the point of furthest tidal influence on the river Neath. However, the structure is in a very poor state of repair with a 20m section demolished during a previous flood, therefore, it can be argued the tidal influence extends further upstream, especially during times of high sea levels.

By removing these structures, it would re-instate the rivers natural unimpeded flow. Their removal will increase sediment transport and prevent shoaling immediately upstream that can be seen on both rivers, which if left un-managed also contributes to flood risk. By taking away these structures, it would also free up resources, as the trapped debris needs to be mechanically removed after prolonged or intense rainfall. NRW are the responsible party tasked with removing the detritus that builds up and should be consulted on the matter.

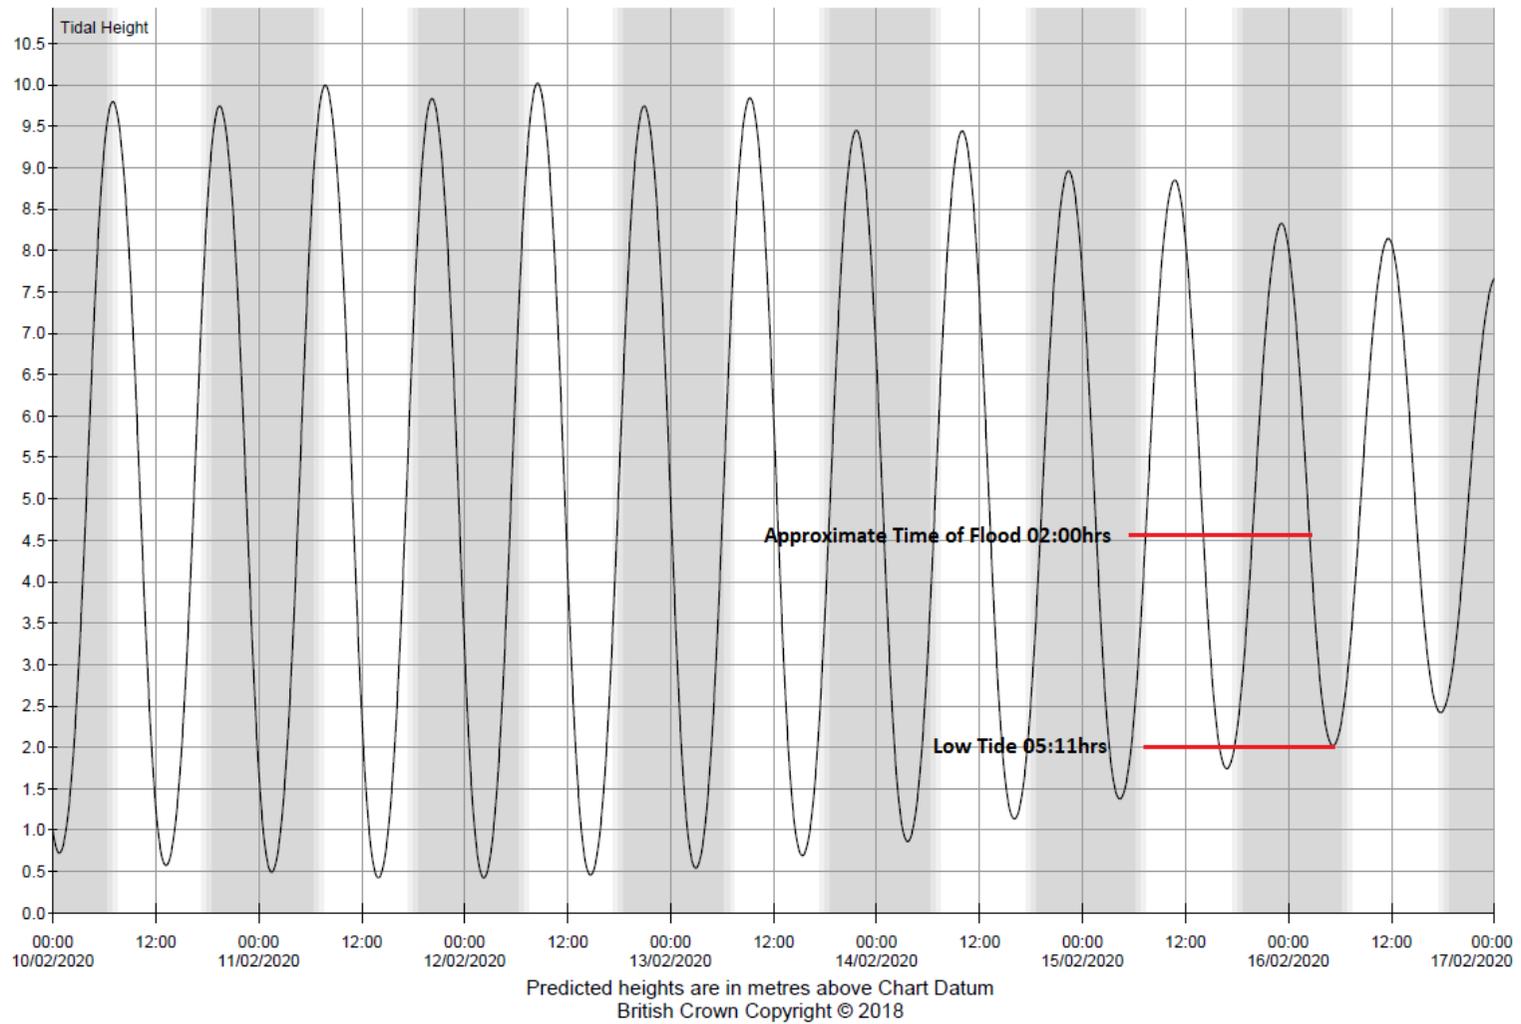
Figure 8 – Tide data showing time of low tide and the flood event at Canal Side.

This flood event on Sunday 16th February was found to coincide with a low spring tide at 05:11 hrs Sunday morning at a height of 2.02m, as seen in Figure 8. It can therefore be surmised the tide was not an impacting factor during this storm event.

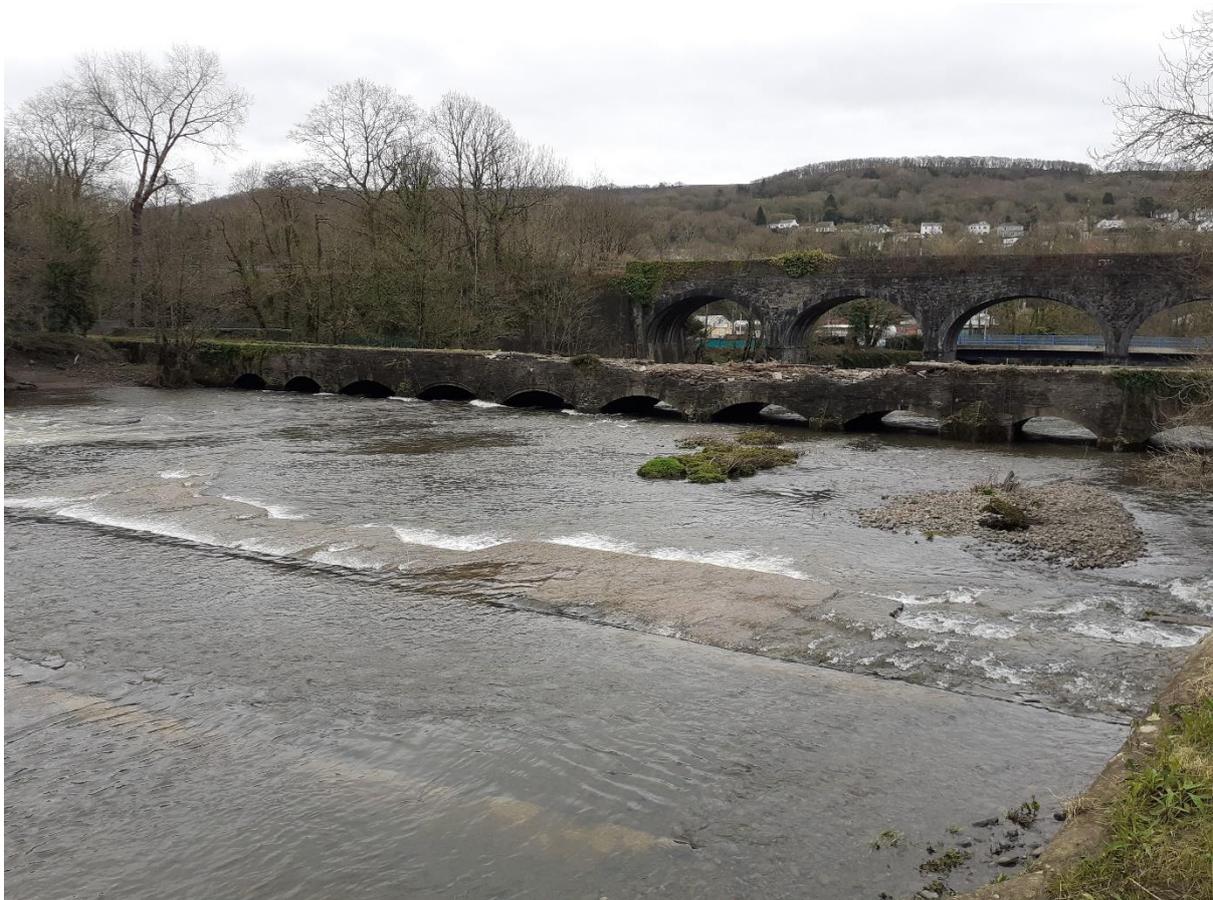
Immediately 30 meters downstream of the weir is the Tennant canal aqueduct that crosses the river Neath. The aqueduct is a 130m long ten arch masonry structure that was built in 1823 to link the Tennant and Neath canals. The structure imposes itself on the river as you can see in Image 2 and water is forced to channel between the arches. Downstream from here the river flows beneath the Vale of Neath railway line viaduct and the B4434 Dulais Fach Road Bridge that is often overtopped during high river levels. Although the aqueduct is understood to be privately owned, it has scheduled monument (SM) designated under the Ancient Monuments and Archaeological Areas Act 1979, as amended by the Historic Environment (Wales) Act 2016.

The structure is also in a very poor state of repair; however, it is protected and preserved in its current state by Cadw who are a division of Welsh Government. The structure, although protected has suffered from extensive damage following recent storms and Cadw should therefore appoint a qualified structural engineer with experience of historic structures to thoroughly inspect.

Image 2 – Tennant Canal Aqueduct

As previously stated, the river levels of the Neath were the highest on record and would have been carrying a large amount of silt and tree debris down from the catchment. When this debris reached the Tennant canal aqueduct it is known to have become trapped in front and beneath the bridge structure creating a dam.

The aqueduct is a key factor in flood risk at the location. The aqueduct likely increases flood risk with the structure seen to act like a dam for both sediment and large trees/branches washed down from both the Neath and Dulais catchments. The effect this structure has on the river can be seen during heavy rainfall, slowing flows and creating a dangerously high backwater. This effect can stimulate the river to react by dropping sediment out of the water column that further worsens the situation by rising bed levels that in turn decreases the volume in which water can flow within its channel. Prior to the overtopping event, the backwater would have extended upstream over time until it reached the location of the breakout on the Dulais approximately 80m upstream from the aqueduct. The impact the weir had during the flood event is unknown but its potential effect cannot be discounted.

5.	WG/Cadw	Consider flood risk impact of Aqueduct.	WG/Cadw to consider following the outcome of action 2 and implement any agreed recommendations.

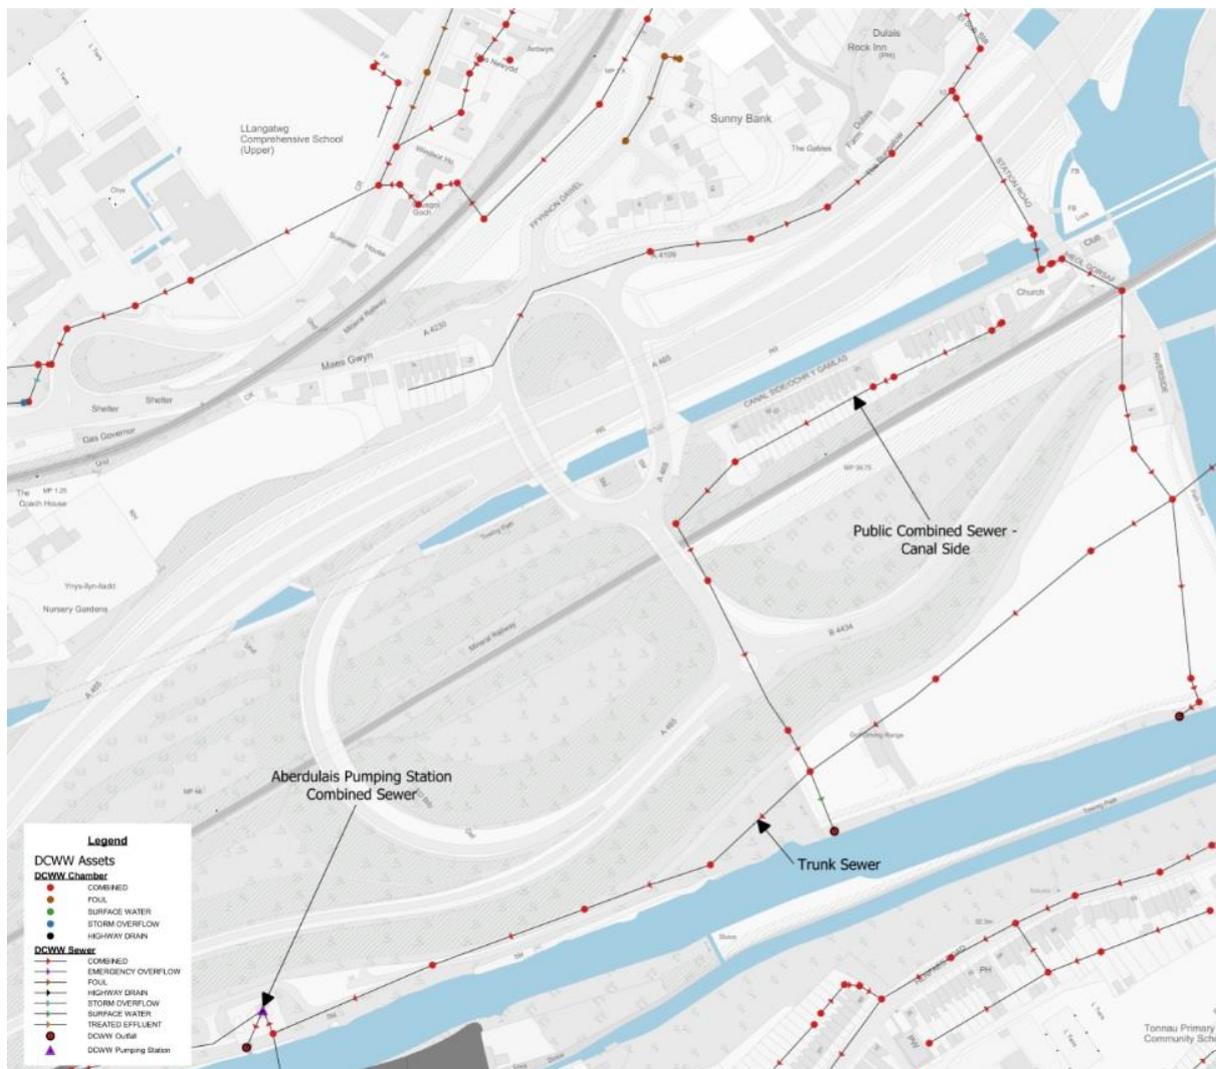
Figure 9 - Map showing the public combined sewer network at Canal Side

There are no public or private, surface water drainage networks or culverted watercourse on Canal Side. Rainwater that lands on hardstanding is known to drain into the Welsh Water combined sewerage network. The combined sewers are located to the rear of the properties and drain out into the main trunk sewer that runs in a south-westerly direction alongside the riverbank towards the pumping station on Riverside lane, as can be seen in figure 9. There is no positive drainage at the property frontages, only the downpipes from roofs discharge water directly on to the un-adopted track that is located between the canal and properties.

Discussions with Welsh Water have also confirmed the pumping station that serves the trunk sewer at Riverside (Figure 9) suffered from flooding from the river Neath, as it overtopped the bank and inundating the station.

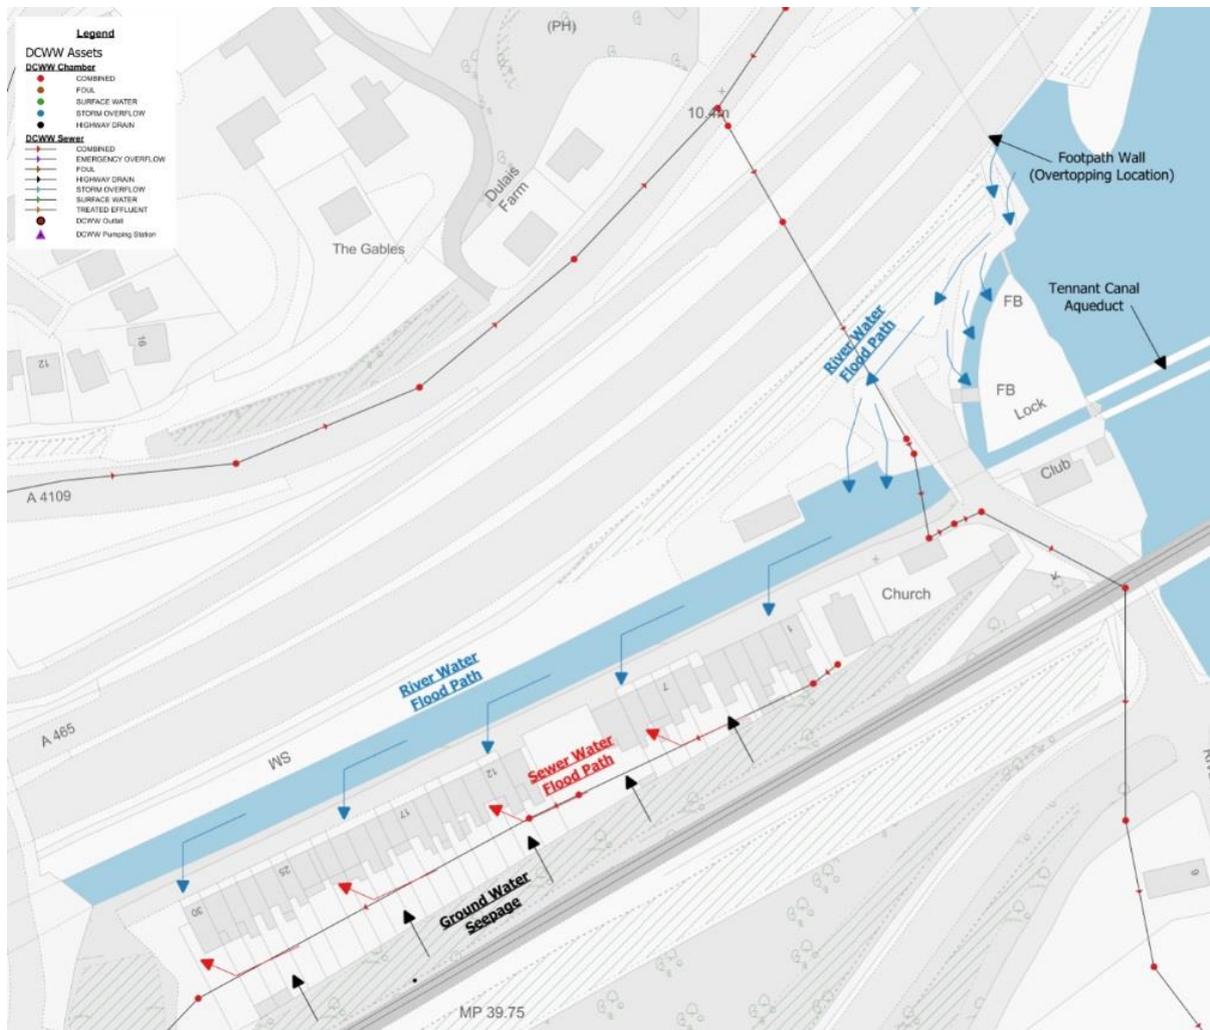
Figure 10– Flood water paths

Reports from residents and indications on the ground during site investigations point toward flooding coming from two main sources, the river Dulais and the combined sewerage network. Figure 10 illustrates the likely flood paths.

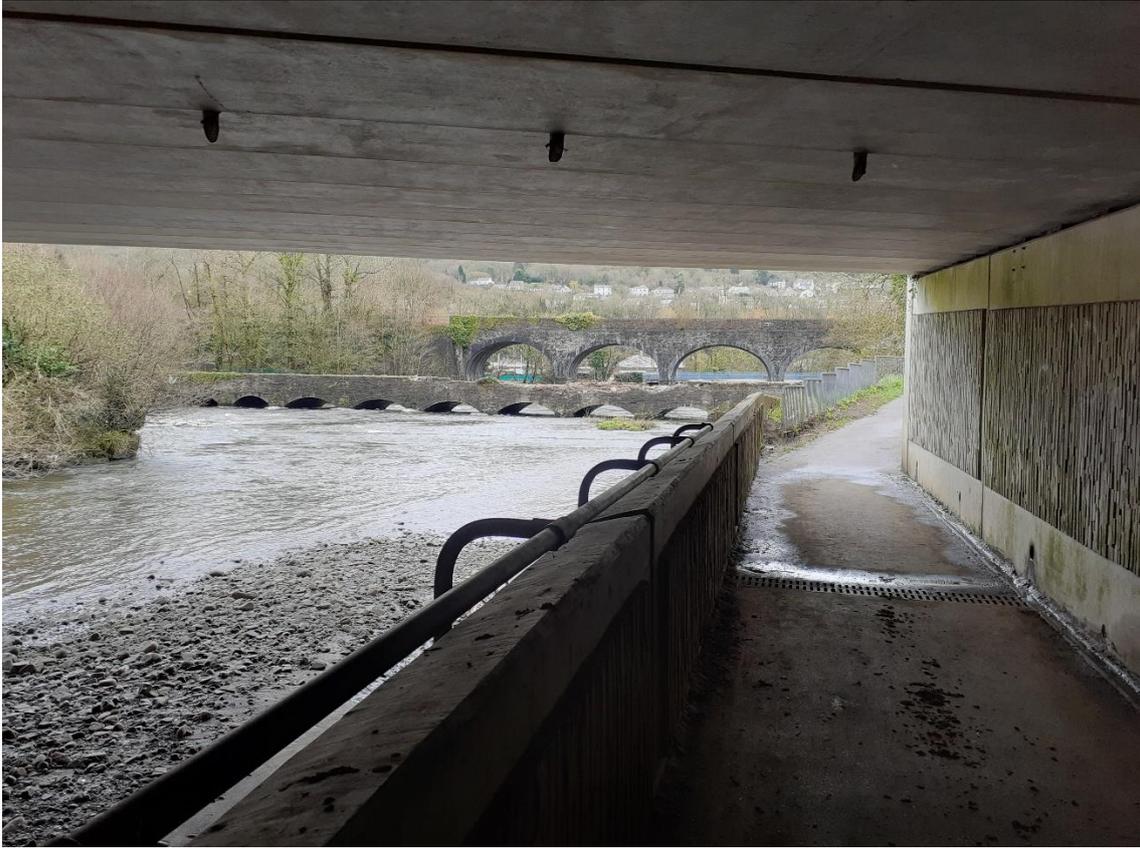
It is understood the river Dulais overtopped the wall that is adjacent to the A465 underpass footpath (Image 3 and 4), the resultant floodwater then flowed down the footpath towards Canal Side entering the canal at various points. Around the same time, it is reported the drains and sewer chambers at the rear of the properties started to surcharge. It is also noted that residents reported ground water seeping through the railway embankment that backs onto the properties, although this would not have been critical on its own, it would have contributed to the floodwater. The volumes of water at the front and back of properties increased and eventually overcame the sandbag defences the residents erected in their doorways, flooding internally up to a depth of 1m.

Image 3 – Footpath wall where the river Dulais overtopped, downstream.

The authority's investigations have determined the river Dulais overtopped a wall adjacent to the footpath that passes beneath the A465. Please see image 3 and 4. The floodwater then entered into the Tennant canal rising the water levels before inundating the properties as depicted in figure 10.

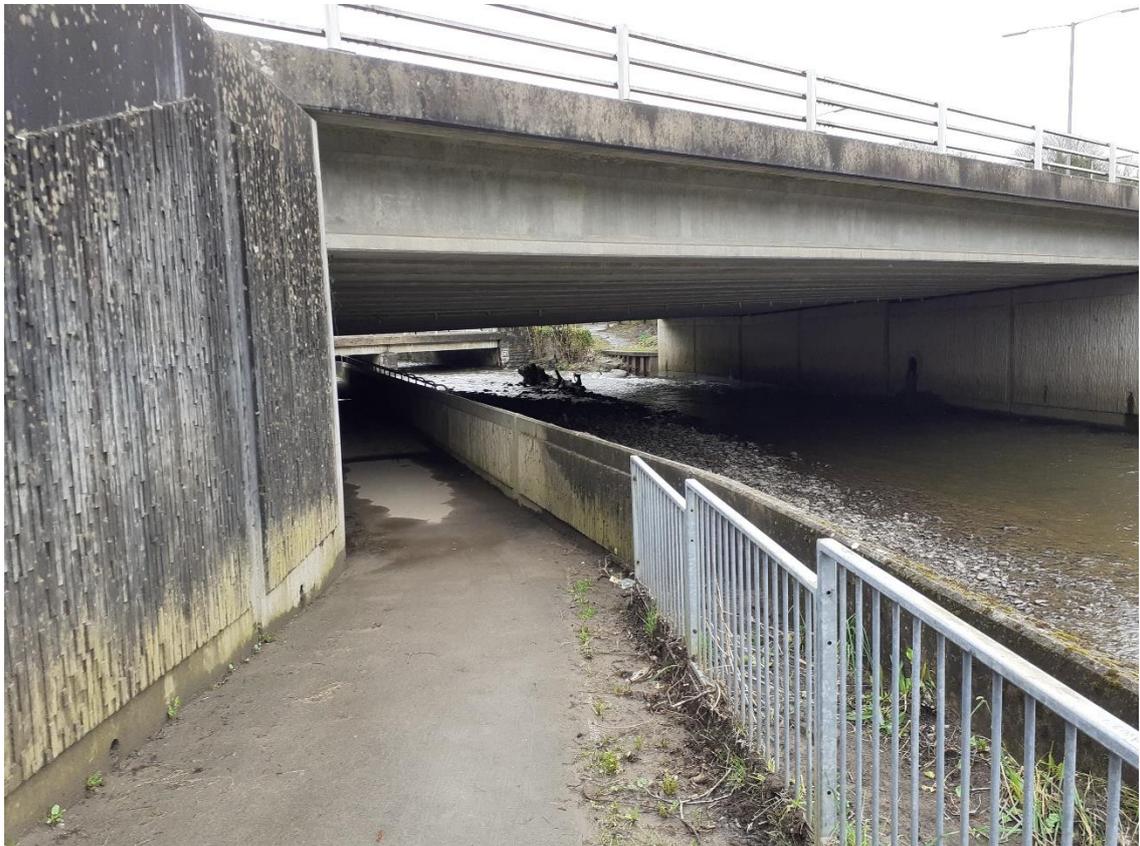
Image 4 – Footpath wall where the river Dulais overtopped, upstream.
