Grounded Trees and Ecology

## BS 5837: 2012 Survey

| Site Address: | Skewen,<br>Neath<br>(Various sites) | Client: | Neath Port Talbot CBC<br>The Quays<br>Brunel Way<br>Neath<br>SA11 2GG |
| Report Ref: | GT&E/NPTCBC | Report Date: | October 2025 |

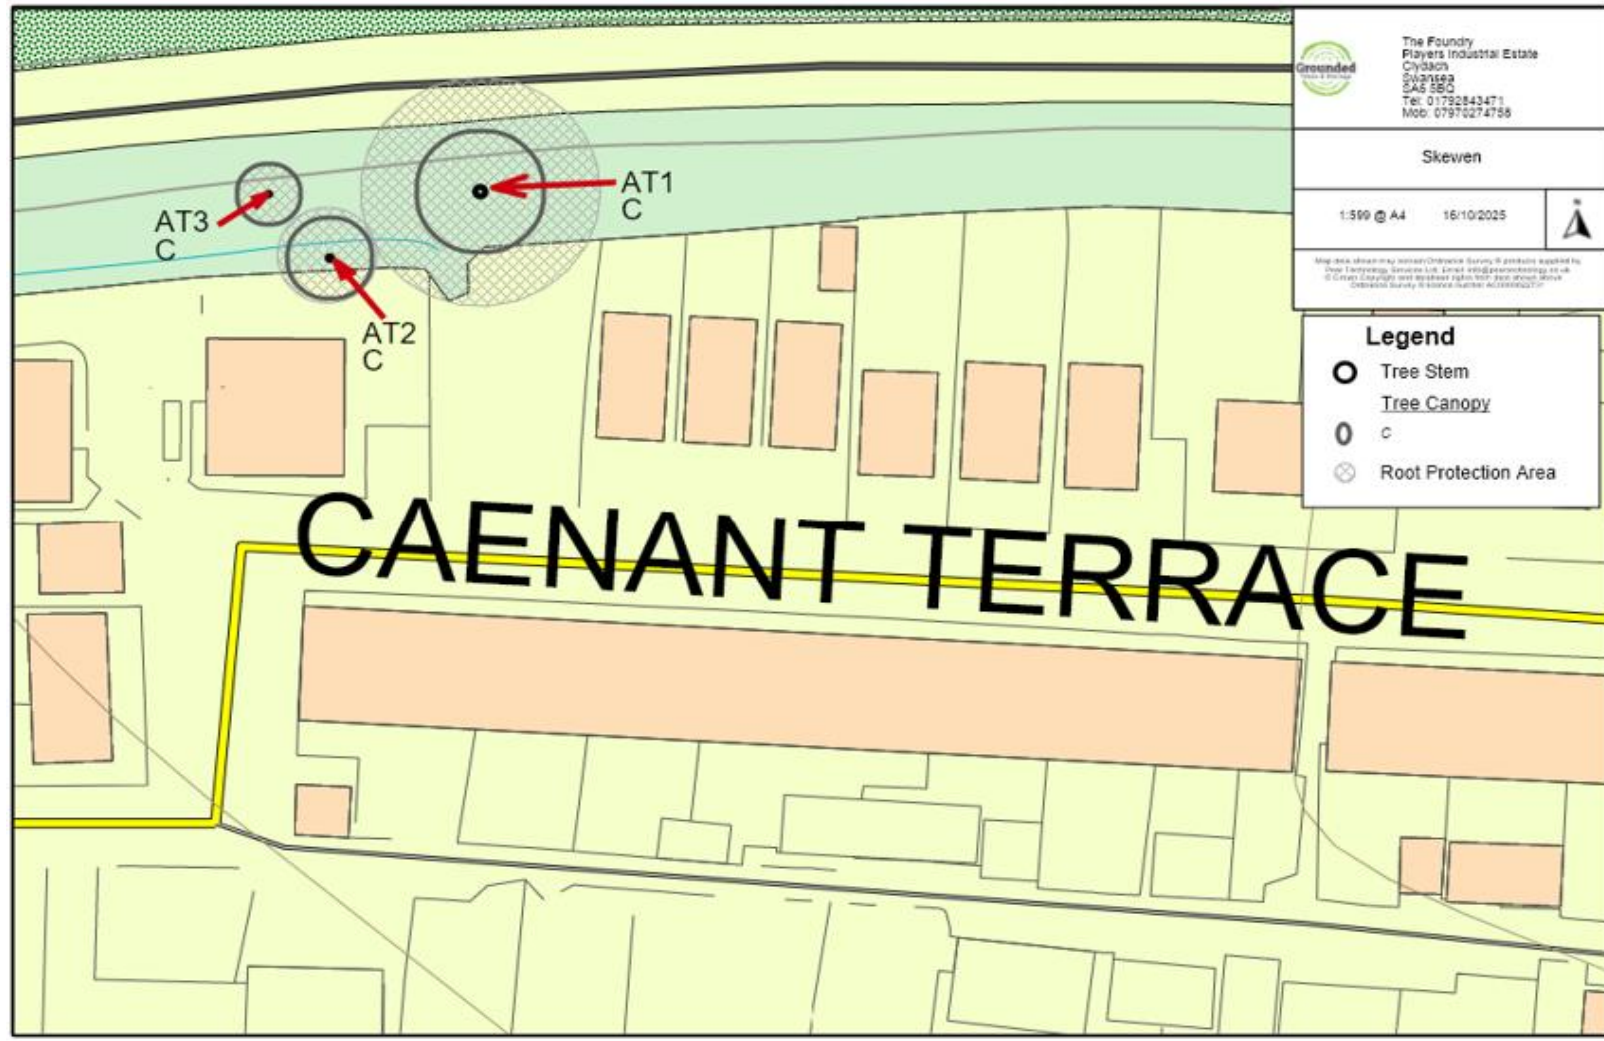
Location A

There are 3 sycamore trees in this area, AT1 is a lapsed coppice stool with several stems, AT2 is growing out of the banking on the south side of the watercourse at the end of a garden, AT3 is higher up the banking and will potentially be in conflict with railway transport in the near future.

| Ref | Life Stage | Species | Height (m) | Stem Diameter (mm) | Crown Spread (m) | | | | Lowest Branch, direction | Vitality | General Observations | Preliminary Recommendations | Estimated Remaining Contribution | Category Grading | RPA Area (m <sup>2</sup> ) | RPA Radius (m) |
|---|---|---|---|---|---|---|---|---|---|---|---|---|---|---|---|---|
| AT1 | M | Sycamore<br>( <i>Acer pseudoplatanus</i> ) | 12 | 300 | 6 | 6 | 6 | 6 | 2W | F | Lapsed coppice stool with several Stems. Ivy covering stems | Re-coppice and repeat on a cyclical basis (e.g. 10years) | 10 -20 | C1 | 40.72 | 3.6 |
| AT2 | M | Sycamore<br>( <i>Acer pseudoplatanus</i> ) | 9 | 280 | 4 | 4 | 4 | 4 | 3S | F | Stem growing out of south bank of watercourse at the north end of garden | Fell to prevent tree failing<br>And blocking watercourse | 10-20 | C1 | 71 | 4.75 |
| AT3 | SM | Sycamore<br>( <i>Acer pseudoplatanus</i> ) | 8 | 250 | 3 | 3 | 3 | 3 | 1.5N | F | Tree close to railway | Fell to ensure safety of railway | 20-40 | C1 | 28.27 | 3 |

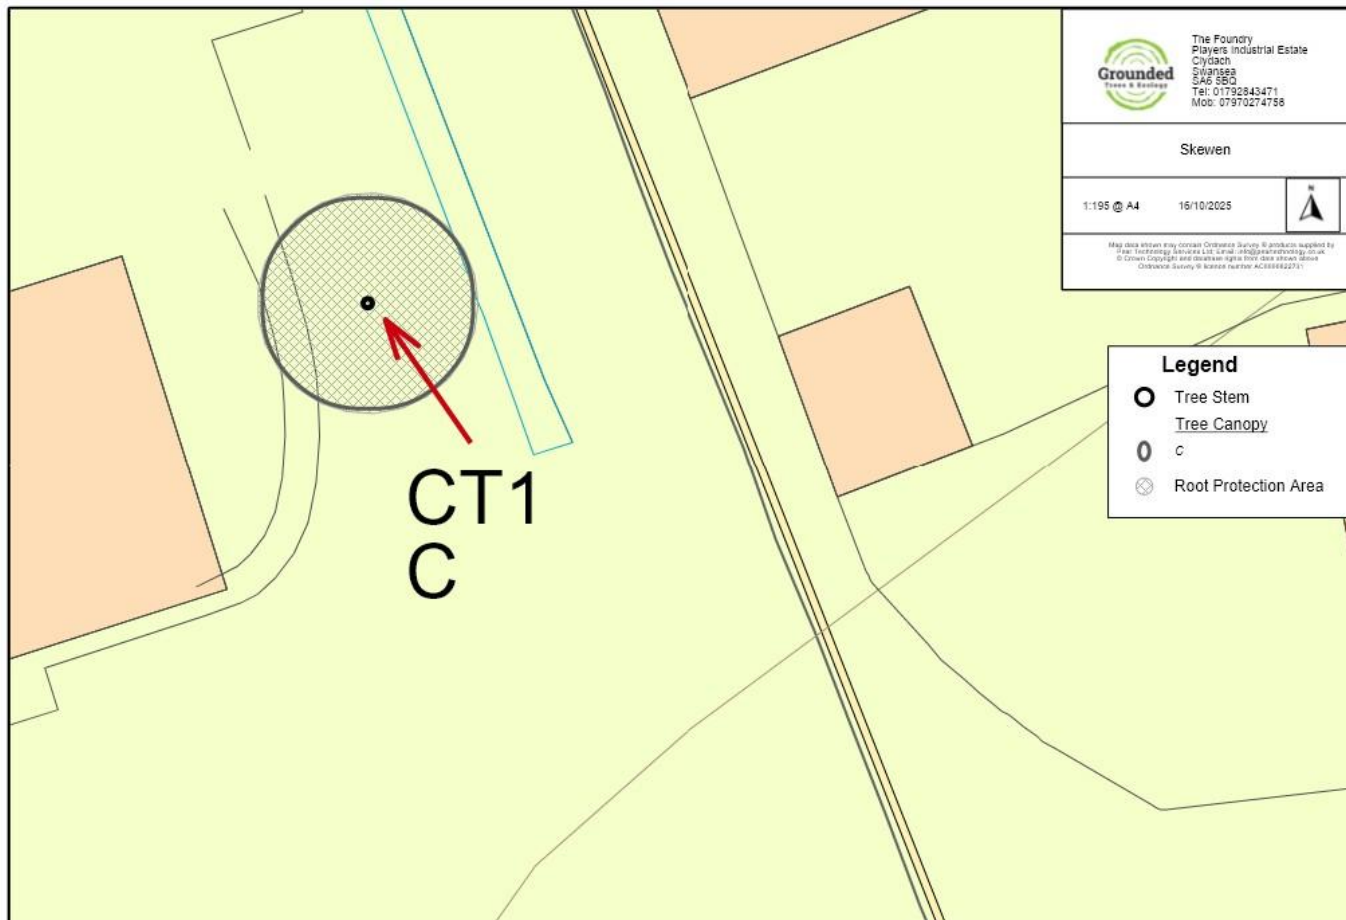
A silver birch situated on a grass area approximately 7 metres from Drummau Road to the south-east corner of Cwrt-Clwydi-Gwyn Care Home. There has been some recent culvert work in this area.

| Ref | Life Stage | Species | Height (m) | Stem Diameter (mm) | Crown Spread (m) | | | | Lowest Branch, direction | Vitality | General Observations | Preliminary Recommendations | Estimated Remaining Contribution | Category Grading | RPA Area (m <sup>2</sup> ) | RPA Radius (m) |
|---|---|---|---|---|---|---|---|---|---|---|---|---|---|---|---|---|
| CT1 | M | Silver birch<br>( <i>Betula pendula</i> ) | 9 | 350 | 4 | 4 | 4 | 4 | 1N | G | The root system will not penetrate<br>Beyond the boundary of the new wall<br>Installed on the watercourse | None | 10 -20 | C1 | 55.42 | 4.2 |

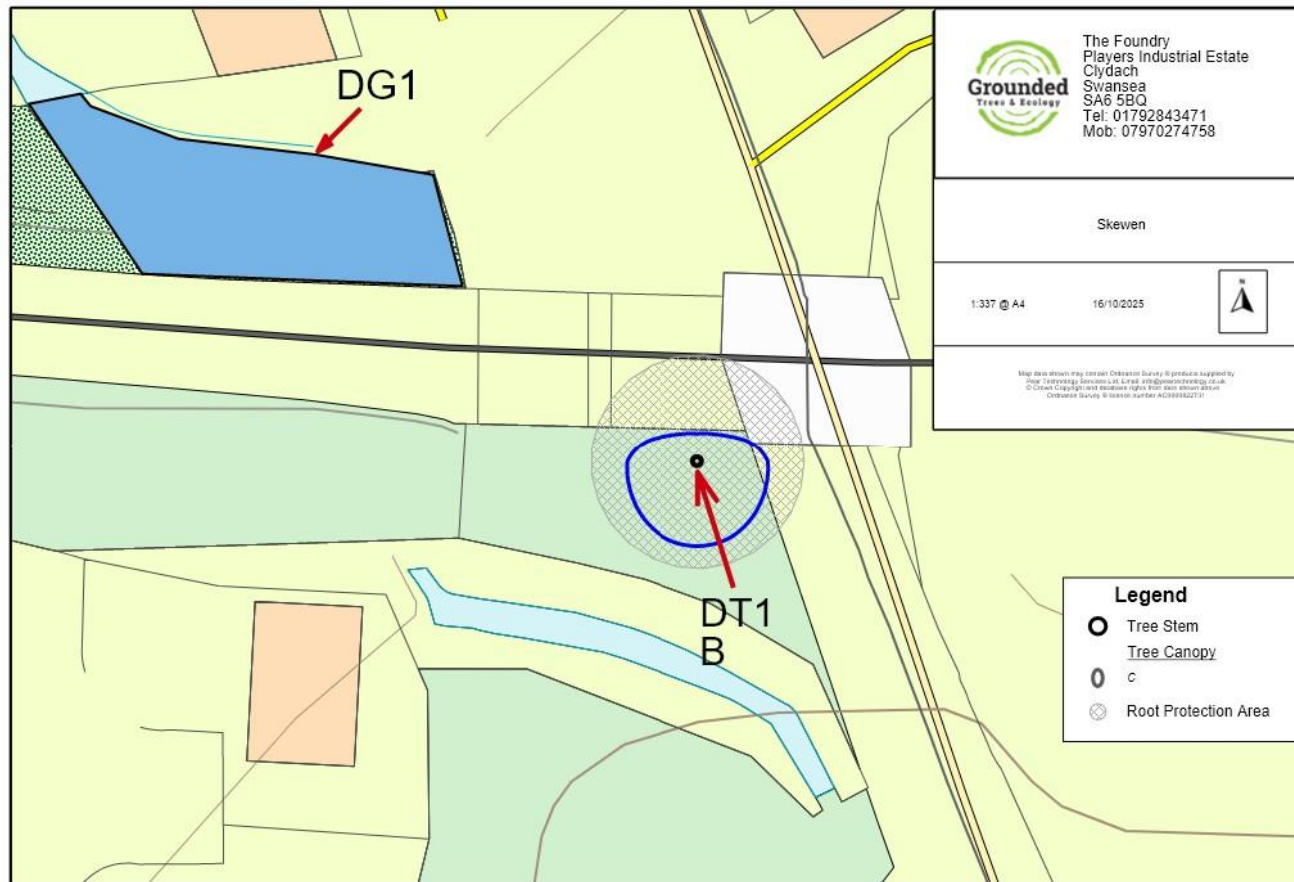
Location D

This location has two sites in close proximity; they are north and south of the railway. A multiple stemmed sycamore is to the south of the railway adjacent to a viaduct on a grassed area. This tree has historic evidence of reduction on the north side to prevent conflict with the structure. The north location is on the embankment of the railway and is accessed through a locked gate, this will be identified as DG1 on the map below. There are approximately 12 sycamore stems on this banking, 2 of which are coppice stools with a number of stems, their average height is estimated between 10-12 metres. There are only one single stem and one coppice stool adjacent to the watercourse. If excavation is required in this area, it is recommended to fell the trees and allow any undisturbed stumps coppice. The embankment trees have not been plotted on the maps.

| Ref | Life Stage | Species | Height (m) | Stem Diameter (mm) | Crown Spread (m) | | | | Lowest Branch, direction | Vitality | General Observations | Preliminary Recommendations | Estimated Remaining Contribution | Category Grading | RPA Area (m <sup>2</sup> ) | RPA Radius (m) |
|---|---|---|---|---|---|---|---|---|---|---|---|---|---|---|---|---|
| DT1 | M | Sycamore<br>( <i>Acer pseudoplatanus</i> ) | 17 | 320<br>330<br>330<br>280 | 2 | 5 | 6 | 5 | 2S | F | Multi stemmed tree on greenspace<br>Adjacent to footpath and railway viaduct | Sever lvy, to aid future inspection | 10 -20 | B1 | 180.32 | 7.58 |
| DG1 | M | Sycamore<br>( <i>Acer pseudoplatanus</i> ) | 10-12 | | | | | | | F | Approx 12 stems including coppice<br>Stools, only 1 stem and 1 coppice<br>Stool adjacent to watercourse | Fell and allow remaining<br>Stumps to coppice | | | | |

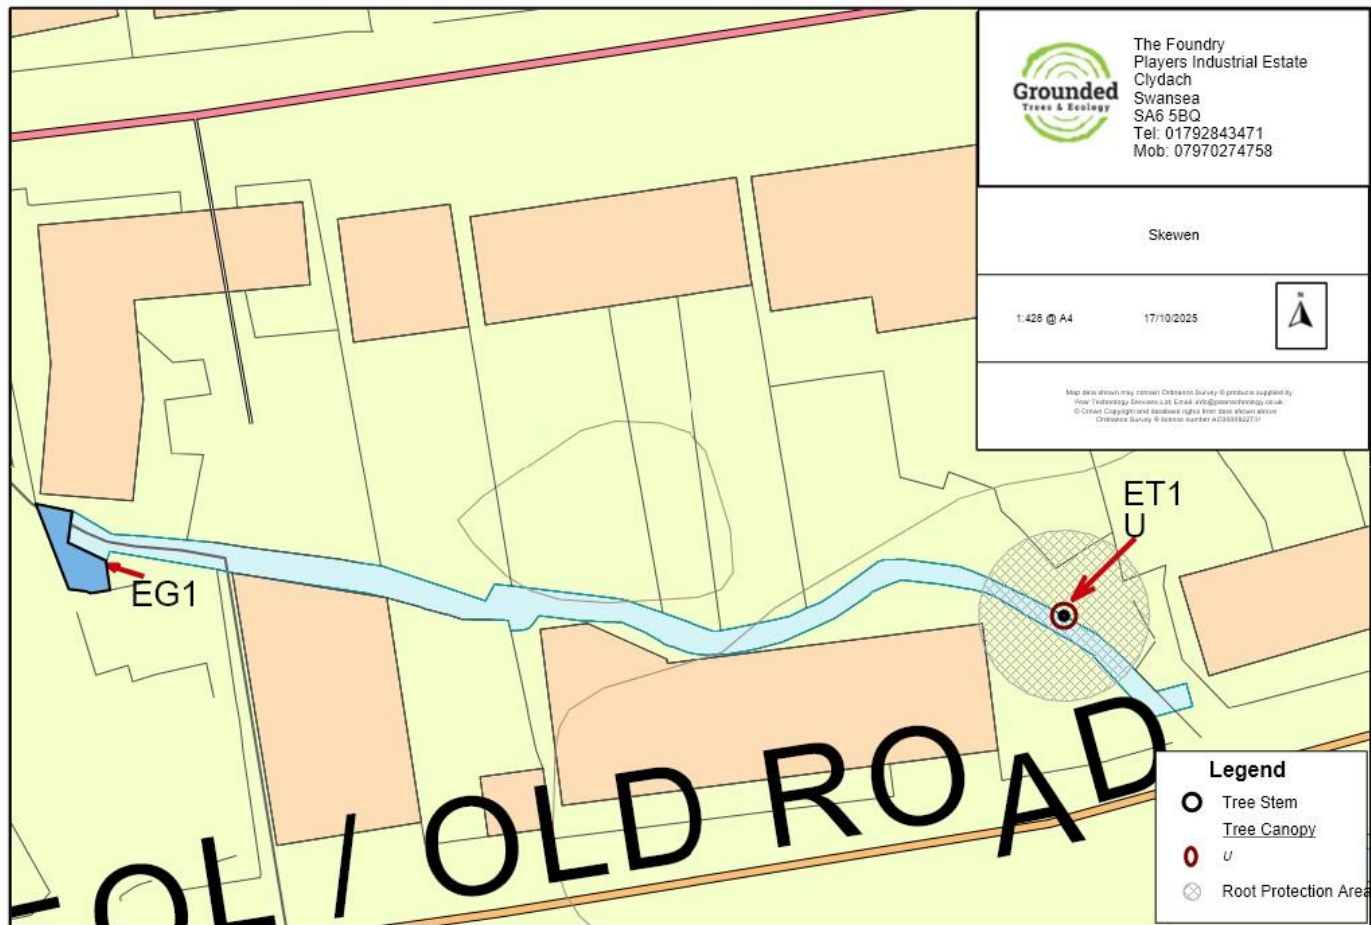
Location E

This location is in two parts, to the west and east of a linear watercourse located between St. Johns Terrace and Old Road. The location to the west has low growing scrub and has no arboricultural significance but will be identified as EG1 on the map below. The location to the east contains a pollard ash stem with growth reaching an estimated 7 metres in height, the stem is ivy covered so it was unable to ascertain its condition. No signs of ash dieback.

| Ref | Life Stage | Species | Height (m) | Stem Diameter (mm) | Crown Spread (m) | | | | Lowest Branch, direction | Vitality | General Observations | Preliminary Recommendations | Estimated Remaining Contribution | Category Grading | RPA Area (m <sup>2</sup> ) | RPA Radius (m) |
|---|---|---|---|---|---|---|---|---|---|---|---|---|---|---|---|---|
| EG1 | | Low vegetation | | | | | | | | | Low vegetation, including bramble & buddleia | Clear/remove | | | | |
| ET1 | M | Ash ( <i>Fraxinus excelsior</i> ) | 7 | 600 | 1 | 1 | 1 | 1 | | F | Pollard ivy covered stem with Multiple small stem growth | Fell | <10y | U | | |

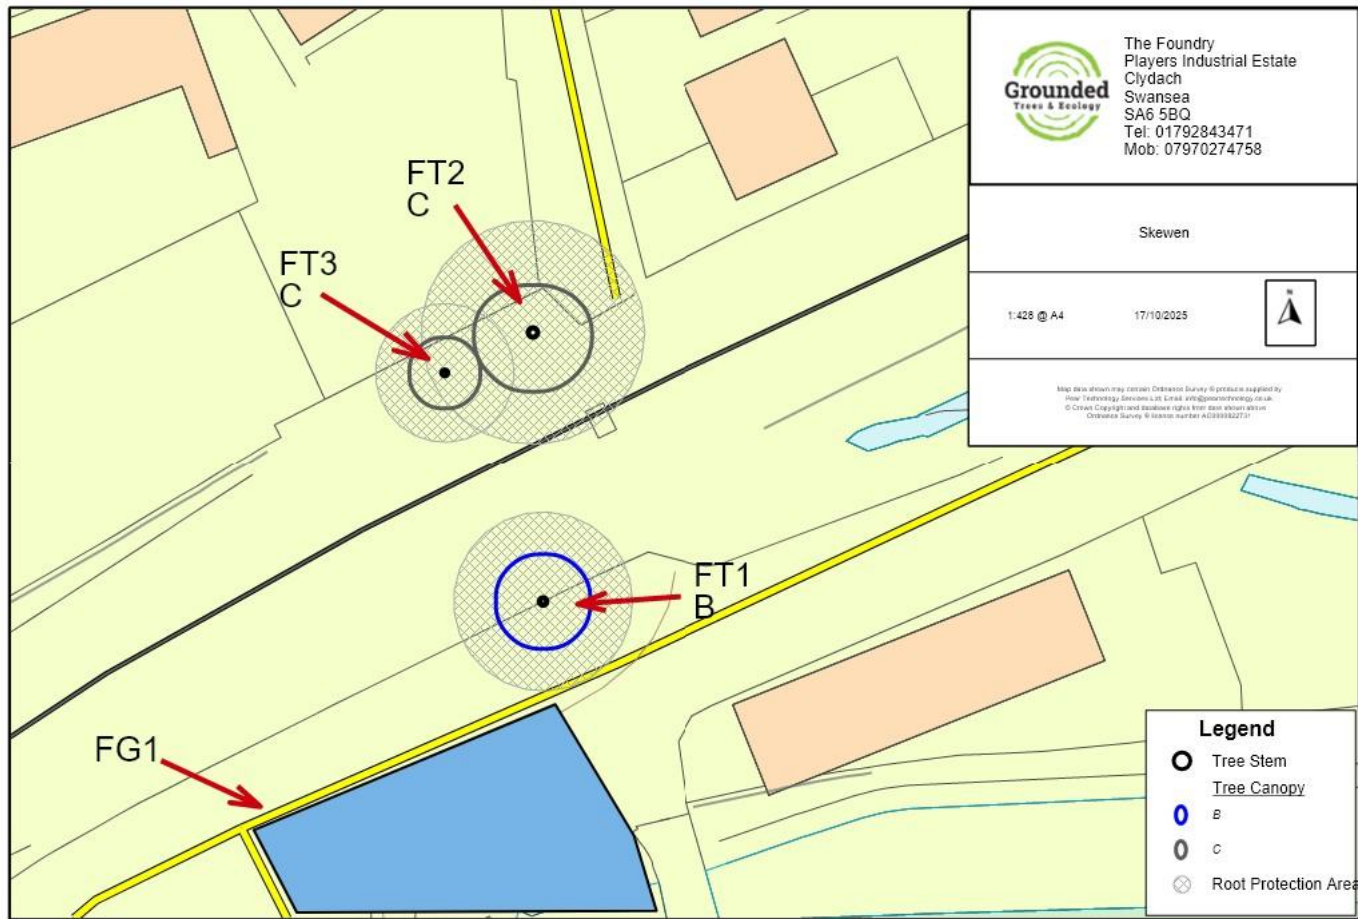
Location F

This location includes three areas of survey, both sides of the railway and an area adjacent to the canal. The canal area consists of low vegetation with some small diameter trees to the western edge adjacent to the overhead road bridge. This area has little concern for arboricultural purposes. The area to the south of the railway has a sycamore coppice stool with 10 stems growing from it and some small hawthorn growing further along the verge. The area to the north of the rail line also contains sycamore coppice stools again with a number of stems growing from each stool.

| Ref | Life Stage | Species | Height (m) | Stem Diameter (mm) | Crown Spread (m) | | | | Lowest Branch, direction | Vitality | General Observations | Preliminary Recommendations | Estimated Remaining Contribution | Category Grading | RPA Area (m <sup>2</sup> ) | RPA Radius (m) |
|---|---|---|---|---|---|---|---|---|---|---|---|---|---|---|---|---|
| FG1 | | Low vegetation | | | | | | | | | Low vegetation, including bramble & Buddleia and small diameter trees | Clear/remove | | | | |
| FT1 | M | Sycamore<br>( <i>Acer pseudoplatanus</i> ) | 12 | 200 | 4 | 4 | 4 | 4 | 3W | G | Coppice stool with 10 stems,<br>Average stem diameter 200mm | Fell/coppice to reduce conflict with railway | 10-20 | B1 | | |
| FT2 | M | Sycamore<br>( <i>Acer pseudoplatanus</i> ) | 12 | 250 | 4 | 5 | 5 | 5 | 3N | F | Coppice stool with multiple stems<br>Ivy covered | Fell/coppice to reduce conflict with railway | 10-20 | C1 | | |
| FT3 | M | Sycamore<br>( <i>Acer pseudoplatanus</i> ) | 10 | 200 | 3 | 3 | 3 | 3 | | F | Coppice stool | Fell/coppice to reduce conflict with railway | 10-20 | C1 | | |

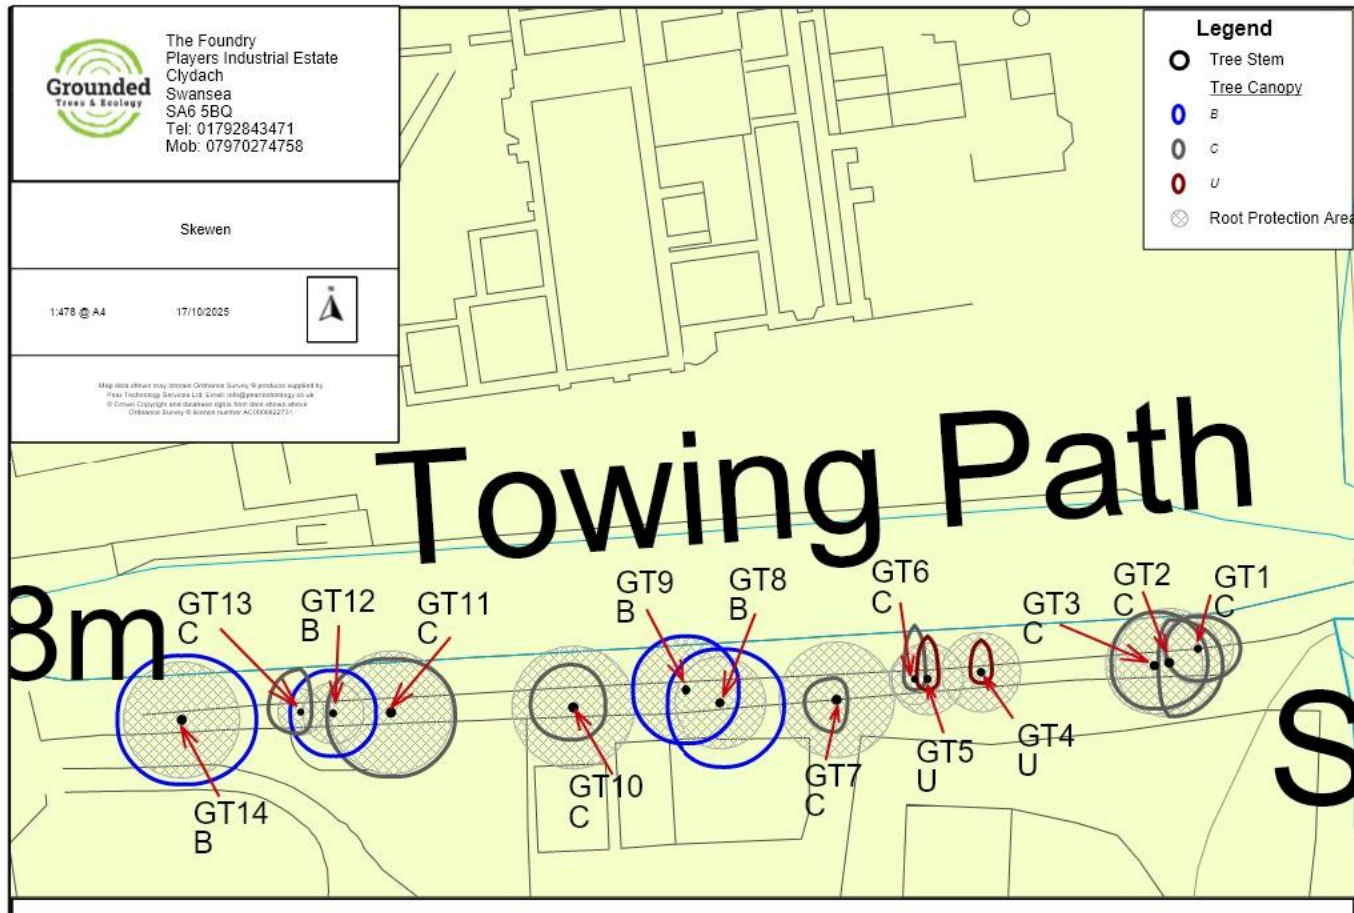
Location G

This location is along the towpath of the Tennant canal opposite Neath Abbey. The tree species here are predominantly sycamore with alder (which are in poor health) and willow. The trees have heavy covering of ivy which limits inspection of the stems, therefore, if any of these trees are to remain it would be advisable to sever the ivy at the base to aid future inspection which will benefit the trees by removing the sail area which could cause failure in high winds. The alder are generally in poor health and it is recommended to remove these.

| Ref | Life Stage | Species | Height (m) | Stem Diameter (mm) | Crown Spread (m) | | | | Lowest Branch, direction | Vitality | General Observations | Preliminary Recommendations | Estimated Remaining Contribution | Category Grading | RPA Area (m <sup>2</sup> ) | RPA Radius (m) |
|---|---|---|---|---|---|---|---|---|---|---|---|---|---|---|---|---|
| GT1 (23) | SM | Goat willow ( <i>Salix caprea</i> ) | 8 | 180<br>150<br>150 | 3 | 4 | 3 | 3 | 3N | F | Three stemmed tree.<br>Typical for species | None | 10-20 | C1 | 35 | 3.34 |
| GT2 (24) | M | Alder ( <i>Alnus glutinosa</i> ) | 11 | 300<br>300 | 4 | 5 | 5 | 1 | 4E | F | Suppressed to the east by neighbouring tree. Ivy covered stem | Sever ivy at base to aid future inspection | 10-20 | C1 | 81 | 5 |
| GT3 (25) | M | Sycamore ( <i>Acer pseudoplatanus</i> ) | 12 | 380 | 5 | 5 | 4 | 4 | 3W | F | Ivy covered stem | Sever ivy at base to aid future inspection | 10-20 | C1 | 65.33 | 4.56 |
| GT4 | M | Alder ( <i>Alnus glutinosa</i> ) | 10 | 310 | 3 | 1 | 1 | 1 | 4N | P | Ivy covered stem, crown in decline | Fell | <10 | U | | |
| GT5 (26) | M | Alder ( <i>Alnus glutinosa</i> ) | 10 | 280 | 4 | 1 | 1 | 1 | 5N | P | Ivy covered stem, crown in decline | Fell | <10 | U | | |
| GT6 (27) | M | Alder ( <i>Alnus glutinosa</i> ) | 10 | 200 | 5 | 1 | 1 | 1 | 3N | P | Ivy covered stem, crown in decline | Fell | <10 | C1 | | |
| GT7 | M | Alder ( <i>Alnus glutinosa</i> ) | 11 | 320<br>320 | 2 | 1 | 3 | 3 | 6S | P | Ivy covered stem, crown in decline<br>Double stemmed tree | Fell | <10 | C1 | | |
| GT8 (28) | M | Sycamore ( <i>Acer pseudoplatanus</i> ) | 14 | 360 | 5 | 6 | 6 | 5 | | F | Ivy covered stem, leaning to south | Sever ivy at base to aid future inspection | 10-20 | B1 | 58.63 | 4.32 |

| Ref | Life Stage | Species | Height (m) | Stem Diameter (mm) | Crown Spread (m) | | | | Lowest Branch, direction | Vitality | General Observations | Preliminary Recommendations | Estimated Remaining Contribution | Category Grading | RPA Area (m <sup>2</sup> ) | RPA Radius (m) |
|---|---|---|---|---|---|---|---|---|---|---|---|---|---|---|---|---|
| GT9 (29) | M | Sycamore ( <i>Acer pseudoplatanus</i> ) | 12 | 420 | 5 | 5 | 5 | 5 | 4N | F | Ivy covered stem | Sever ivy at base to aid future inspection | 10-20 | B1 | 79.8 | 5 |
| GT10 (30) | M | Alder ( <i>Alnus glutinosa</i> ) | 8 | 480 | 4 | 3 | 3 | 4 | 4W | P | Pollard stem, ivy covered stem, willow stem adjacent (ownership uncertain) | Sever ivy to aid future inspection, consider early removal. Fell willow if possible | <10 | C1 | 104.2 | 5.76 |
| GT11 (31) | M | Sycamore ( <i>Acer pseudoplatanus</i> ) | 12 | 480 | 5 | 6 | 6 | 6 | 4N | F | Ivy covered stem. Damage to bark at the base on south side. Building debris around the base which can interfere with root function. | Sever ivy to aid future inspection, monitor for decline due to basal damage consider early removal | <10 | C1 | 104.2 | 5.76 |
| GT12 (32) | SM | Sycamore ( <i>Acer pseudoplatanus</i> ) | 11 | 240 | 4 | 4 | 4 | 4 | 4N | F | Ivy covered stem | Sever ivy to aid future inspection. | 20-40 | B1 | 26 | 2.88 |
| GT14 (34) | M | Sycamore ( <i>Acer pseudoplatanus</i> ) | 10 | 290<br>350 | 6 | 7 | 6 | 6 | 3E | F | | None | | B1 | 93.46 | 5.45 |
