# Investigation Report into Flooding Incident of 3rd September 2016 Varteg Road, Ystalyfera

Highways and Drainage Services  
Environment Directorate  
Neath Port Talbot County Borough Council  
The Quays  
Brunel Way  
Briton Ferry  
Neath  
SA11 2GG

Version	Prepared by	Reviewed by	Approved by	Date
Rev 1	James Davies (Drainage Officer)	Steve Owen (Highways and Drainage Manager)	Mike Roberts (Head of Streetcare)	February 2017

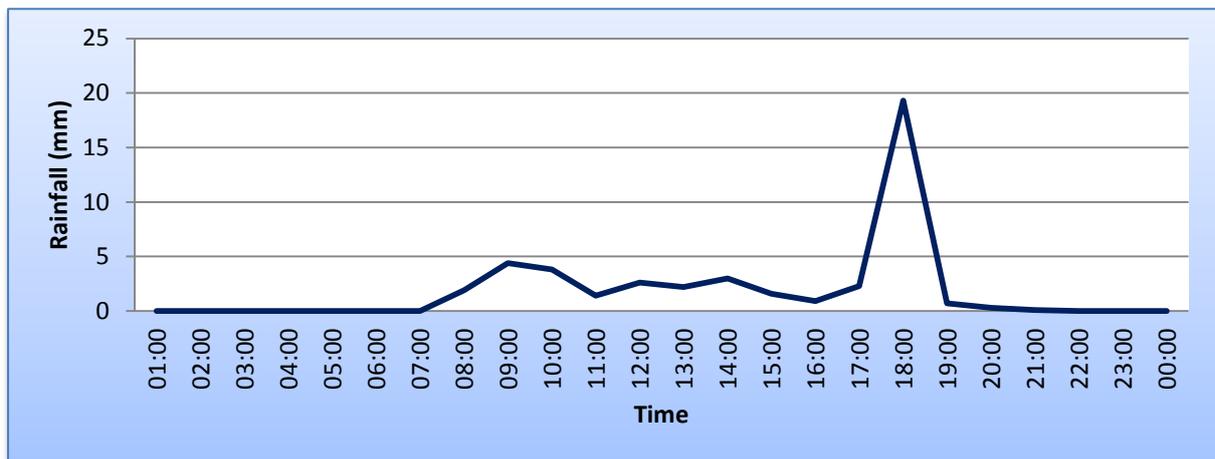
Figure 1, Rainfall in Ystalyfera on 3rd September 2016 (Rainfall data provided by MetDesk Limited)

The graph identifies that between 18:00hrs and 19:00hrs the average rate of rainfall in Ystalyfera was approximately 19.3mm/hr. However when studying the five minute rainfall radar over the same period, it was found that the peak rainfall intensity during that hour reached between 50-100mm/hr. A screenshot of the rainfall radar produced by NPTCBC's weather forecasters MetDesk Limited can be seen in Figure 2. The period where the rainfall intensity peaked above 50mm/hr was the time that numerous communities throughout the North West of the County Borough began to suffer from surface water, ordinary watercourse and river flooding. After 19:00hrs the rainfall intensity significantly reduced until it stopped completely by 21:00hrs.

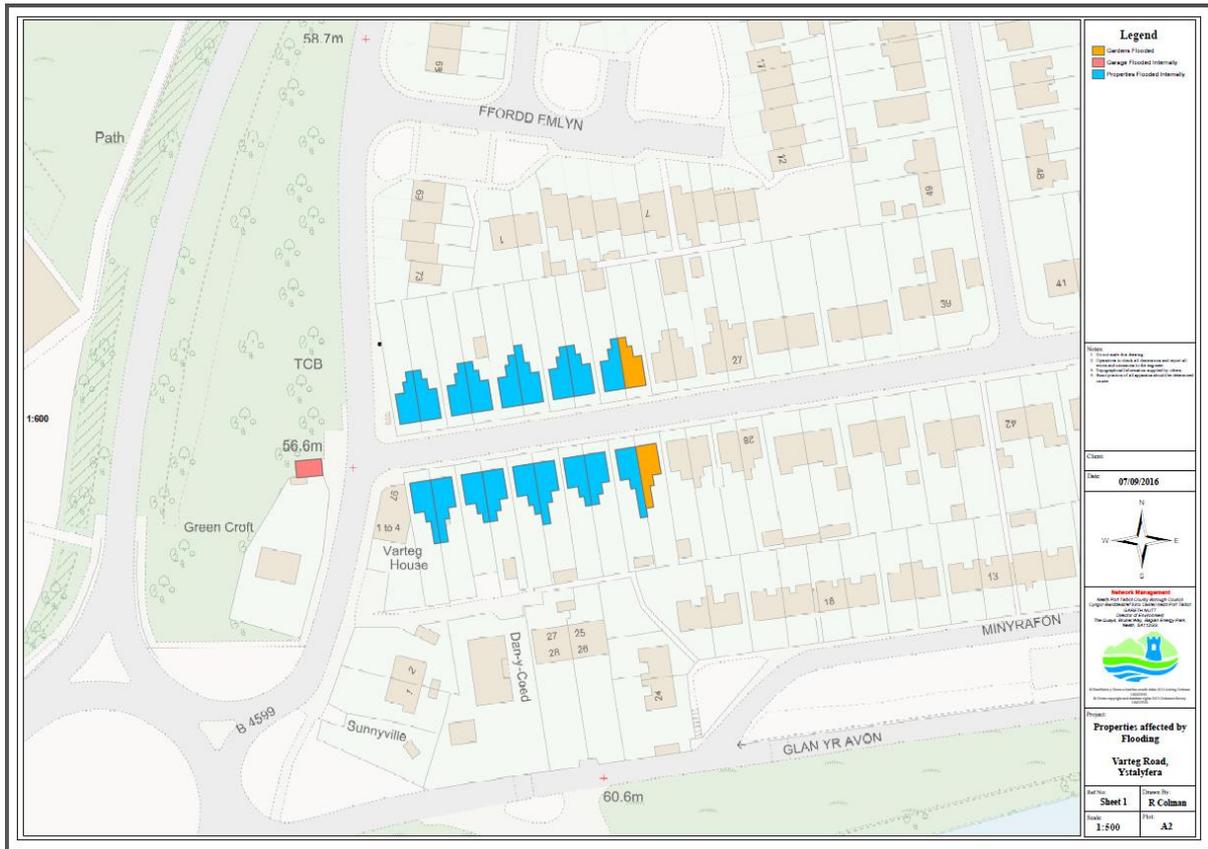
Figure 3, Properties affected by the flood event on 3rd September 2016

A total of 18 properties suffered internal flooding on 3<sup>rd</sup> September at Varteg Road, with at least 2 more properties experiencing flooding of their gardens. In addition to those affected on Varteg Road, 1 property on Ynnsydarren Road suffered internal flooding to an outbuilding. Figure 3 illustrates those properties that were affected as a result of the flooding.

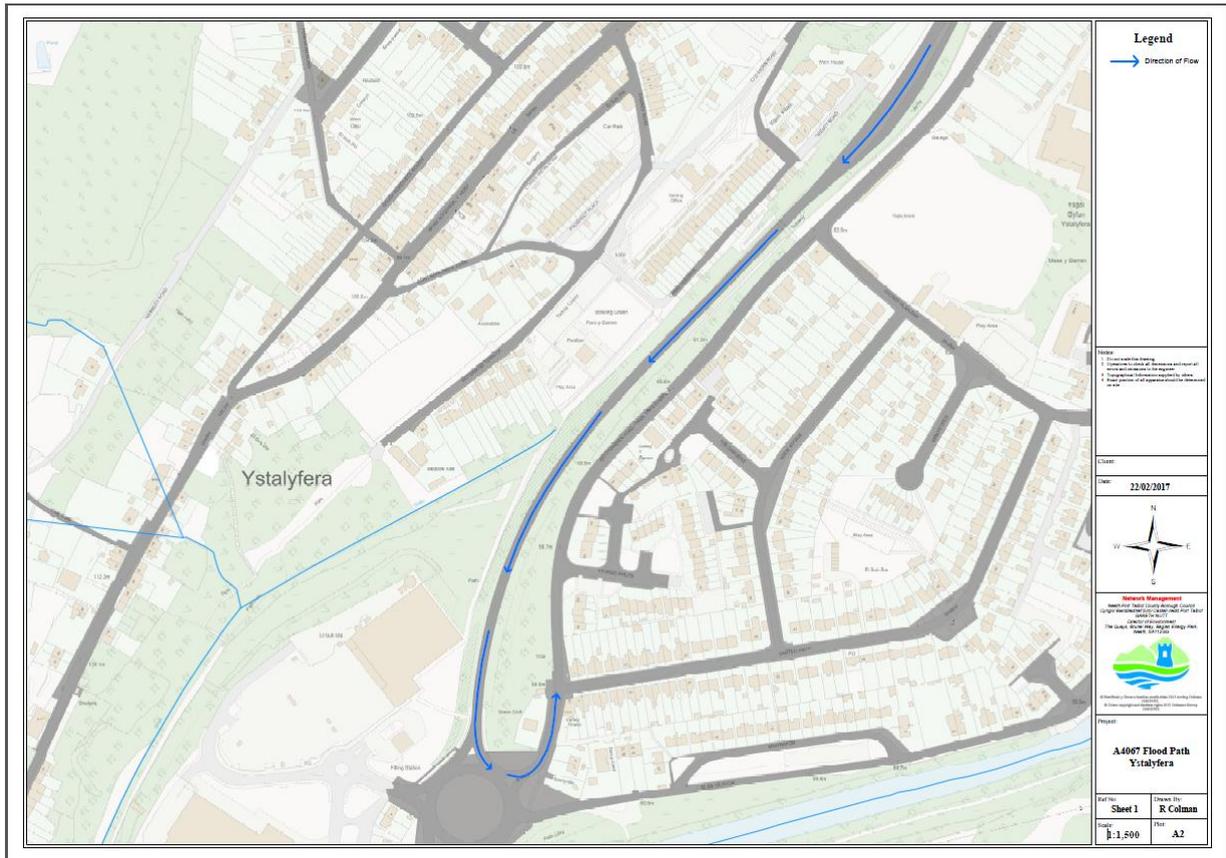
Figure 6, Map showing the flow route of surcharge water from the A4067

The A4067 highway drainage network is a separate system to the network in the Varteg Estate and discharges water directly into the River Tawe. The only time that there is an interaction between the A4067 and the Varteg Estate in drainage terms is when the drainage infrastructure on the A4067 is unable to accept rainwater that falls on the highway due to the level of rainfall exceeding system capacity. When this occurs then, as the A4067 is at a higher level than the Varteg Estate, surface water tracks from North to South on the bypass following the road around the roundabout exit onto the B4599 Ynysydarren Road, progressing towards the low point around the junction with Varteg Road. (See general flow path of surcharge water in Figure 6).

The intensity of rainfall that fell after 18:00hrs on 3<sup>rd</sup> September 2016 far exceeded the design capacity of the drainage infrastructure in the area generally, including that serving the A4067. The drainage infrastructure on the bypass was unable to receive all of the rainwater, resulting in surcharge water following the

Notwithstanding the intense rainfall the condition of the drainage infrastructure serving the A4067 was investigated. This identified some root ingress into the drainage pipes located under the roundabout which is not an uncommon occurrence in drainage systems. Although the roots will have had some impact on the flow rate within the system, given the intensity of severe rainfall which overwhelmed the drainage systems generally, it is believed their presence did not have a significant effect on the level of flood water.

Subsequent to the flood event, to ensure free flow in the system the Authority has completed extensive gully cleansing operations on the A4067 and engaged a specialist contractor to remove roots in the pipes located underneath the roundabout which has been completed. Furthermore, work is planned by the Authority, when conditions permit, to reline the associated pipes. However, as indicated previously, during intense rainfall surface water runoff may be expected to occur from the A4067 and find its natural course.

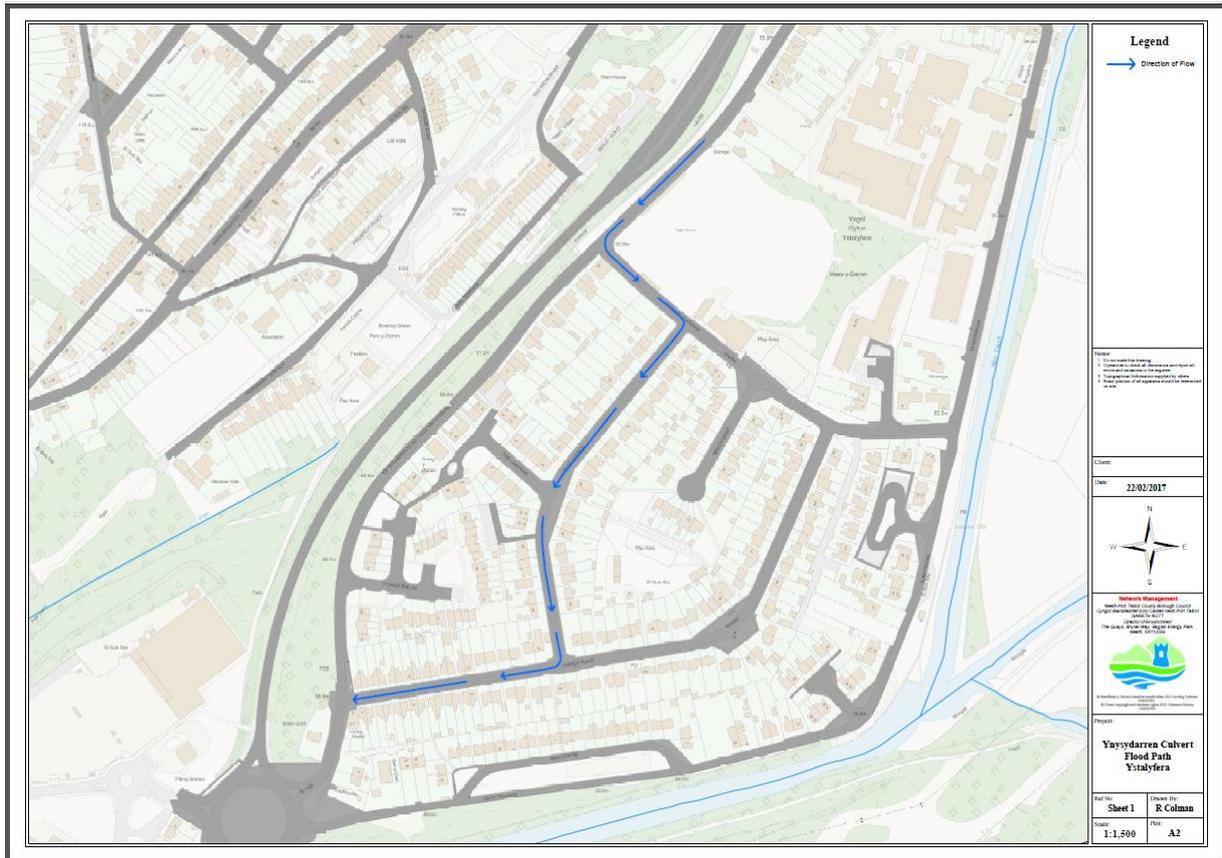
Figure 7, Map showing the flow route of surcharge water from the Ynysdarren culvert

The culverted watercourse does not interact with the drainage system serving the Varteg Estate. However if the culvert surcharges on Ynnsydarren Road as it did during the flooding event then water is channelled through the Varteg Estate to the low point of the catchment around the junction of Ynnsydarren and Varteg Road. (See general flow path of surcharge water in Figure 7).

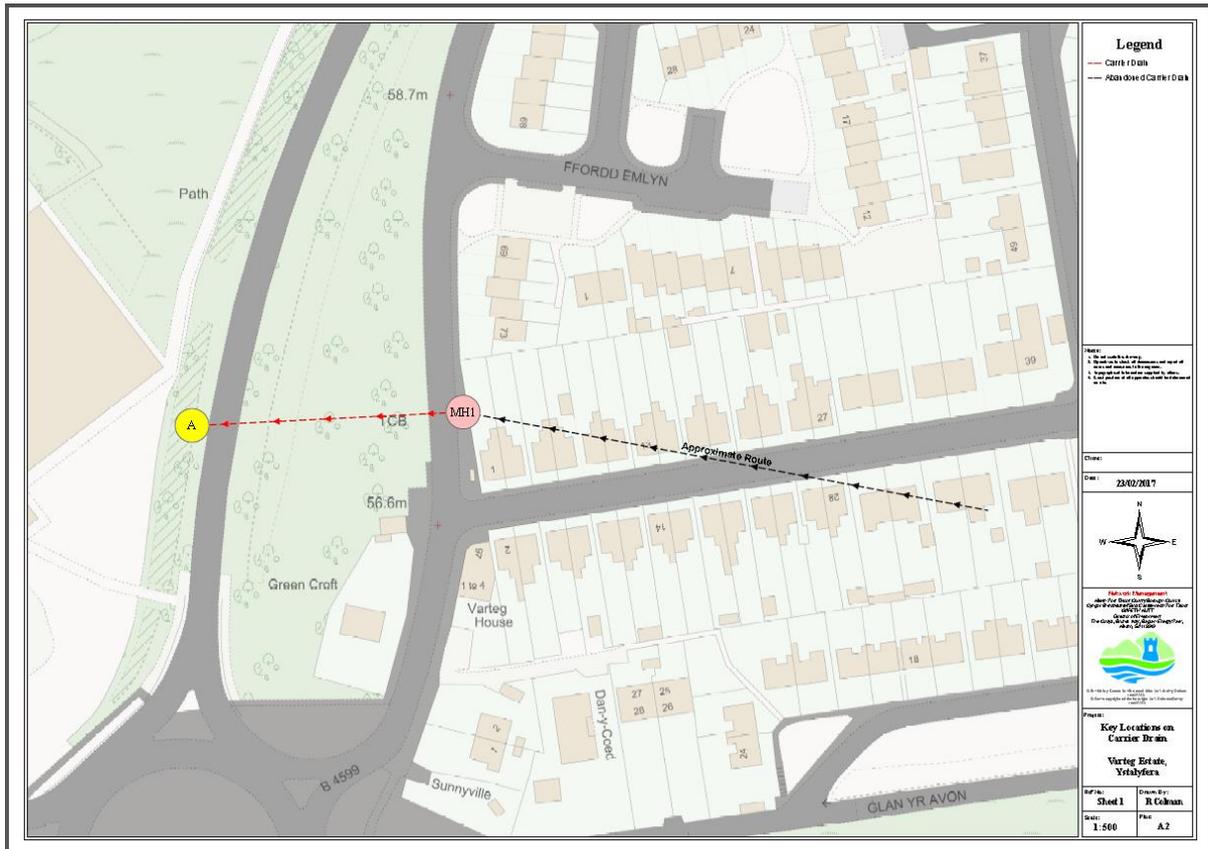
Figure 8, Map identifying the 1.2m diameter culvert (including believed redundant section)

Chamber MH1 shown in figure 8 is situated at the lowest point and is the point at which all surface water would normally arrive. MH1 is built on a 1.2 metre diameter culvert that flows downstream East to West under the Varteg Estate, assumed originally to supply water to the old iron works and now conveys water from the estate under the A4067 towards the recently developed ASDA site. The section under the Varteg Estate itself is believed to be redundant other than it provides some storage capacity for flows entering MH1. Further to the investigation it is believed that water was then historically conveyed via a culvert system down the valley, before outfalling downstream.

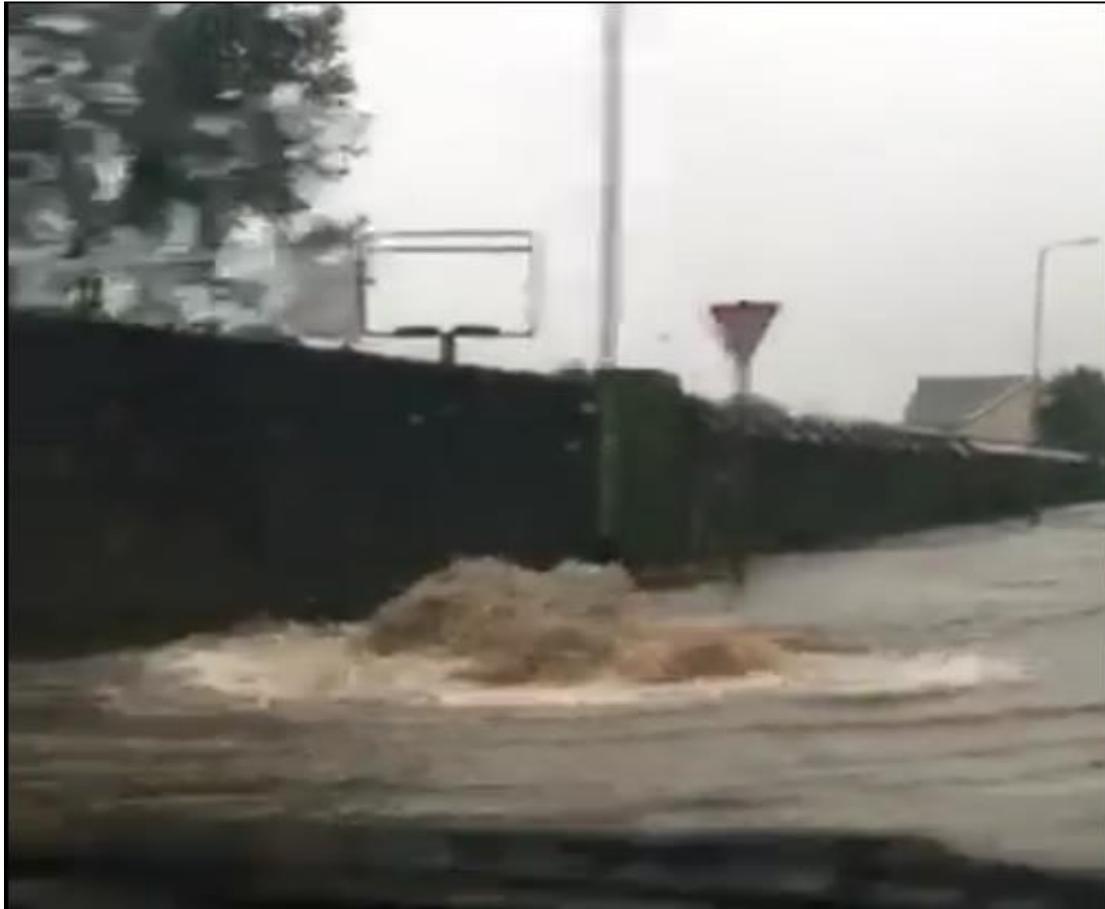
Figure 9, Picture showing surcharging water from Ynysydarren culvert

During the time of the peak intensity rainfall, the available capacity of the culvert downstream of the chamber on Ynysydarren Road was exceeded, resulting in the watercourse surcharging out of the chamber and sending a significant flow of water into the Varteg Estate (Refer to figure 9). Investigations into the section of the culvert downstream of Ynysydarren Road later highlighted reduced capacity caused by a partial collapse of the culvert on privately owned land.

The Authority subsequently contacted the landowner and requested that work be undertaken to address the problem section of culvert, which the landowner has completed.

Further investigation work is planned by the Authority to check for any further issues within the culvert from the point of previous partial collapse down to the point of outfall. If problems are found, these will similarly be raised with the landowner for their attention. In such case, should remedial work not be taken then, the Authority has powers under the Highways Act 1980 or The Land Drainage Act 1991 to seek redress.

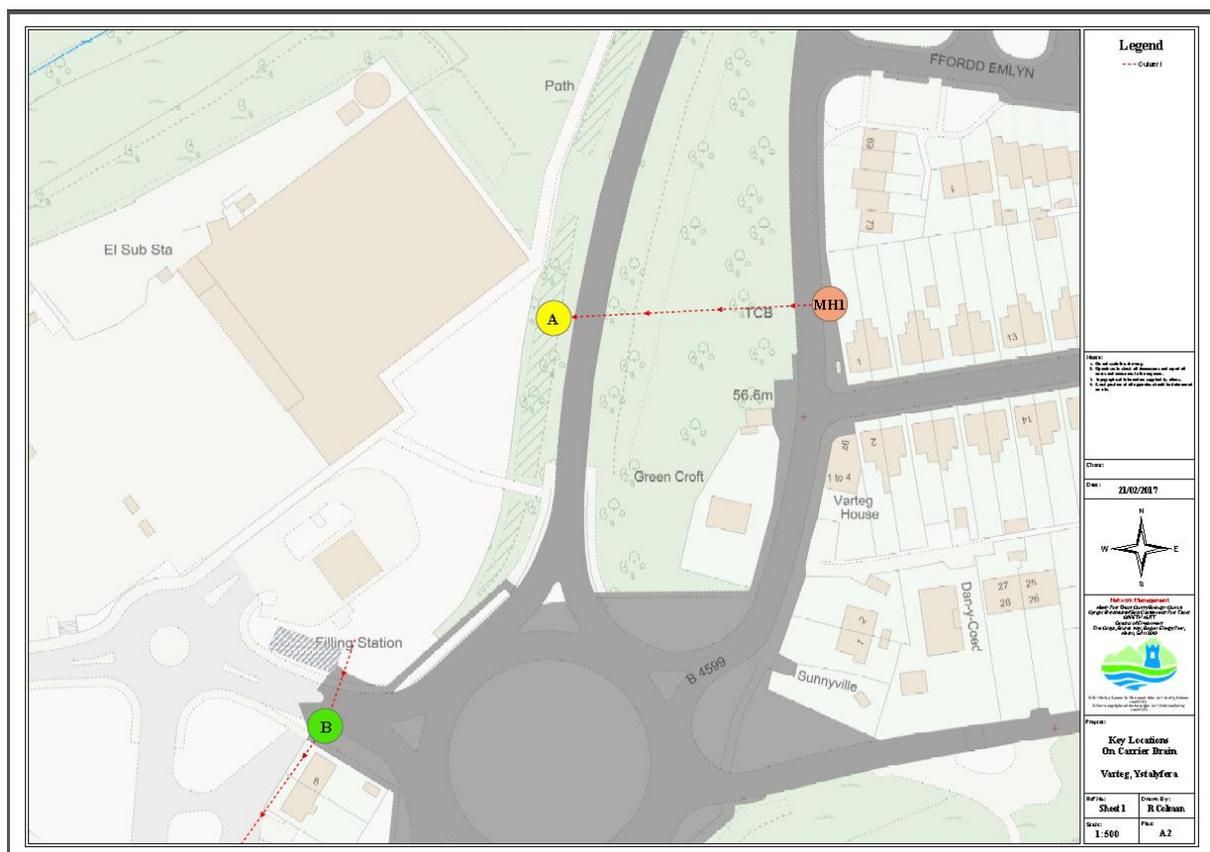
Figure 10

The historical survey also included information from a chamber at Point B as shown in Figure 10. The survey recorded a culvert leading southwards from Point B towards the ultimate point of outfall, and a culvert leading from what is now the ASDA site, surveyed to a distance of circa 30m.

On inspection of the chamber at Point B after the flood event, it was found that a concrete block wall has been constructed in the end of the culvert leading from the ASDA site, blocking any flow of water into the chamber. A small diameter carrier drain had been laid and covered in the bottom of the old culvert, above which the block wall had been constructed. This small diameter drain is understood to carry drainage water from the development site only.

**The conclusion of the authority's investigation is that a drainage system which is believed to have previously connected Point A and Point B in figure 10 has been lost, this being the fundamental reason for the flooding.**

Correspondence has been initiated with the relevant landowner/developer of the ASDA site concerning the fact that the findings of this investigation indicate that the flooding of 3<sup>rd</sup> September 2016 occurred due to the removal and/or blockage of the associated culvert during the ASDA store construction works.

Investigations undertaken after the flood event but prior to the installation of the temporary mitigation measures, showed the ground at Point A to be generally saturated. It is believed that the 1.2m culvert under the A4067 is currently discharging water at a low rate into the ground within the ASDA site by means of percolation and dispersal. As such the ASDA site is believed to be currently acting as a soakaway for the Varteg Estate, with the drainage system acting as an attenuation tank.

Whilst the Council has taken some action to lower the flood risk in the short term, to reduce the flood risk effectively and sustainably in the longer term a drainage connection between points A and B, or between MH1 and another suitable outfall to the south, needs to be established.

The temporary mitigation measures introduced by the Council since the flood included building a new chamber near to the low point of the estate and installing a pump system. The system however only pumps surface water overland into the A4067 highway drainage system, and consequently its effectiveness at dealing with flood conditions can only be considered to be limited. There are also significant resource issues associated with maintaining operation of the temporary pump.
