# Investigation Report into Flooding Incident of 3<sup>rd</sup> November 2022 St Catherines Close, Melyn

Highways and Drainage Services  
Environment & Regeneration Directorate  
Neath Port Talbot County Borough Council

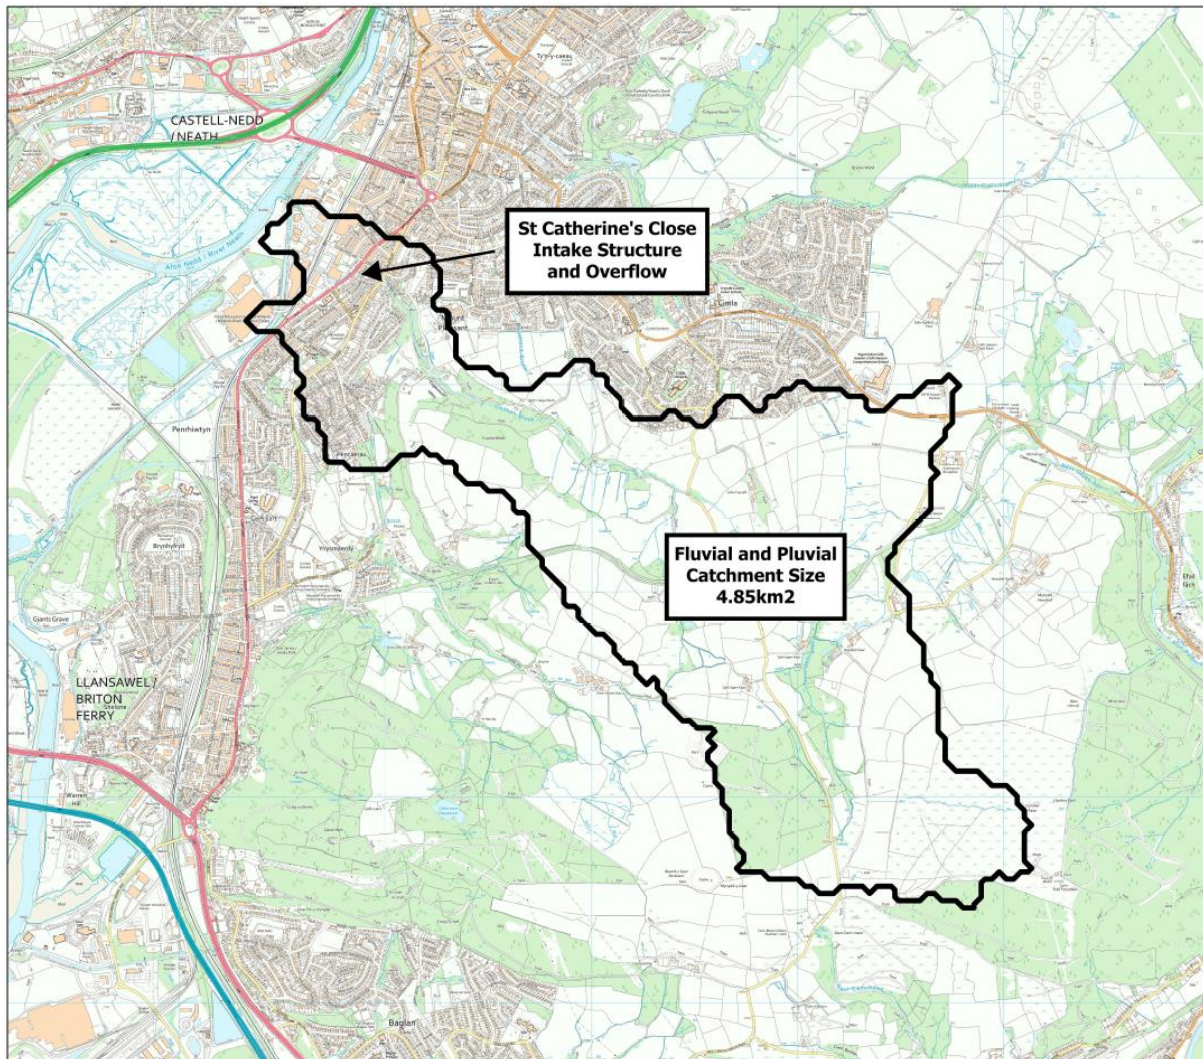
Figure 2 – Cryddan Brook catchment area with location of St Catherine’s Close Intake Structure.

Figure 2 depicts the Cryddan Brook catchment area, highlighting the extent of the ~ 4.85km<sup>2</sup> catchment, starting at the Gelli-Gaer Brook towards the outfall into the River Neath. From this map, it can be observed that the single intake at St Catherine’s Close accommodates for a vast catchment area and large watercourse.

From previous investigations and knowledge of the environment upstream of St Catherine’s Close, it is evident that the intake receives a large amount of natural, coarse debris, much of which is sufficiently small to pass through the trash screen situated at the culvert. However, some of the debris that accumulates with the flow of the brook is too large and cannot pass through effectively. It would be appropriate to summarise that the flood event on November 3<sup>rd</sup> 2022 was mainly caused by a significant blockage, influenced by large debris transported downstream.

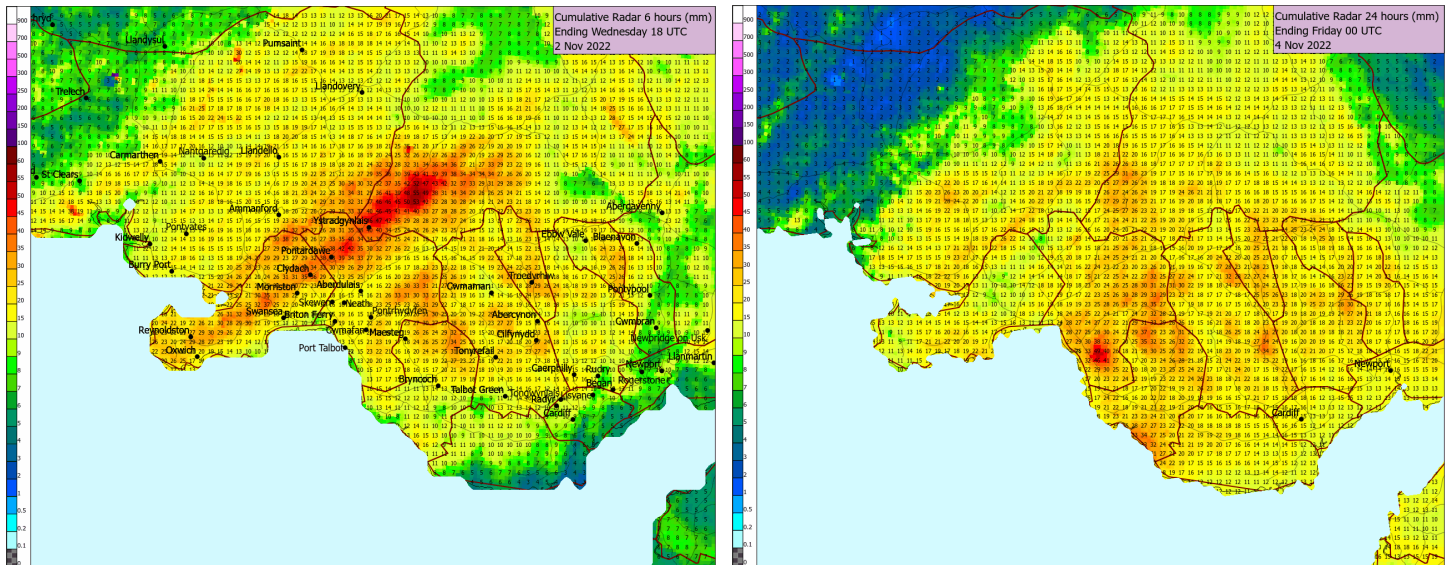
Figure 3 – Cumulative rainfall in NPT for Wednesday 2<sup>nd</sup> November (6hr) & Thursday 3<sup>rd</sup> November 2022 (24hr), Metdesk 2022.

Figure 3 depicts the special distribution of rainfall (cumulative values) across Neath Port Talbot and neighbouring authorities. The first graphic (left) depicts the cumulative rainfall over a six hour period for Wednesday 2<sup>nd</sup> November. During that afternoon, the Swansea Valley area experienced heavy precipitation of approximately 30-50mm over a three hour period from 15:00hrs to 18:00hrs. The county borough received little rainfall preceding and succeeding this window of three hours.

The second graphic displays cumulative rainfall over the twenty-four hour period spanning Thursday 3<sup>rd</sup> November 00:00hrs to Friday 4<sup>th</sup> November 00:00hrs. This covers the period of heavy rain which led to the localised flooding at St Catherine’s Close, among other regions neighbouring Briton Ferry and Neath. Figure 3 illustrates the quantity of rainfall which fell over the thirty-six hour period that coincided with the blockage and resulting flood event.

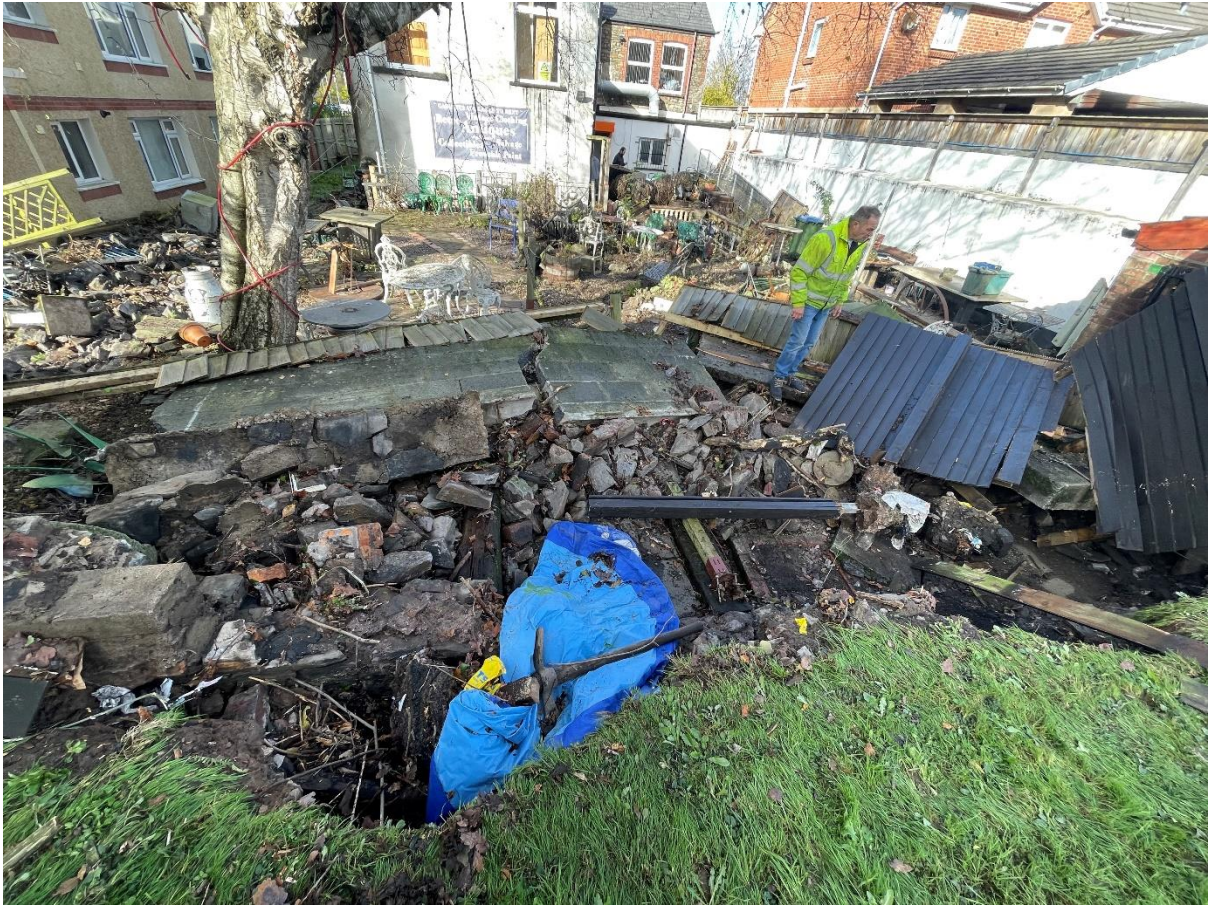
It is important to note that floodwater continued to overtop during a period of approximately two hours. Flows travelled west to Briton Ferry road A474 and followed the slope of the road south towards the Esso garage. Flood water also travelled over the impermeable road at St Catherine's Close towards the Vintage 7 Antique Centre, collapsing a stone wall that had been standing since the late 1800s. A photograph of the collapse can be seen in figure 5 overleaf. This collapse resulted in the flooding of both the outside open-area of the Vintage 7 Antique Centre, and ground-floor public house situated within the property. Efforts to fully clean St Catherine's Close carried on through the night until the daylight hours of Friday 4<sup>th</sup> November.

Figure 5 – Collapsed stone wall outside Vintage 7 Antique Centre.

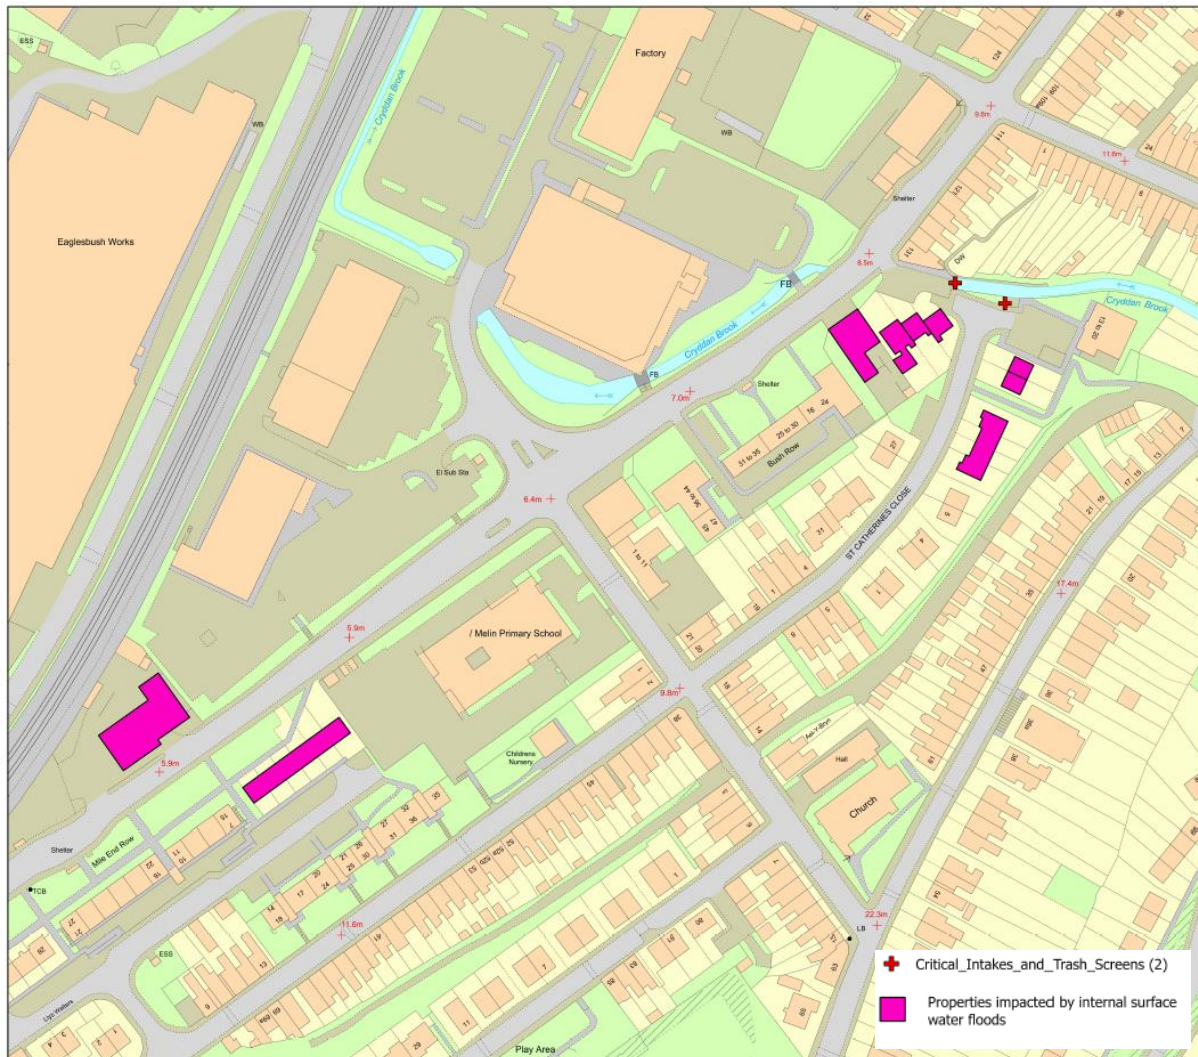
More than thirty (30) properties suffered varying degrees of internal flooding on 3<sup>rd</sup> November in Melyn, including twelve (12) on St Catherine's Close. Figure 6 below illustrates the main flood location and the properties impacted on St Catherine's Close.

Figure 6 – Properties affected by the 3<sup>rd</sup> November 2022 flood event.

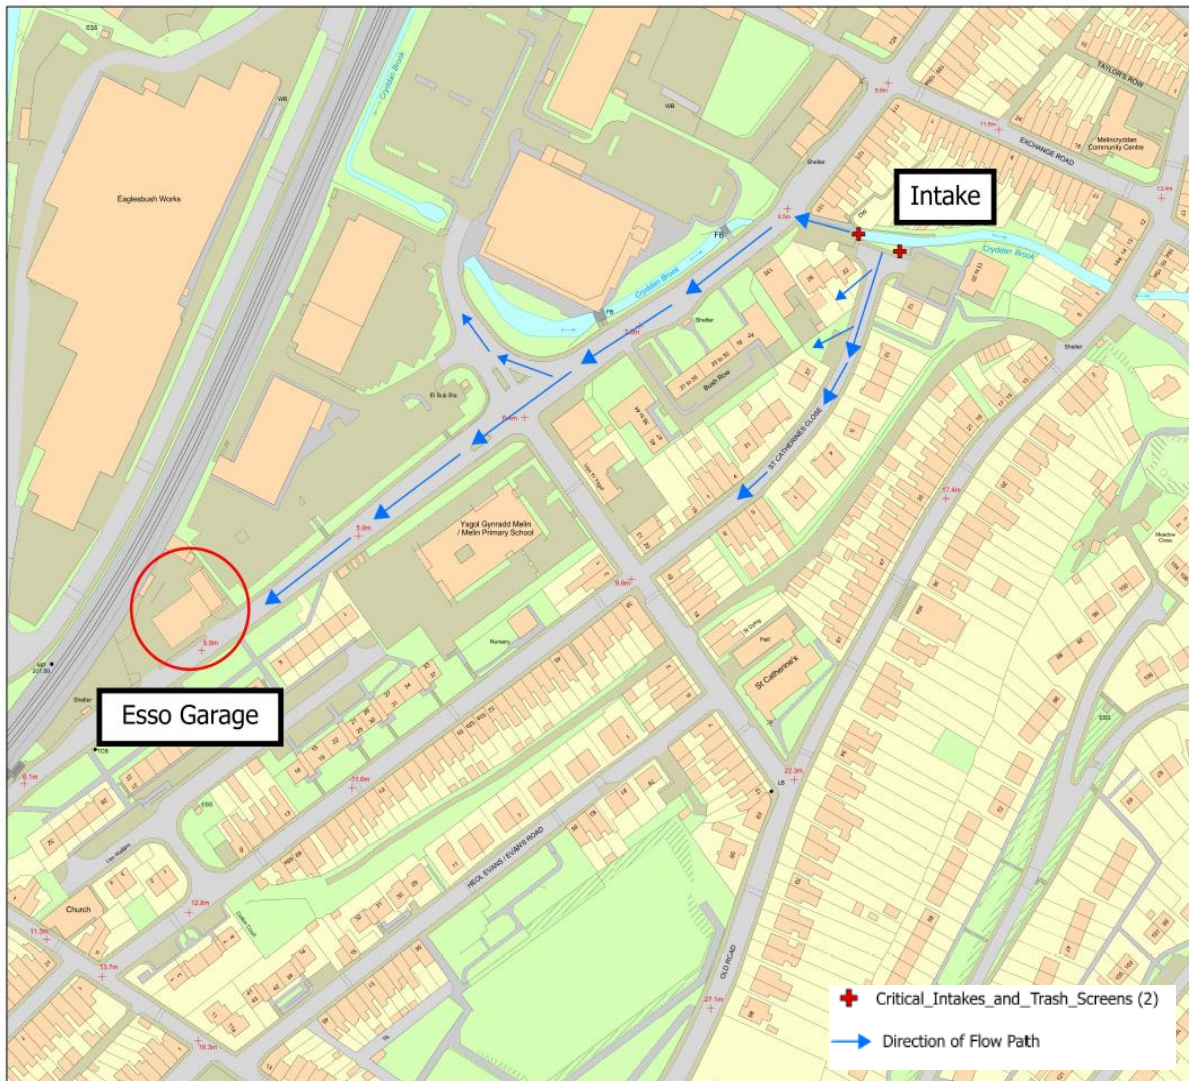
Figure 9 overleaf illustrates the general flow path of the flood water that overtopped on the afternoon of November 3<sup>rd</sup> 2022, with the arrows marking the direction of flow. From the map, it is clear that the properties at St Catherine's Close are at severe risk when this overtopping occurs due to their location in relation to the position of the culvert.

These flood paths provide an indication into the topography of the site. For instance, when overtopping occurs, the flow of water first travels in a north-westerly direction before diverting south west along the A474, towards the Esso Garage. This reflects the difference in ground level where the topography of the site dips west of the culvert and then dips again as the gradient of the road flows south-west.

Figure 9 - Map depicting the general flow route of water through Melyn and St Catherine's Close.
