**The Coal  
Authority**

## **Site Inspection Report**

### **Pen y Graig Arw Quarry, Ystalyfera**

**Date: November 2017**

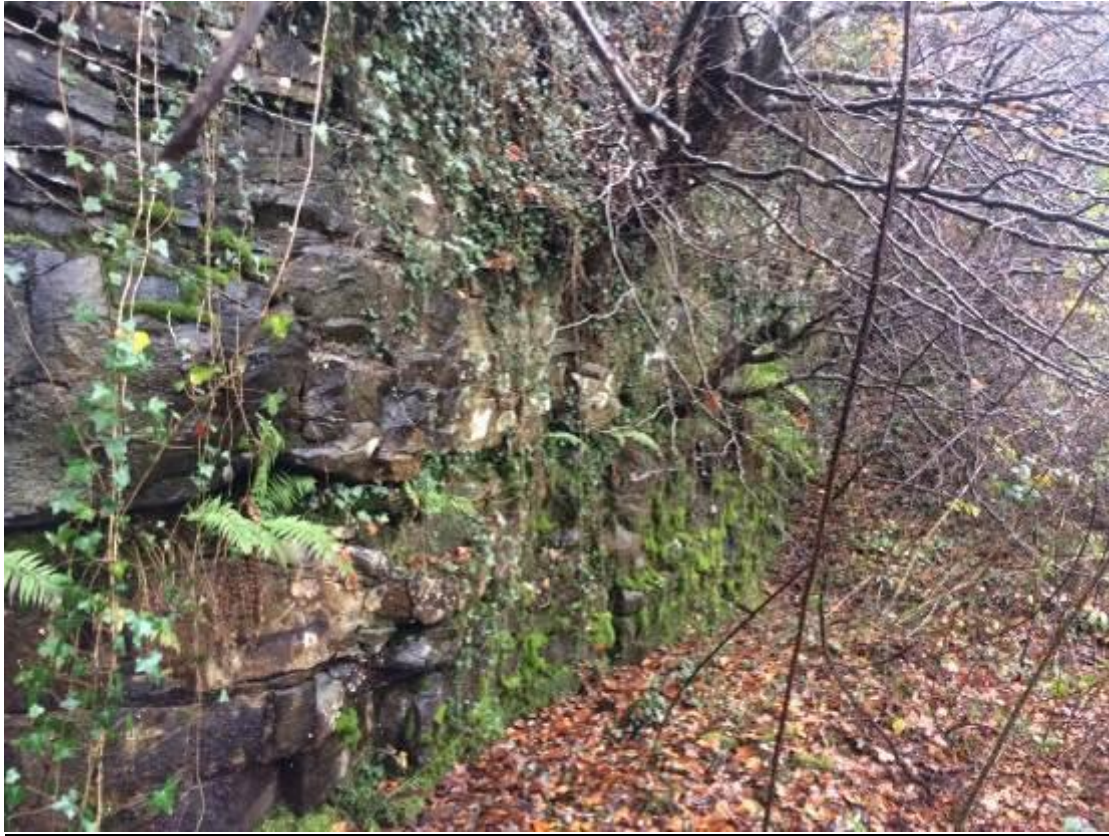
The quarry high wall is generally vertical, with the exposed strata comprising moderately weathered thin to thickly bedded sandstone units, with occasional subordinate siltstones (Photographs 1 to 6).

Occasional moderate groundwater seepages were observed from the face, generally at the interface of sandstone / siltstone units and at main joint sets. Several areas of loose overhanging blocks were observed, with occasional small rockfall areas noted (Photograph 6).

**Photograph 1 – Quarry high wall location**

Edge protection fencing and warning signs should be placed along the quarry high wall, and warning signs should be placed at the head of the Panteg landslide to warn the general public of the risk from falling rocks.

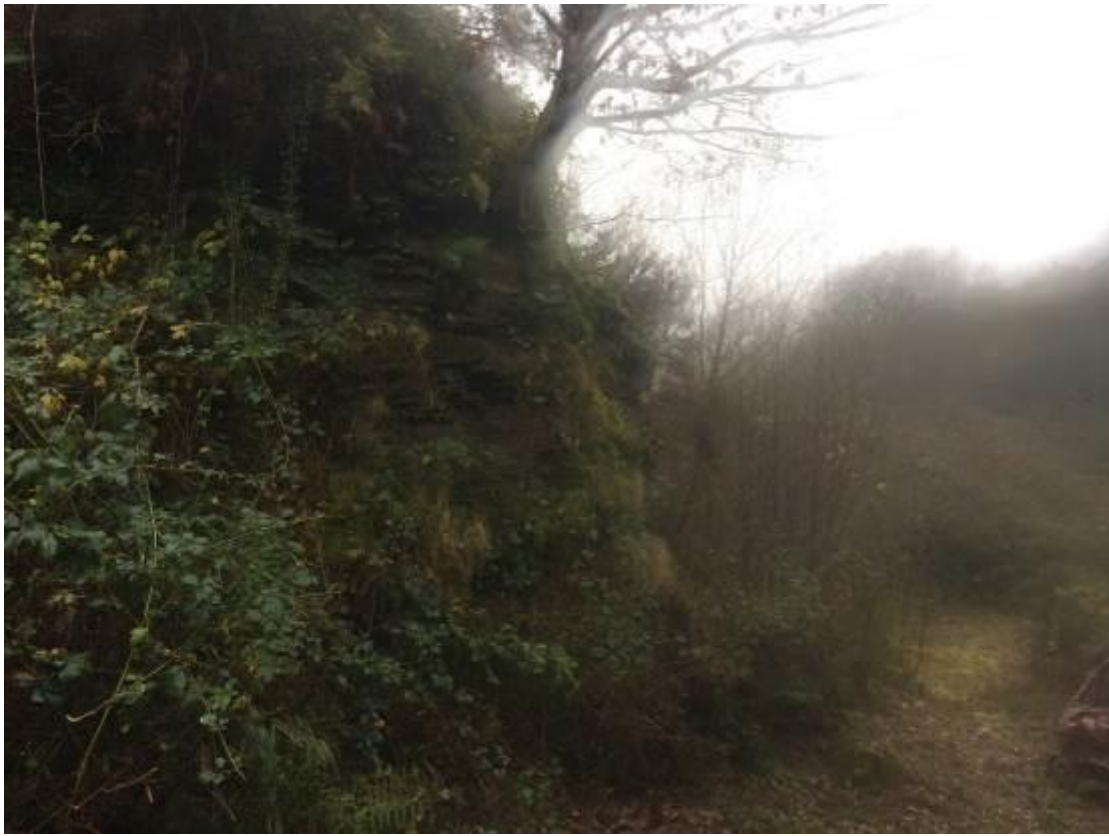
**Photograph 2 – Quarry high wall location**

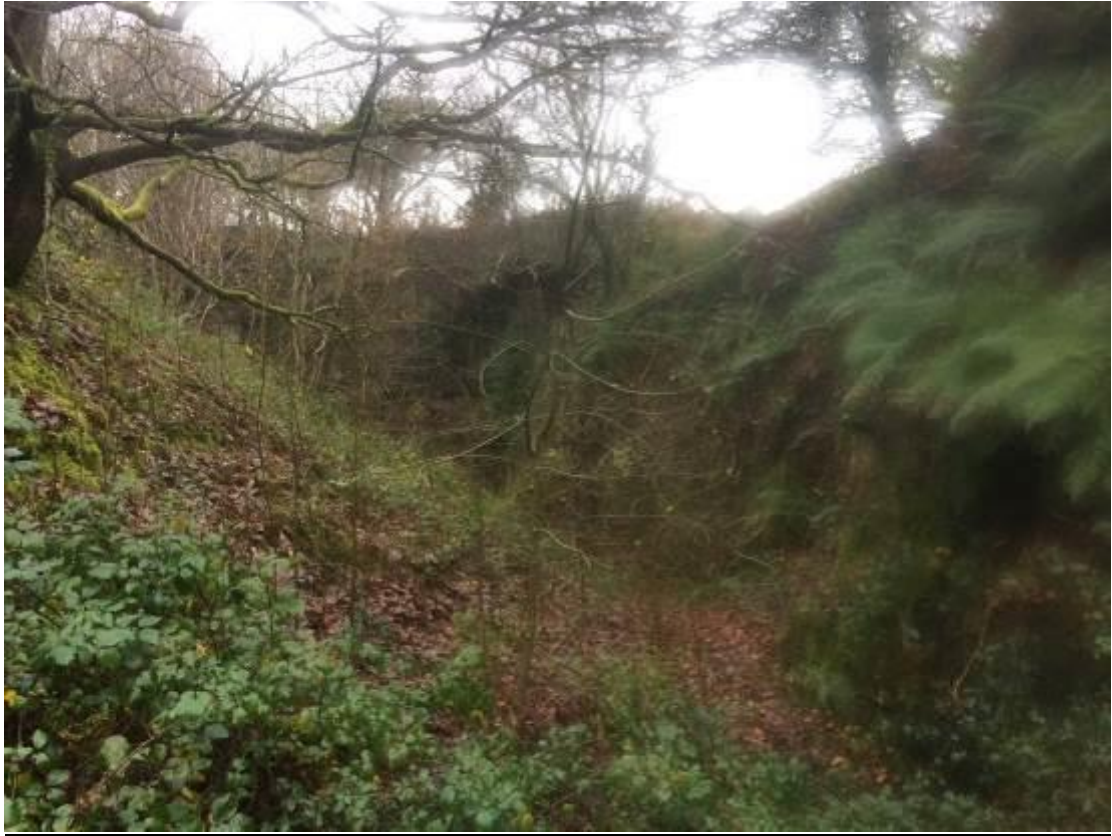
**Photograph 3 – Quarry high wall location**

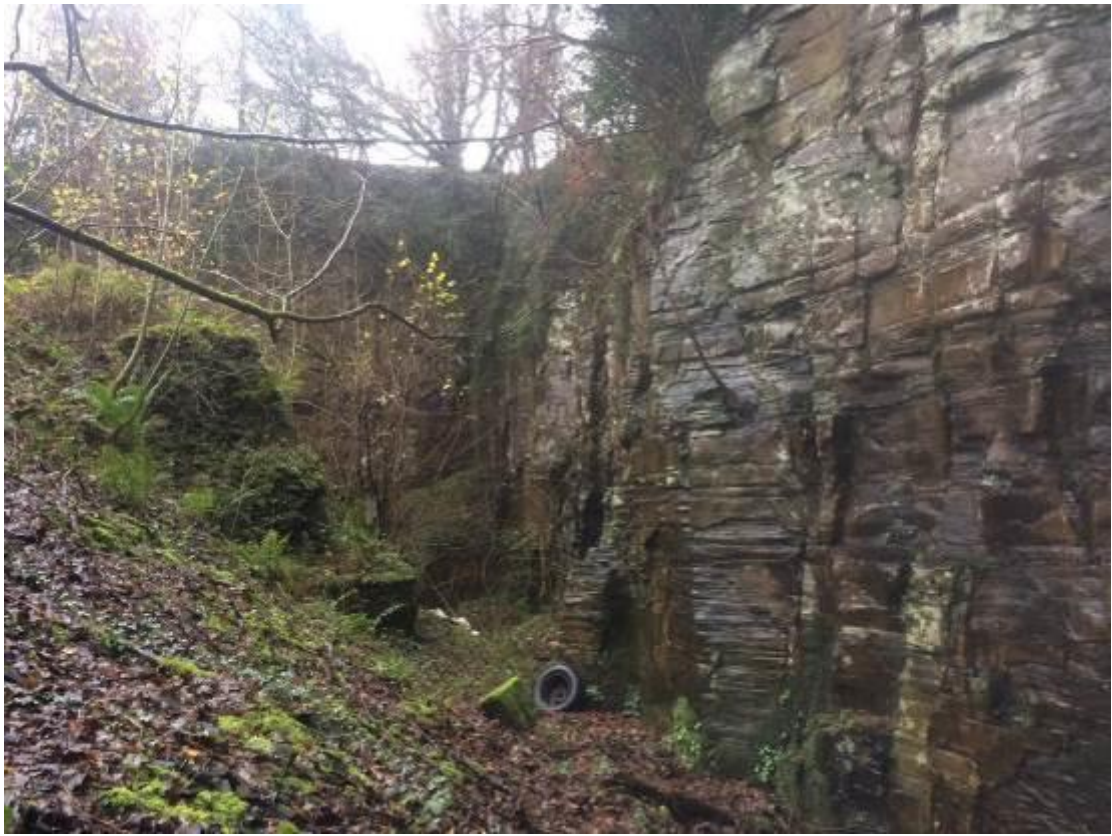
**Photograph 4 – Quarry high wall location**

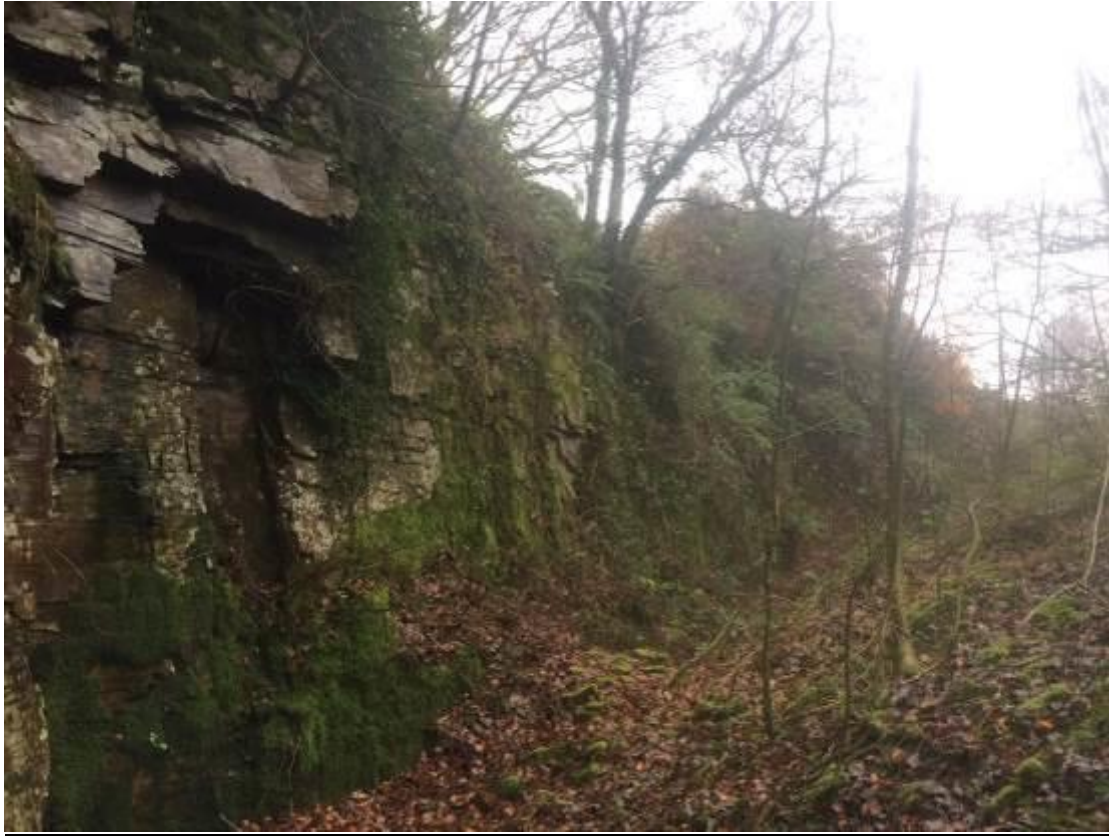
**Photograph 5 – Quarry high wall location**

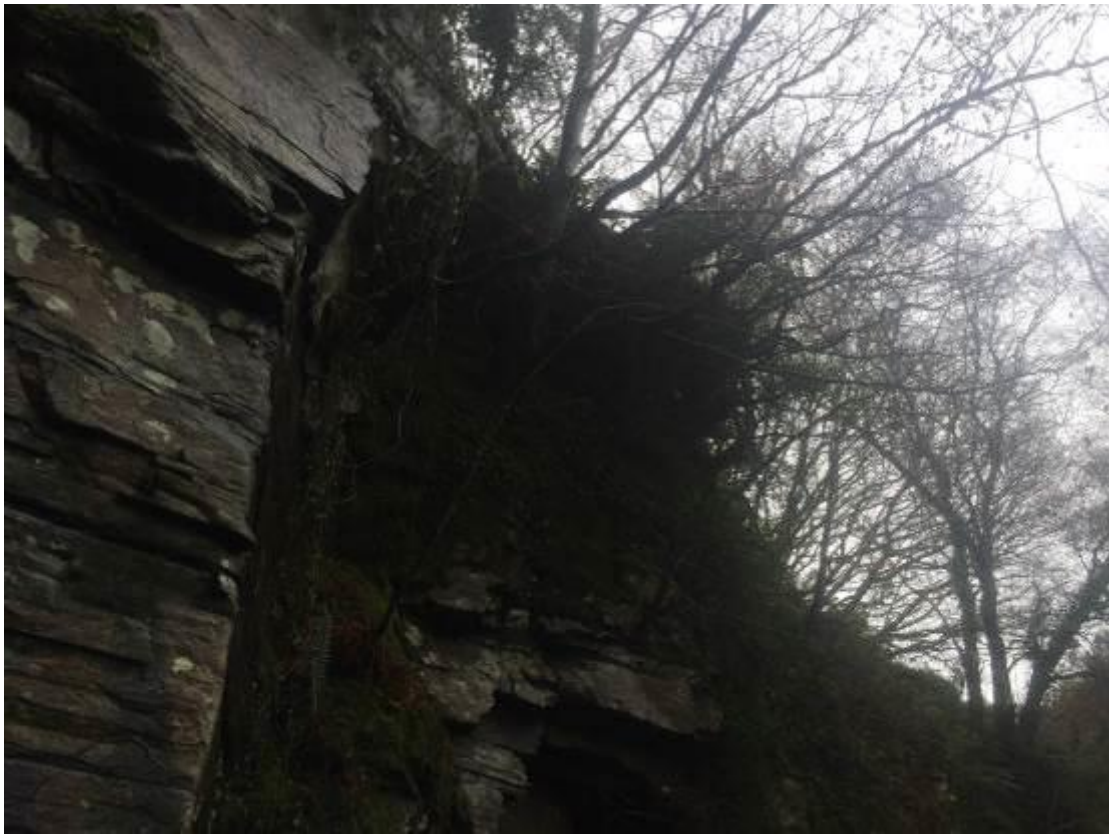
**Photograph 6 – Quarry high wall showing overhanging block and trees**

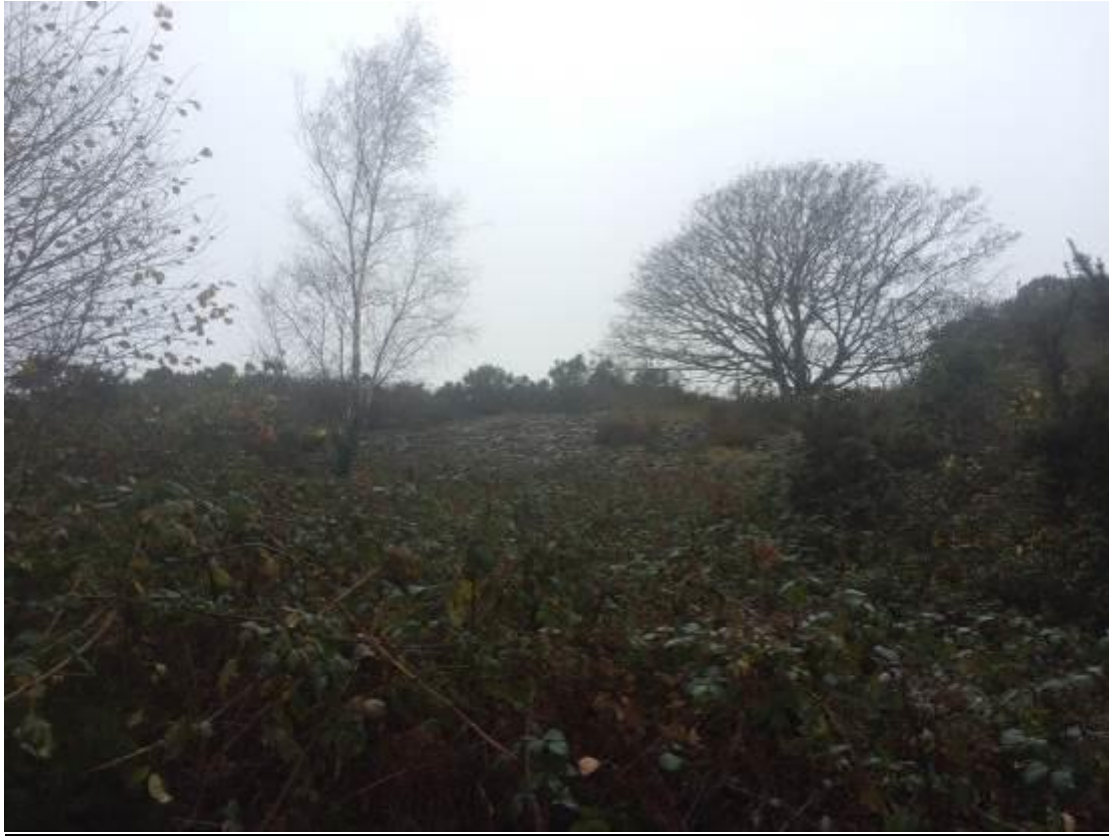
Access was limited to accessible areas and generally along routes cut through the dense vegetation by NPTCBC staff (Photographs 7 and 8).

**Photograph 7 – Typical view of vegetation cover**

It is recommended that a further inspection is undertaken when additional targeted vegetation clearance has been undertaken, in order to assess any unidentified areas of instability which could affect the quarry site.

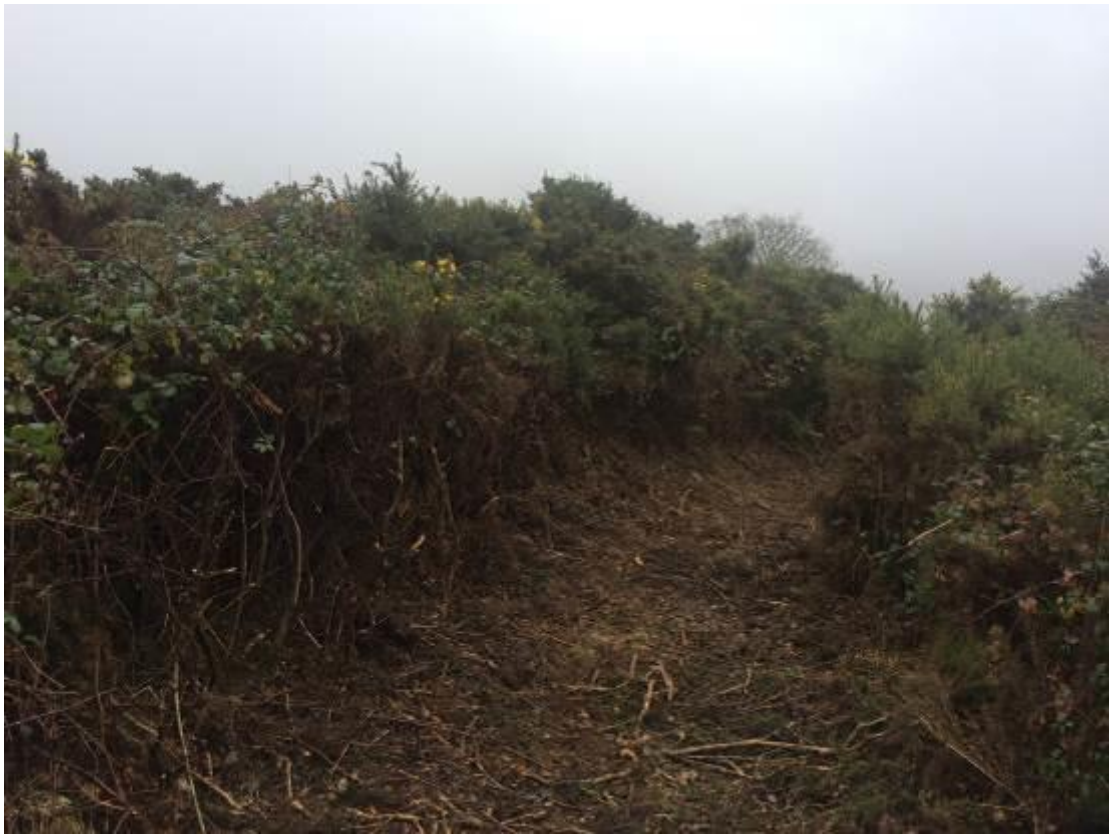
**Photograph 8 – Access tracks cut through vegetation**

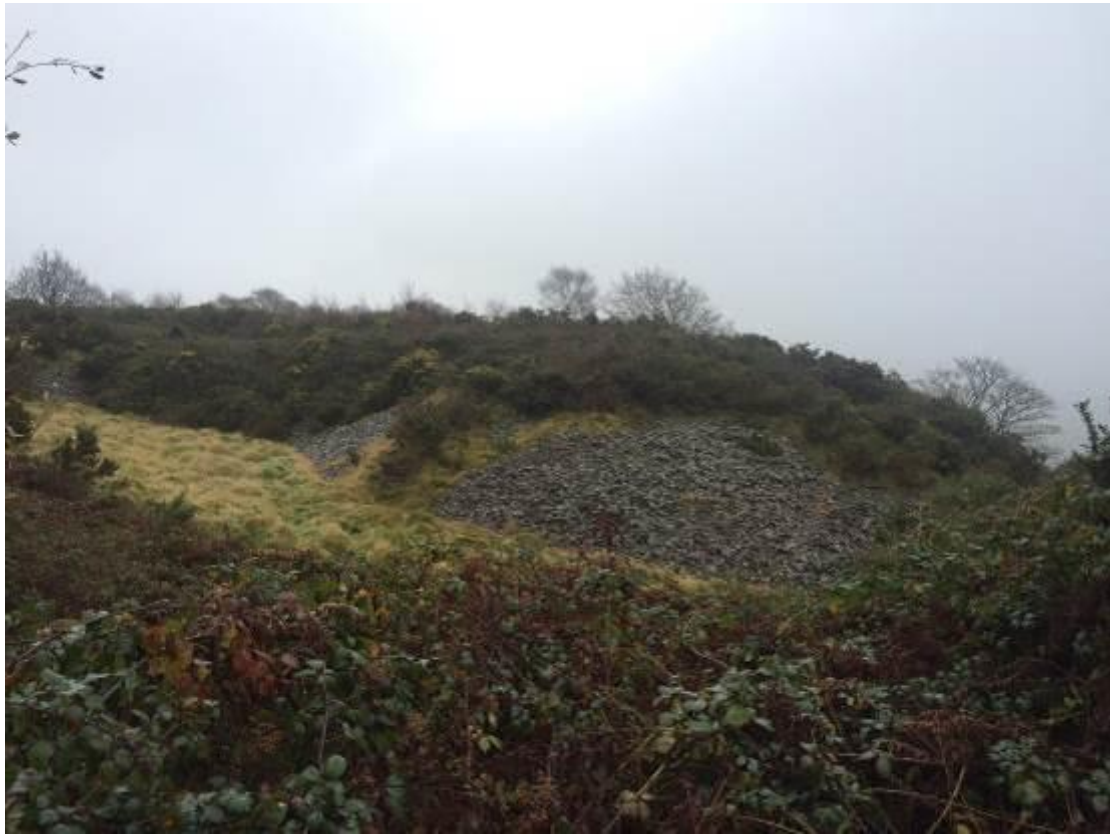
The inspection then viewed the various spoil mounds within the centre of the site. The mounds comprise quarry discard generally comprising flat sandstone within a matrix of finer material (Photographs 9 to 12).

The mounds are generally set at the maximum angle of repose, having been end tipped with little or no compaction. Where the spoil is un-vegetated, the materials appeared relatively loose.

There was no evidence of significant slope failures on any of the spoil mounds, with only localised scour and erosion, probably due to surface water erosion.

**Photograph 9 – Quarry waste tip**

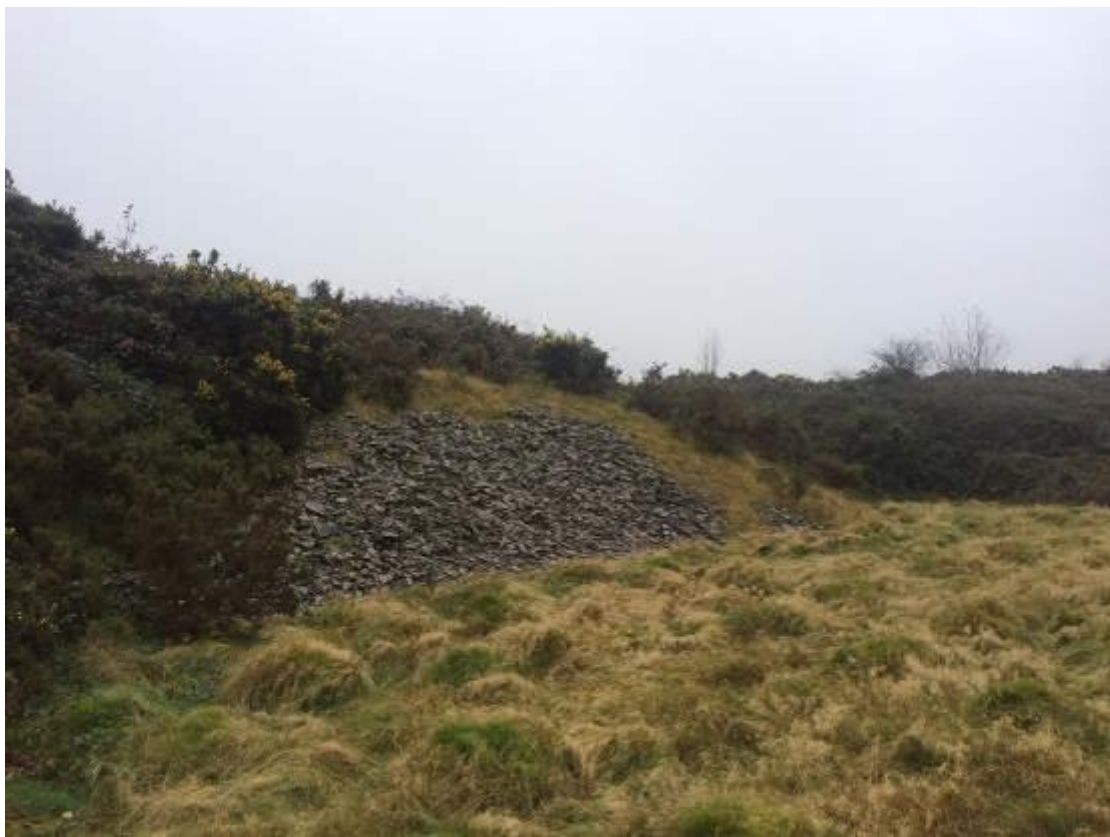
**Photograph 10 – Quarry waste tip**

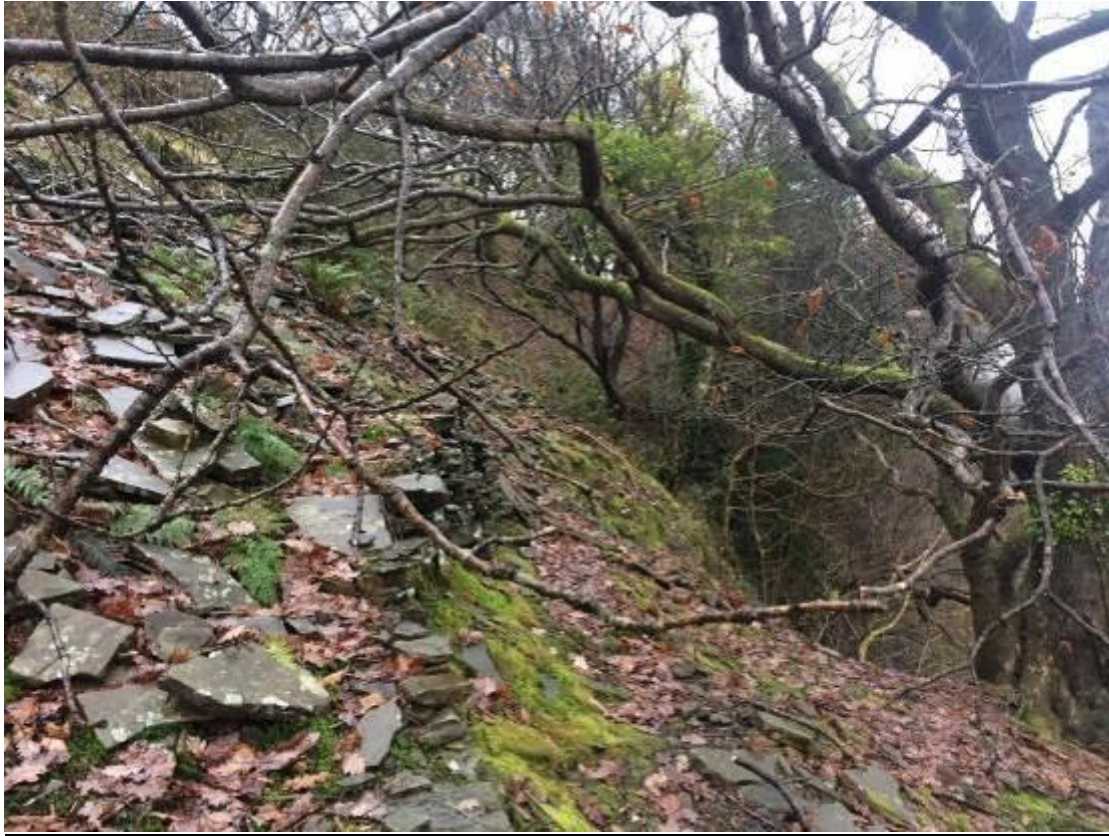
The inspection proceeded to the southern eastern perimeter, where a vertical cliff forms the site boundary. The spoil mounds in this area are in close proximity (<1m in places) to the cliff edge.

Localised spalling and surface erosion of the quarry waste mound sections adjacent the cliff edge may result in small amounts of spoil escaping over the cliff edge during extreme weather events. There was no visual evidence of significant spalling and erosion reaching the cliff edge, but the potential for this to occur presents a low to moderate risk. It is clear that in the past some quarry waste has spilled over the cliff edge, directly above the most recent (2012) Panteg landslide.

**Photograph 11 – Quarry waste toe at crest of cliff**

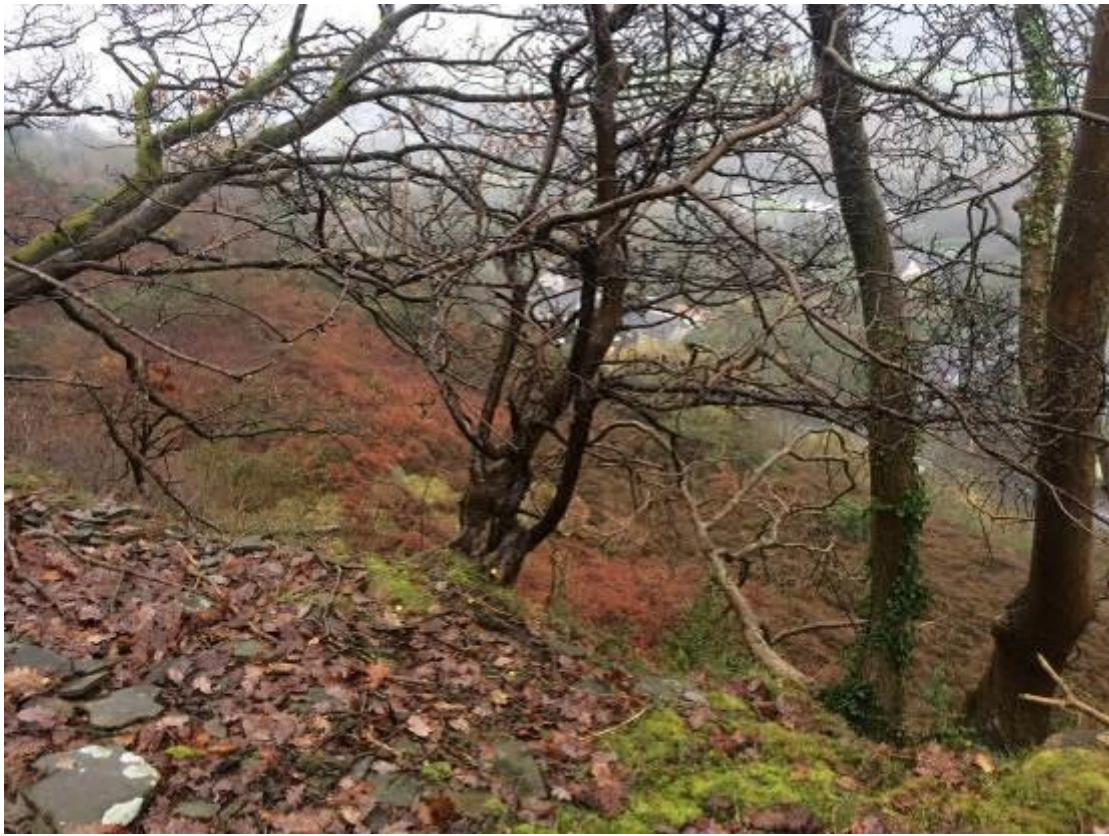
**Photograph 12 – Quarry waste toe at crest of cliff**

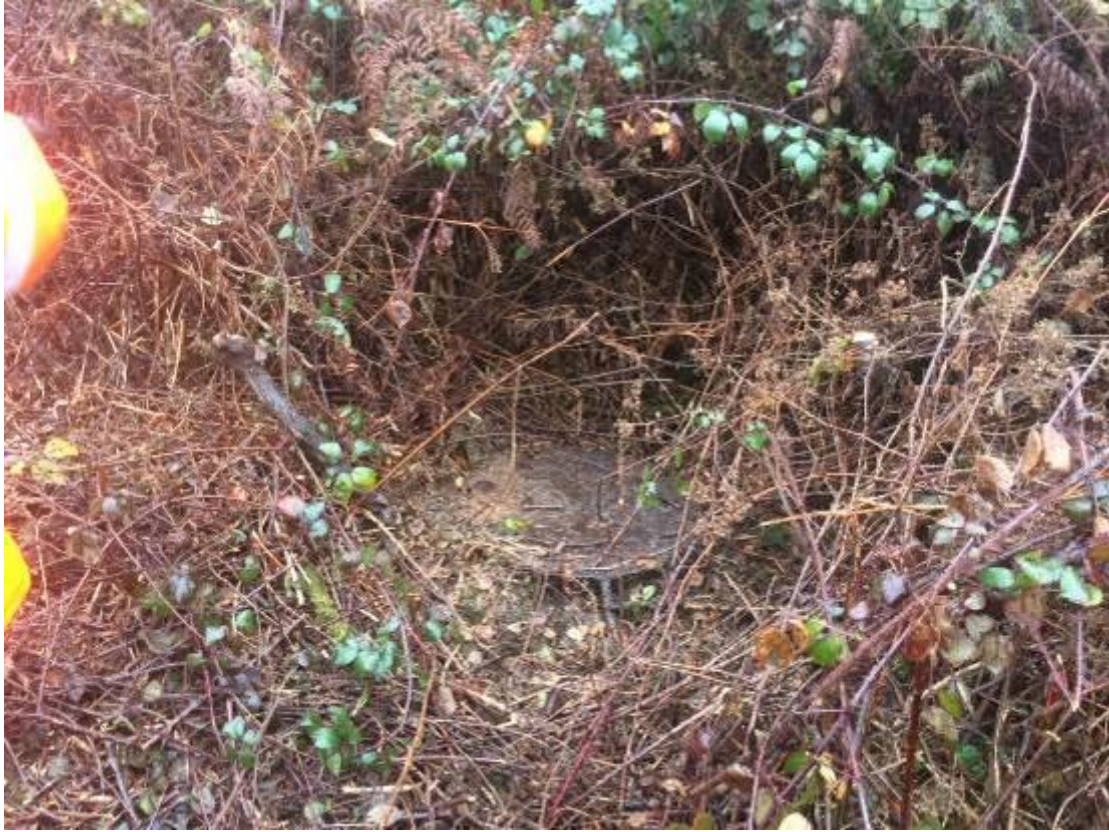
A drainage system comprising a series of manhole chambers and pipes (Photographs 13 to 18) is located at the approximate locations shown on Figure 10. This system is understood to have been installed during the 1950's / 1960's and is recorded in previous reports as the 'Penygraig System'. The drainage system is understood to collect surface water flows from the quarry area and also to convey minewater from recorded mine adits within the area.

The inspection then followed a previously cleared route along the line of the drainage system. The drainage system appeared to be conveying water flows reasonably well although the chamber and pipes appeared visually to be in poor condition.

**Photograph 13 – Manhole chamber along footpath**

The condition of the surface water drainage system should be investigated. Dye testing could be utilised to determine flow routes and the ultimate discharge location.

Loose and missing manhole covers should be replaced.

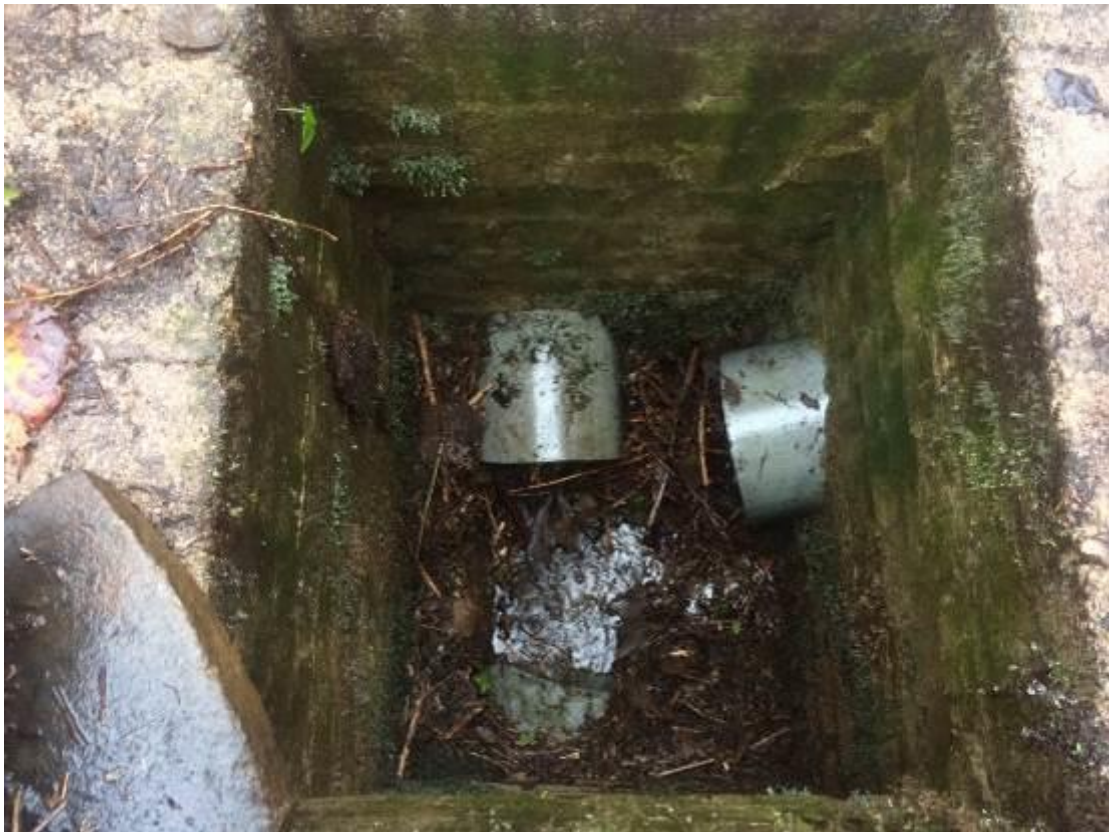
**Photograph 14 – Internal view of manhole chamber**

Under ideal conditions a CCTV survey of the drainage system should be carried out, however, access restrictions may preclude this exercise.

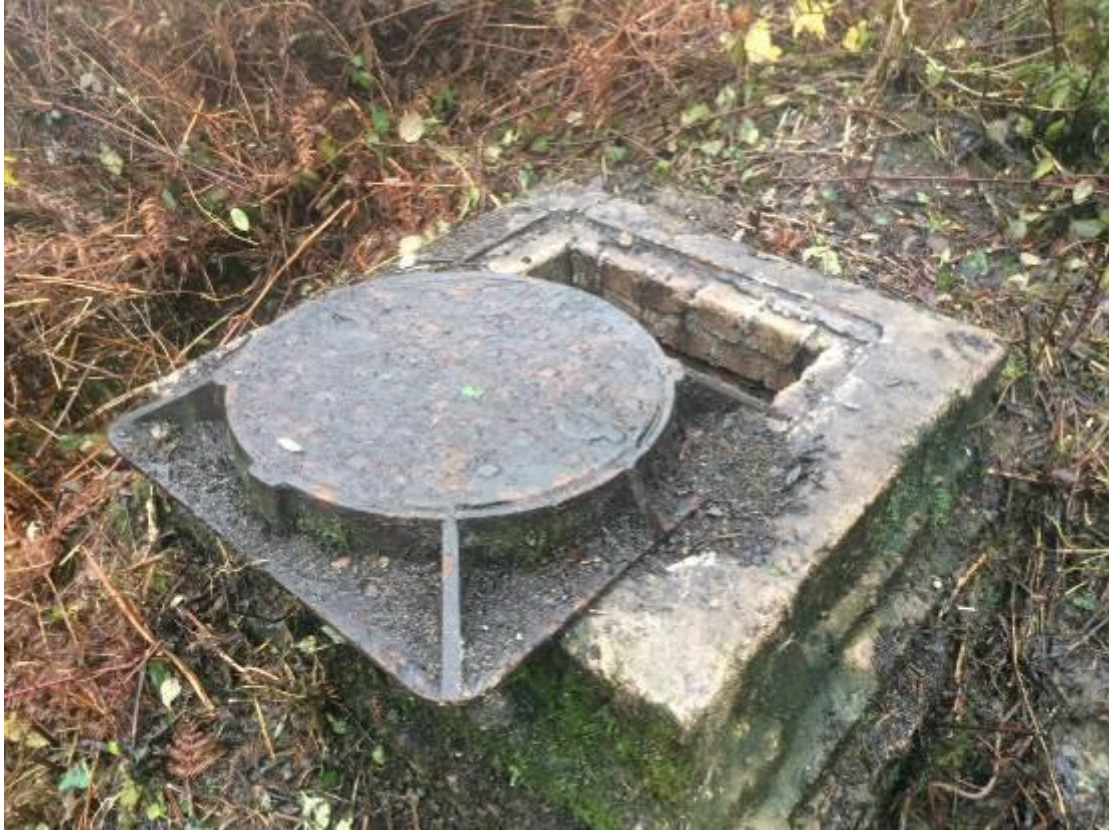
**Photograph 15 – Manhole chamber along footpath**

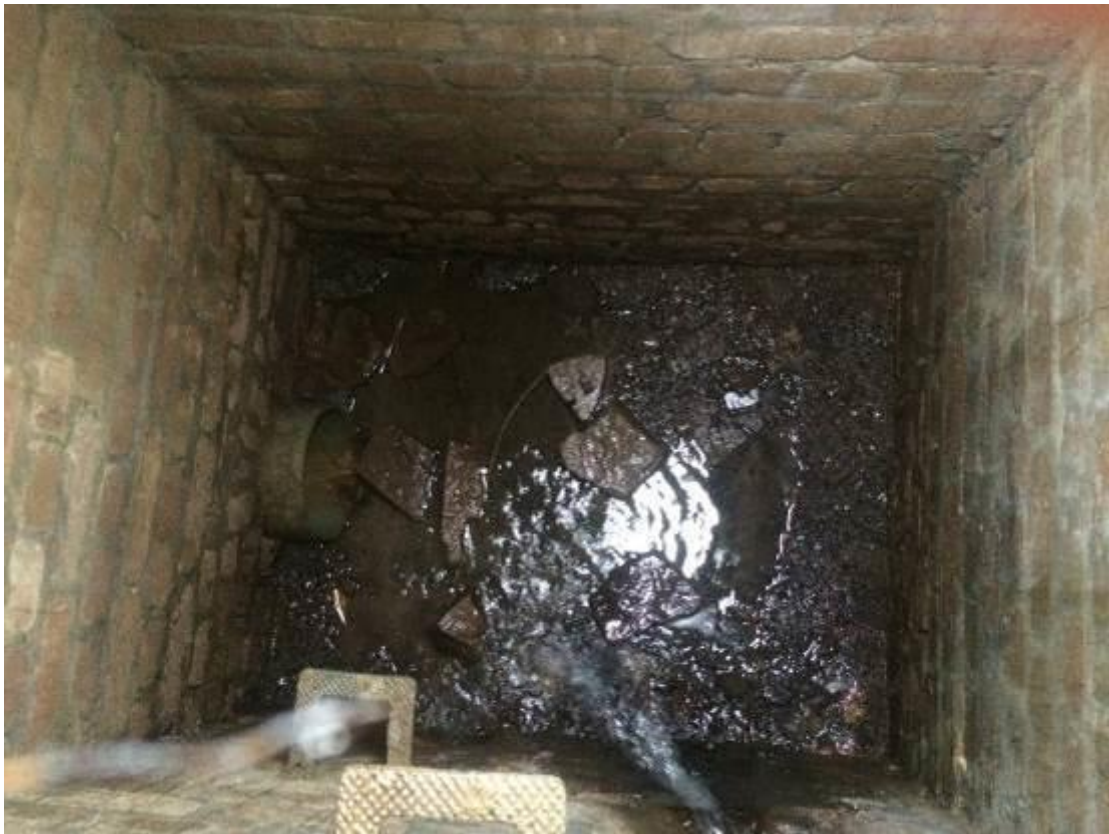
**Photograph 16 – Internal view of manhole chamber**

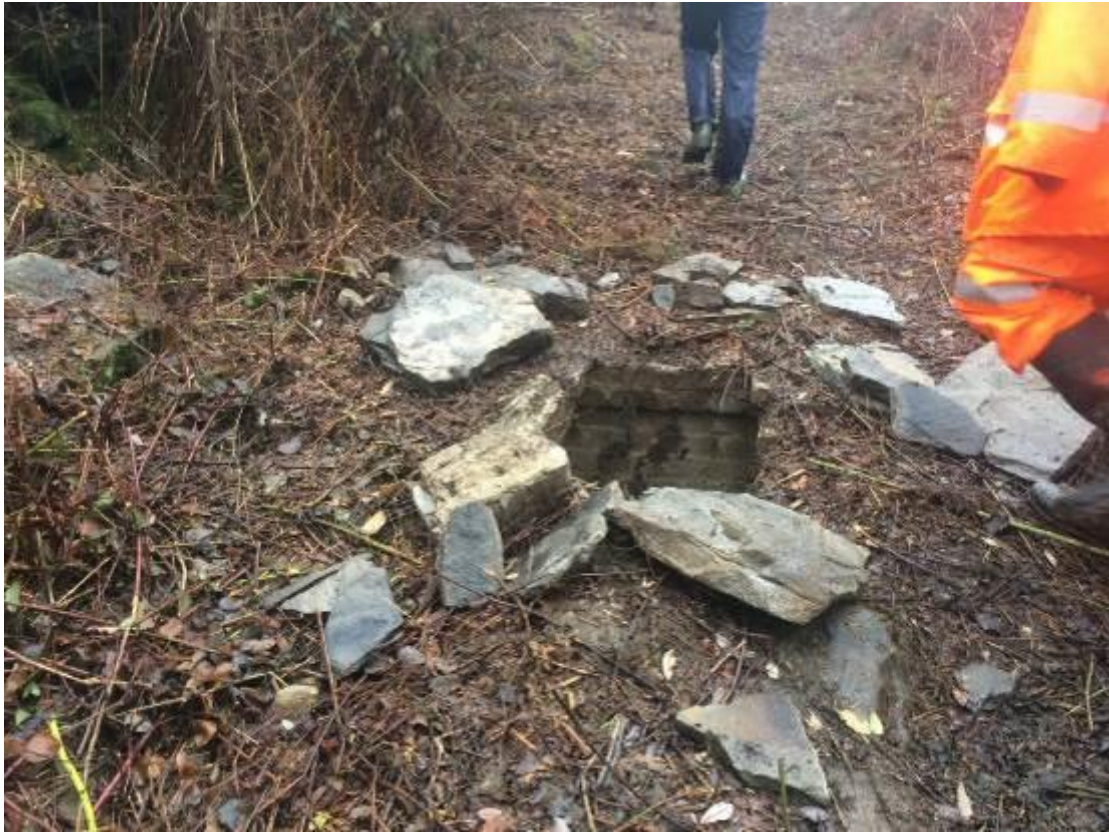
**Photograph 17 – Manhole chamber along footpath**

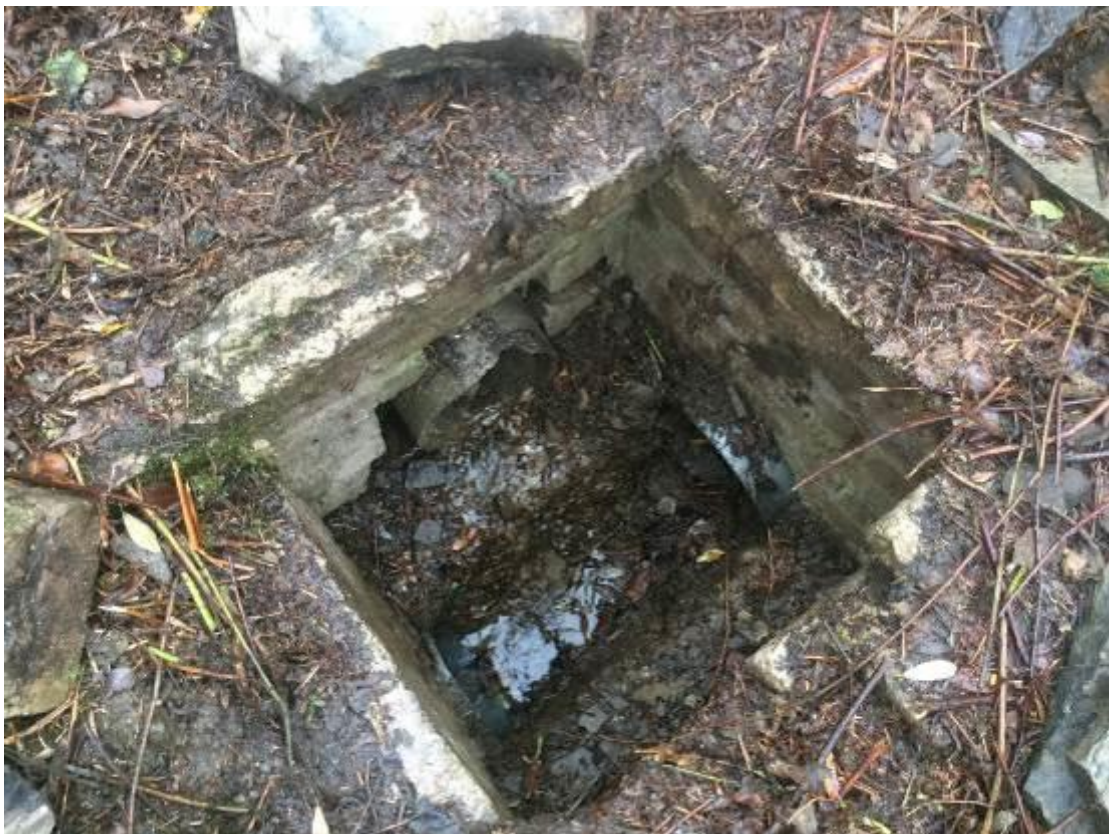
**Photograph 18 – Internal view of manhole chamber**

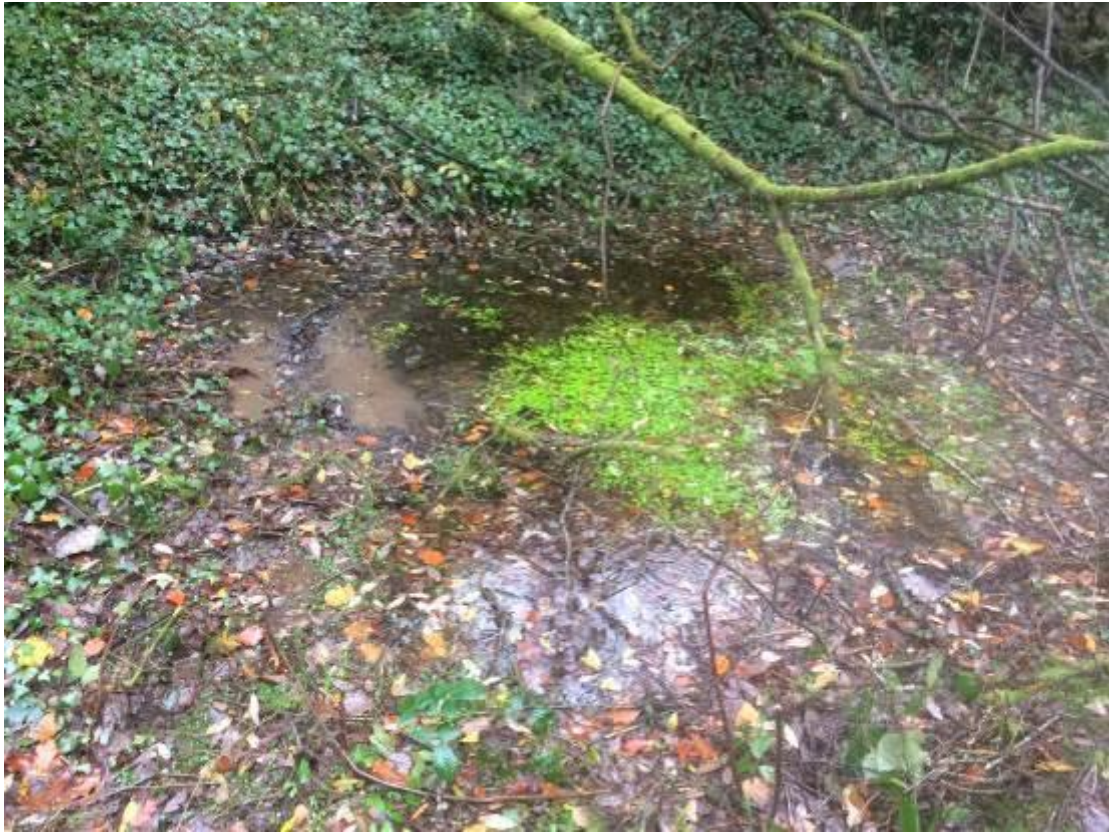
Localised areas of standing water were observed within the quarry floor (Photograph 19), suggesting that the drainage system is either not functioning or not present within this area. It is likely that water infiltrating the quarry floor will emerge at the base of the cliff to the eastern boundary, at the interface of the sandstone / mudstone strata and the position of the Lower Pinchin coal seam.

**Photograph 19 – Area of ponding within quarry floor**

It is suggested that if the existing drainage system has sufficient capacity, it could be extended to capture areas of ponding within the quarry floor.

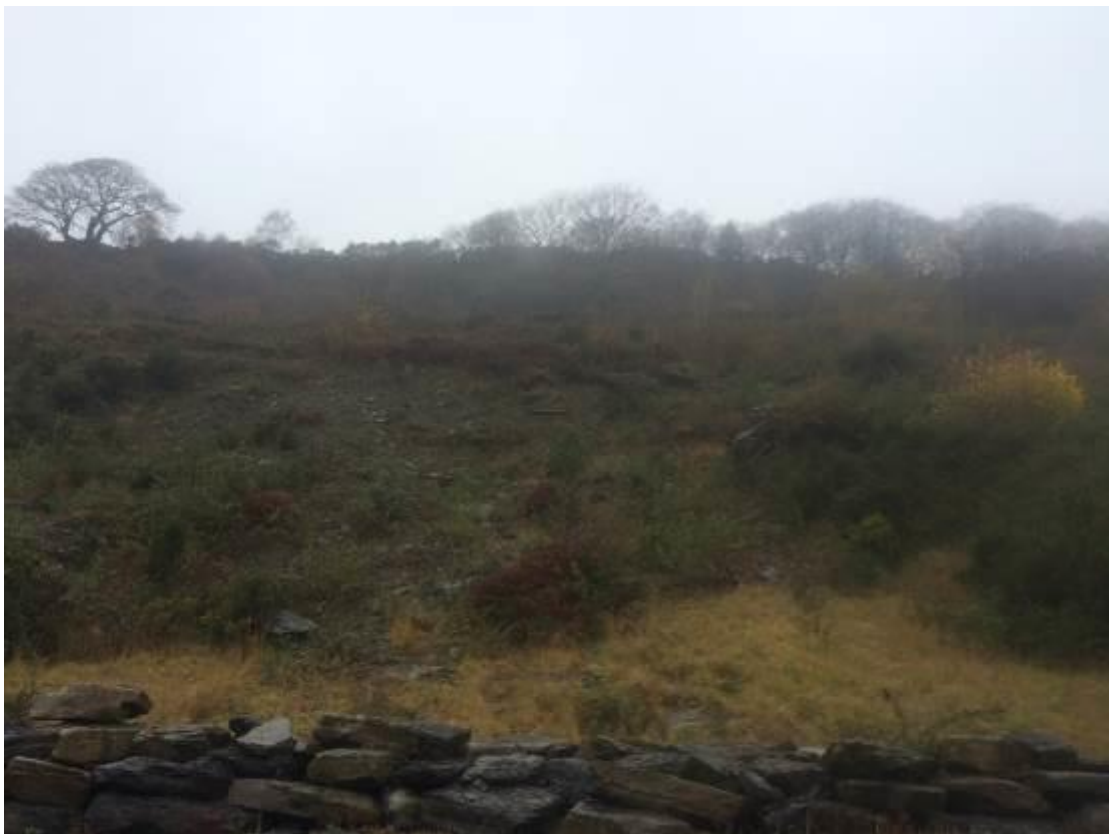
A significant failure of the eastern cliff edge would result in destabilising of the adjacent spoil mounds, leading to collapse and deposition onto the plateau area at the base of the cliff. Such a failure would surcharge the existing landside and would likely cause further downslope movement. Based on a visual assessment this scenario is considered to present a low to medium risk under current conditions. Due to access restrictions and dense vegetation cover, it was not possible to inspect the condition of the interface of the cliff base and head of the Panteg landslide.

**Photograph 20 – View of Panteg landslip with quarry beyond crest**
