*Report No. BC/MB/04.15.03.*

# **Mining Risk Assessment on Land West of Penrhiw Street, Bryn, Port Talbot.**

**Mr V. Price.**

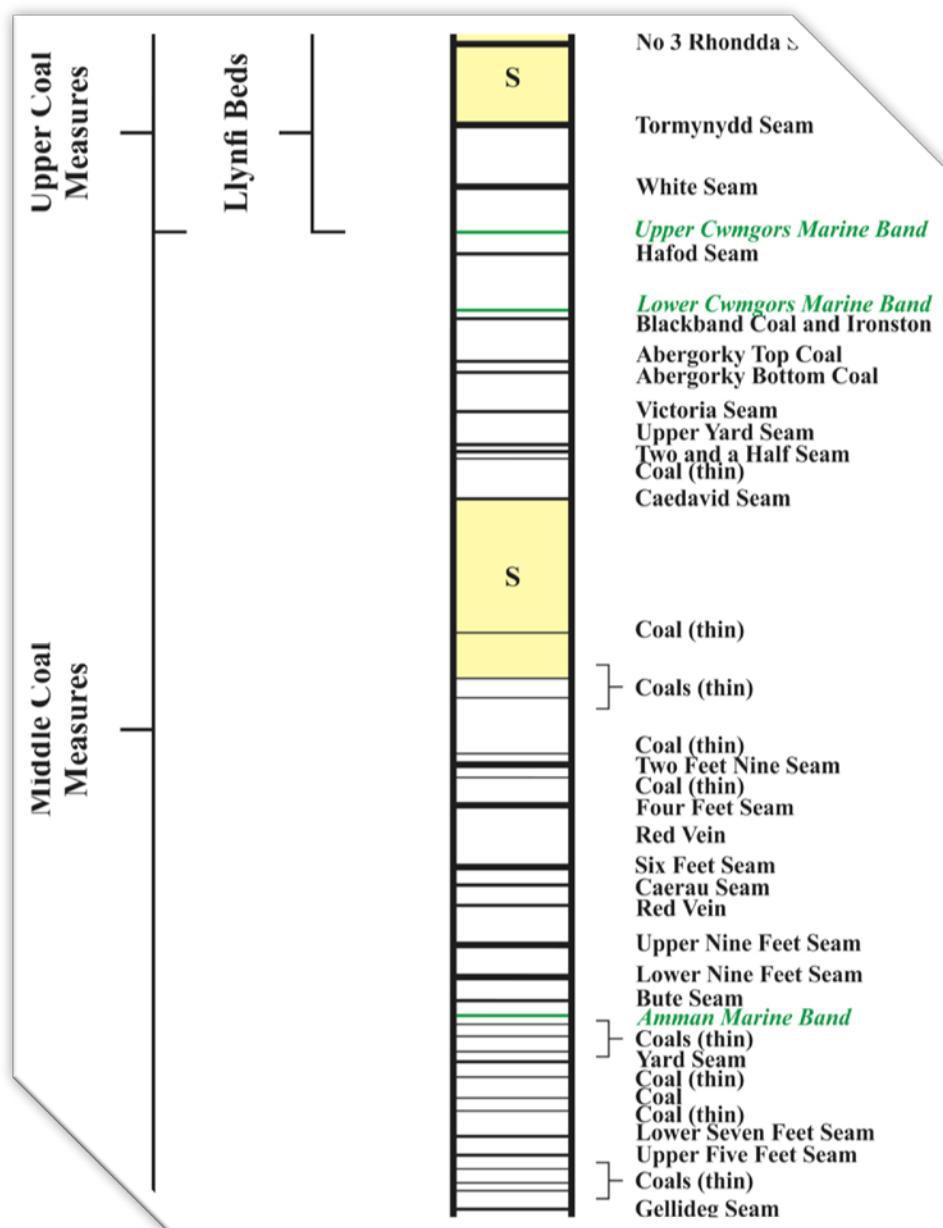
**Figure 1**  
**Part of the Stratigraphic Column**  
**(Not to Scale)**

Carboniferous Measures (see *Geology Plan, drawing no. BC/MB/04.15.03.02*). The most recently published geological sheet (Pontypridd Sheet 248 at 1:50,000 scale) shows the inferred positions of the outcrops of the Two Feet Nine and Six Feet Seams to pass immediately to the south of the Site (see Figure 1, Part of the Stratigraphic Column). The average dip of the strata in the district is between 1 in 2 and 1 in 4 towards the north, but the rate and direction of dip of the strata is locally affected by faults and folds.

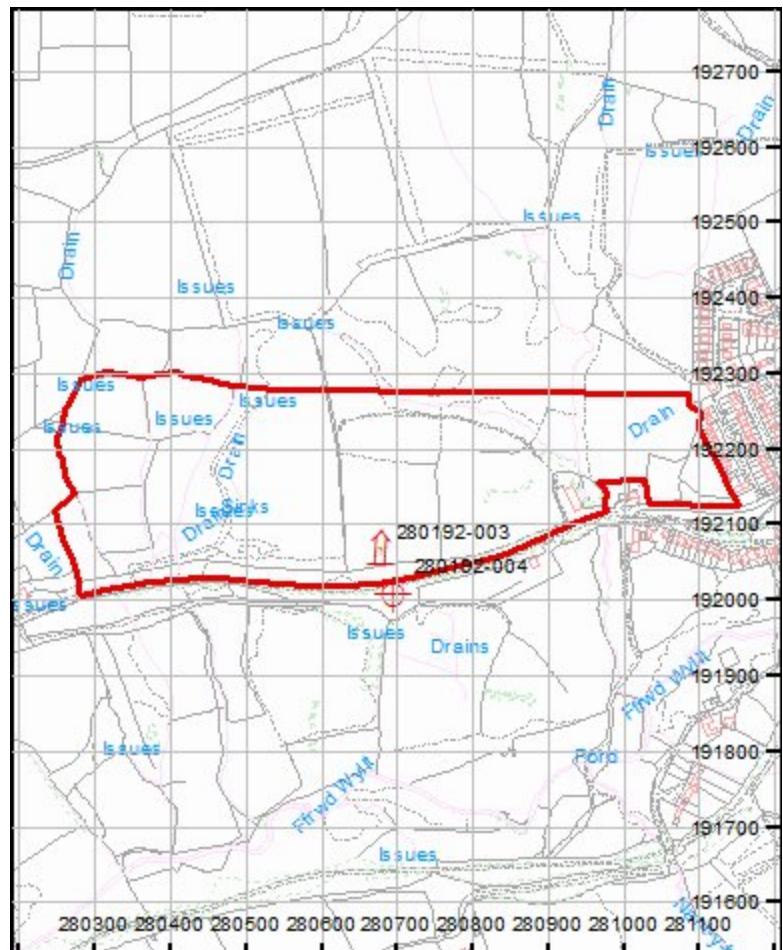
## Enquiry boundary

Our searches found records of two disused mine entries, one shaft and one adit, within the confines of the Site or within 20m of it (see plan included in The Coal Authority’s mining report). The shaft is shown to be present outside the southern boundary of the Site and the adit is

shown to be present centrally near the southern boundary of the Site. There are no working collieries in the locality that would affect the proposed development. The Site has not been part of an opencast coal site (OCCS), and there have been no opencast mining operations close enough to the Site to affect the structural integrity of the proposed development.

Within, or within 20 metres of, the boundary of the property there are 2 mine entries, the approximate positions of which are shown on the attached plan.

280192-004. Subsequent to a reported hazard in March 2011 this shaft location was mounded with 20 tonnes of clean stone and secured with 22m of timber post and rail fence..

280192-003. Subsequent to a collapse of the adit opening the entrance has been infilled with 230 tonnes of local spoil and the area regraded..

Our searches found records of two disused shafts or adits within the confines of the Site or within 20m of its boundaries. A shaft is recorded a short distance outside the southern boundary of the Site and outside of the control of the current land owners/developers. An exclusion zone could be calculated for the shaft, within which no building should take place. To calculate the exclusion zone a request should be made to The Coal Authority in order to determine whether or not they have any records of any work that has been carried out to stabilise the shaft. In addition at least one exploratory borehole should be drilled within the Site as close to the shaft as is practical.

There is a record of one disused adit within the confines of the Site. The precise location of the adit should be determined by means of commonly used techniques such as trenching and drilling exploratory boreholes. When the adit has been located it should be made safe by means of commonly used techniques such as excavating it out and/or drilling and grouting. The adit may need to be formerly stopped up following a methodology to be agreed with the Coal Authority.
