13<sup>th</sup> October 2025

**Re:** Results of tree/bat survey completed on areas A-G within the Skewen area

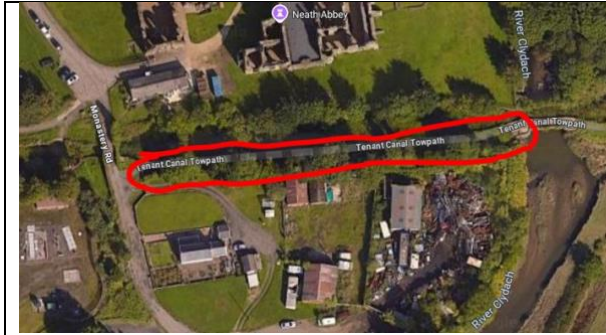
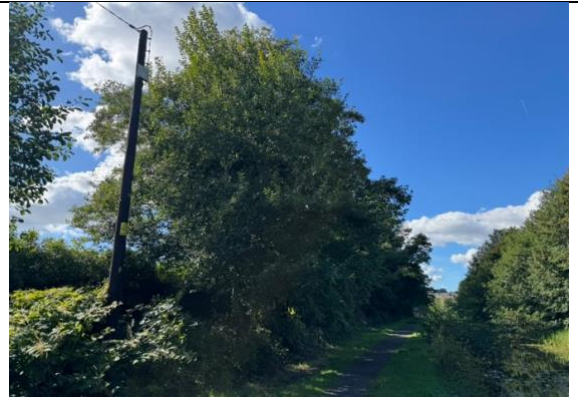
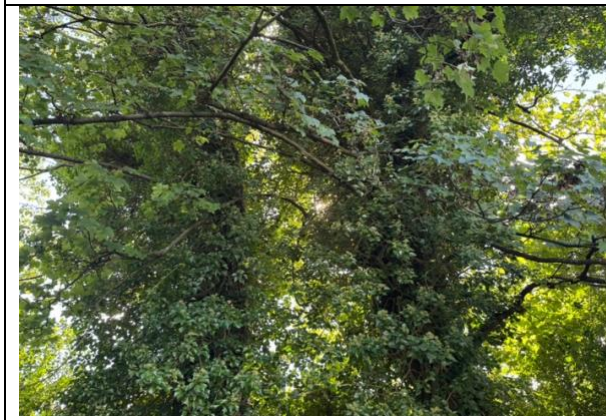
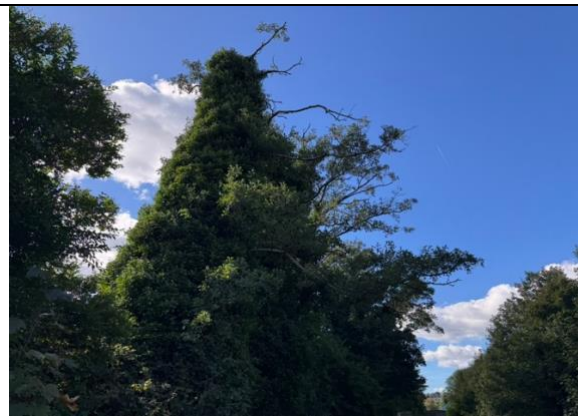
**Area G – Grid Reference – SS73850 97288**

There were several trees across some of the inspected areas that were heavily covered in ivy making a full assessment of them difficult. However, from the inspection that was able to be made there were no visible features noted among the ivy. Trees areas are below that were ivy covered.

| Area A – One tree (Sycamore on the railway banking) | Area G – Several trees along the canal path including some dead trees. |

The recommendations would be to proceed with caution when removing the trees that are covered in ivy. Removing the ivy prior to felling would allow for a full and through inspection of the trees making any PRF's present visible. If any PRF's are noted, then advice should be sort or an inspection by a competent person should be make before proceeding with any tree works.
