Investigation Report into Flooding

Incident of 13th October 2018

Canal Side, Aberdulais

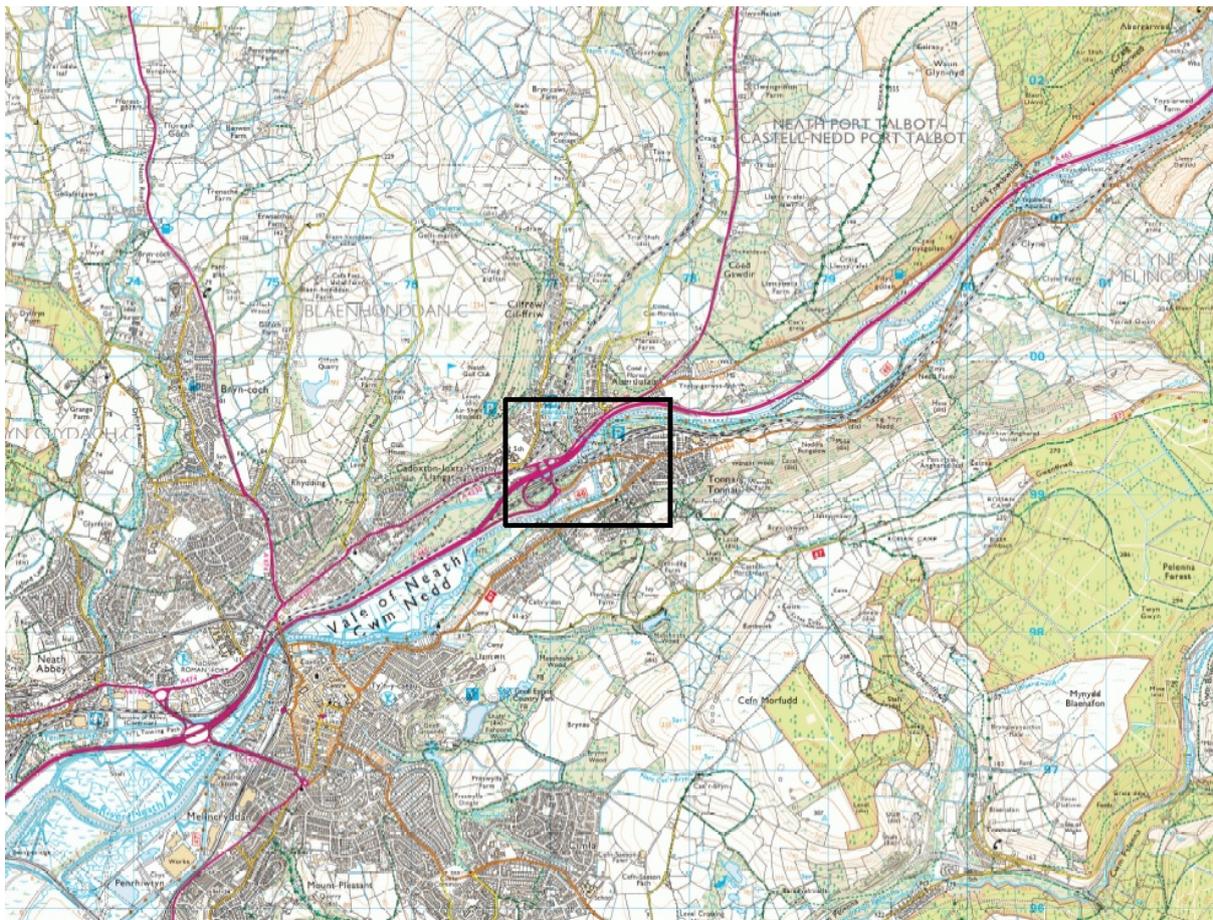
Figure 1 – Canal Side location plan.

Canal Side is located in the electoral ward of Aberdulais which is situated at the end of the Crynant valley where it meets the Neath Valley. The affected properties are situated alongside the Neath Canal and adjacent to the confluence of the River Neath and River Dulais which is located in the centre of Neath Port Talbot County Borough. Figure 1 shows the site location.

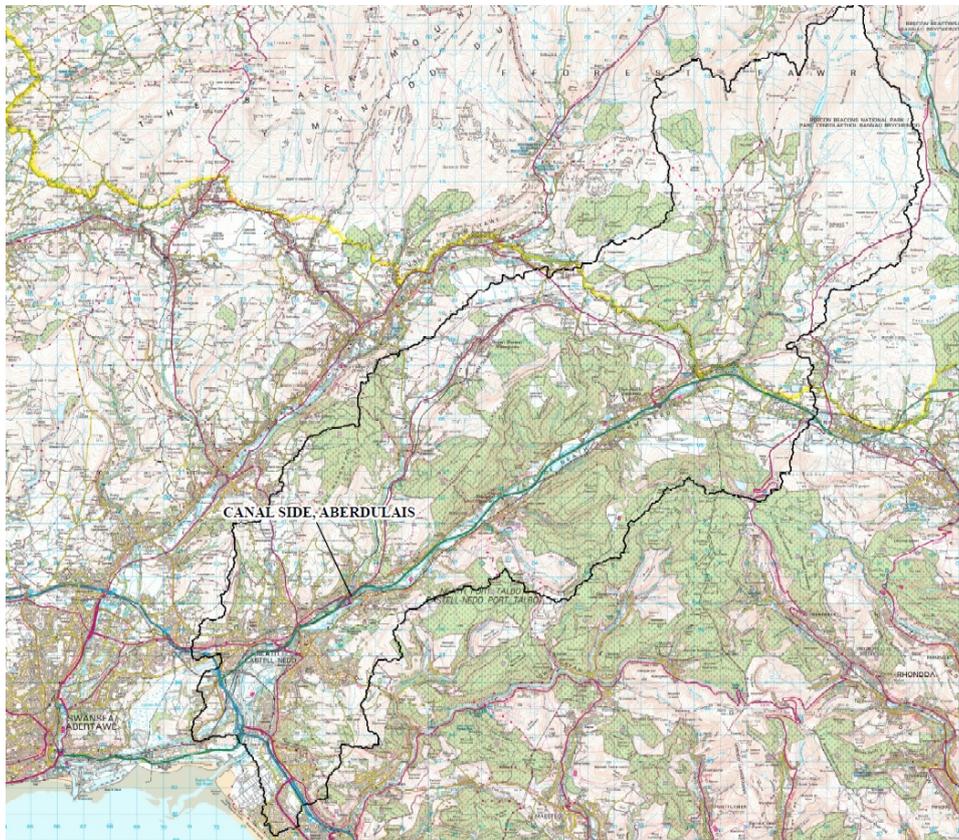
Figure 2 - River Neath fluvial and pluvial catchment plan.

Between Thursday 11th and Sunday 14th October 2018 there was continuous rainfall across the County Borough which lasted approximately 78 hours peaking in intensity late Friday morning. Canal Side sits in the River Neath catchment that received the highest levels of rainfall over the 4 days. The River Neath catchment is approximately 31,652ha in size and encompasses sections of the Brecon Beacons which are drained via a number of recognised watercourses on its southern slopes before converging on the River Neath near Pontneathvaughan.

The river Neath will be discussed throughout this report as one the main contributors to the flooding. Figure 2 below shows the catchment with the location of Canal Side labelled.

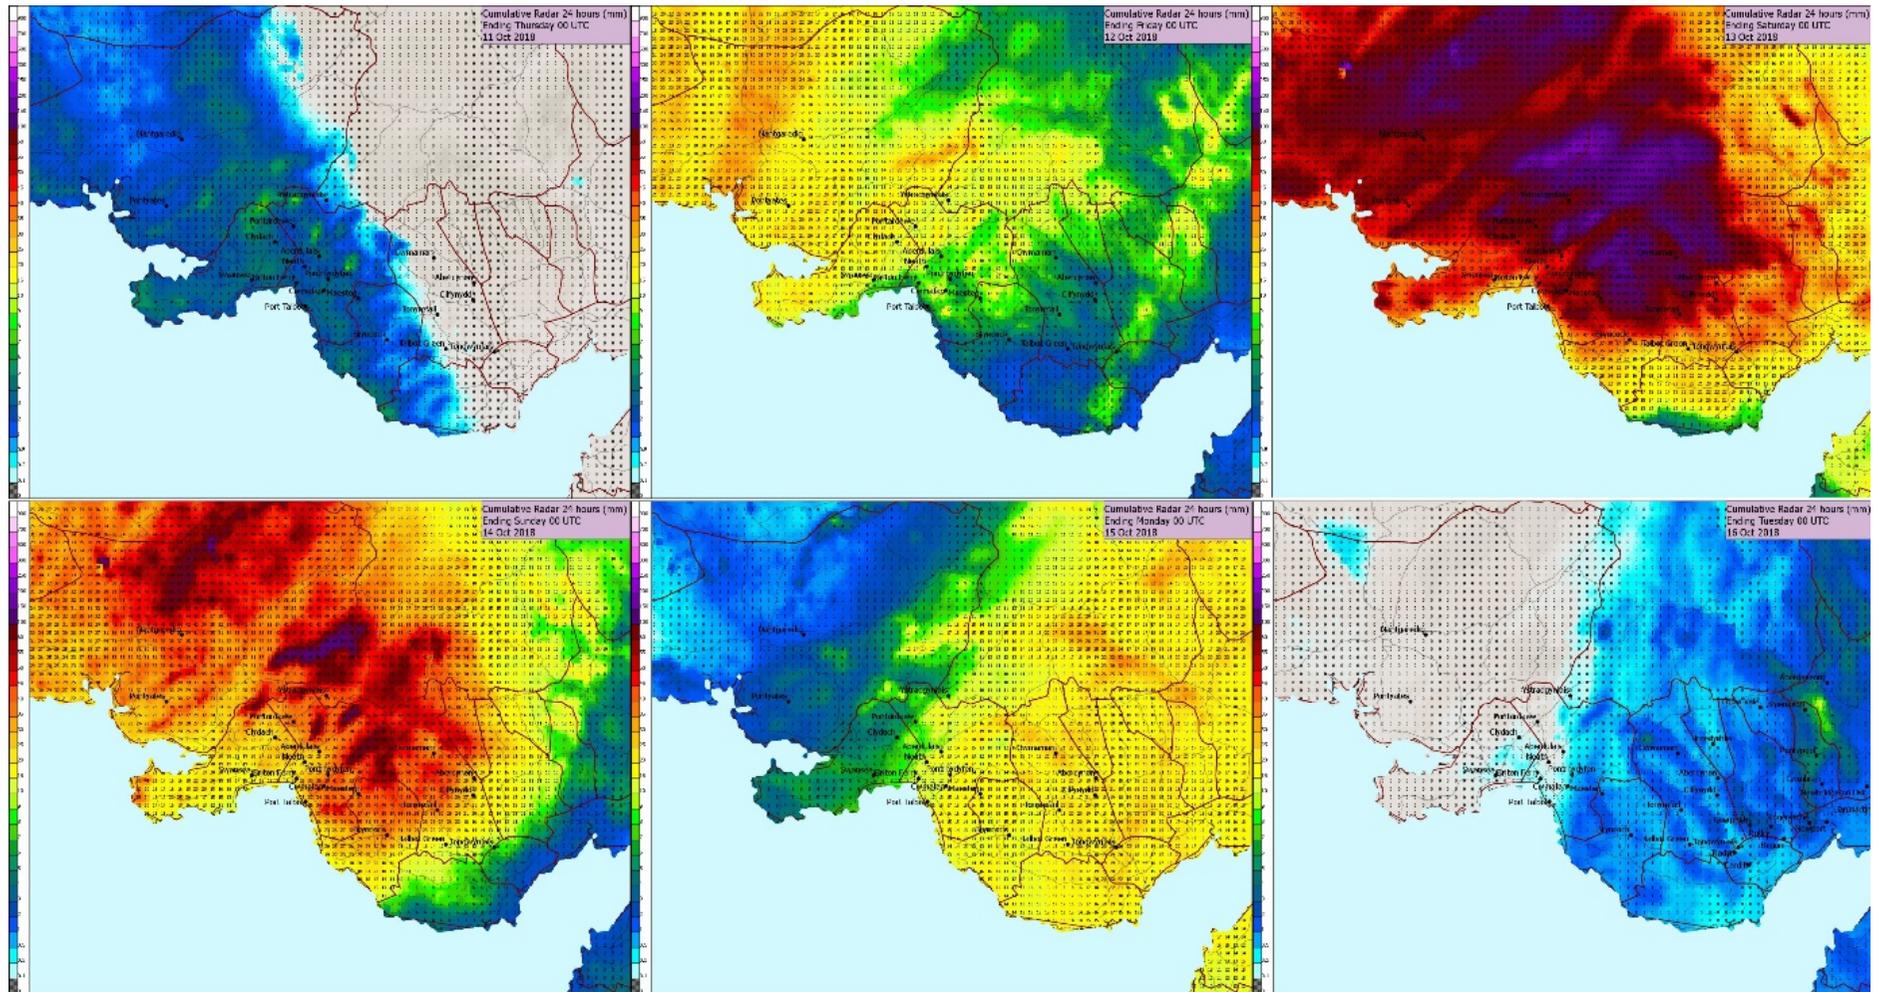
Figure 3 - Daily average rainfall, Wednesday 10th – Monday 15th Oct 2018, Metdesk 2018.

Figure 3 displays the levels of rainfall that fell on NPTCBC during the storm event and shows how it developed and receded across the 6 days. It significantly illustrates how high the average rainfall levels were, especially across Friday and Saturday.

It can be identified that, from Thursday, rainfall gradually intensified and persisted through to Sunday, peaking on Friday with the highest average rainfall across a 24 hour period measured at 142mm in an area of Rheola Forest which forms part of the River Neath catchment. Over the days of the storm it has been calculated that an average of 118mm of rainfall landed within the county boundary over a 72 hour period and an average of 142mm fell within the River Neath catchment over the same 72hr period.

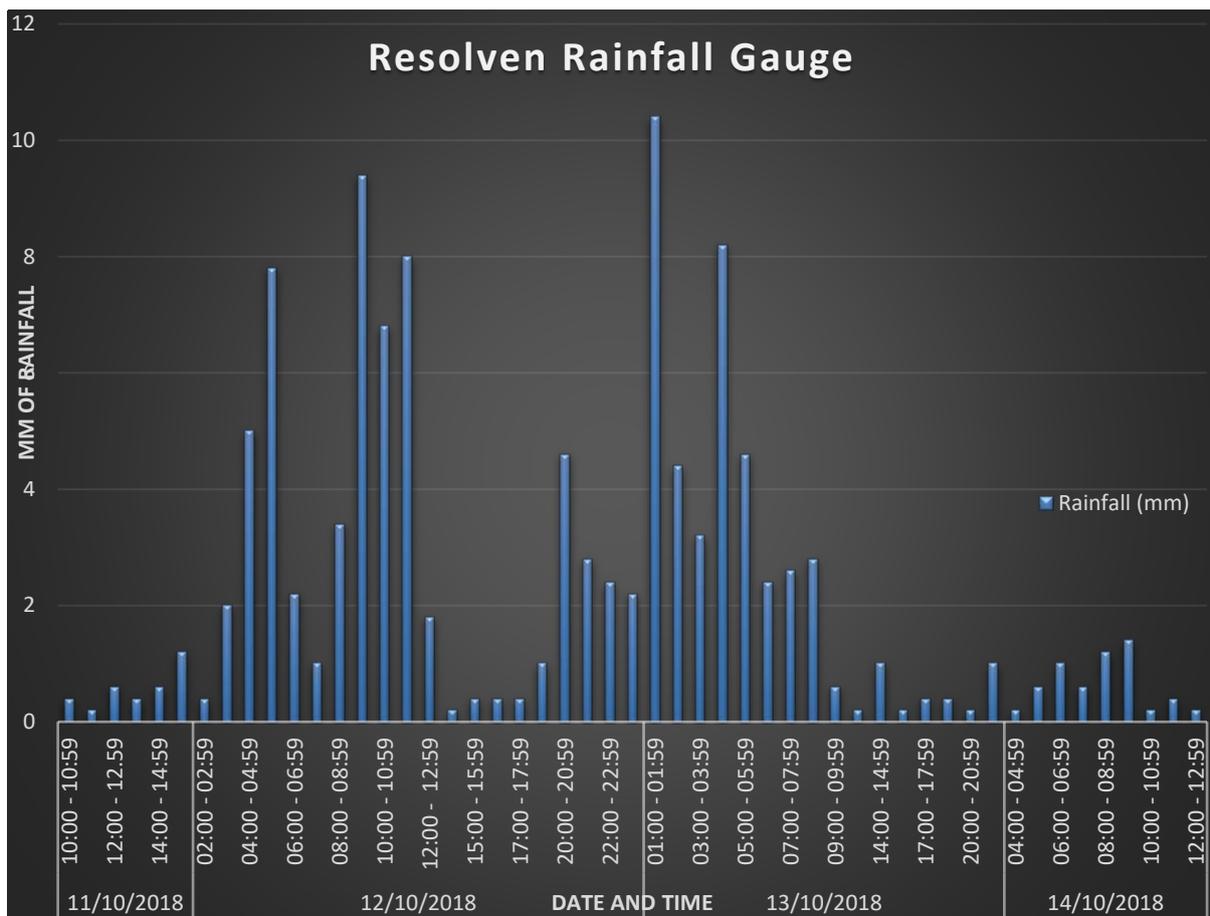
Figure 4 – Rainfall Hydrograph at Resolven, Shoothill Gauge Map 2018.

Is it noted from the River Neath gauging station records at Resolven (6 miles upstream from Canal Side) that during the storm the river level peaked twice at very high levels. Figure 4 & 5 exemplify the magnitude of the rainfall event with the river levels falling just shy of the highest on record. The rainfall hydrograph and river level records show how the river levels reacted with a lag time from the peak of around 3-4 hours on both occasions. Rainfall peaked between 09:00-10:00 on Friday 12th October with the river levels peaking 4hrs after at 14:00. Rainfall again peaked between 01:00-02:00 on Saturday morning with river levels rising to their highest at 17:00 to approximately 2.9m just hours before Canal Side experienced flooding.

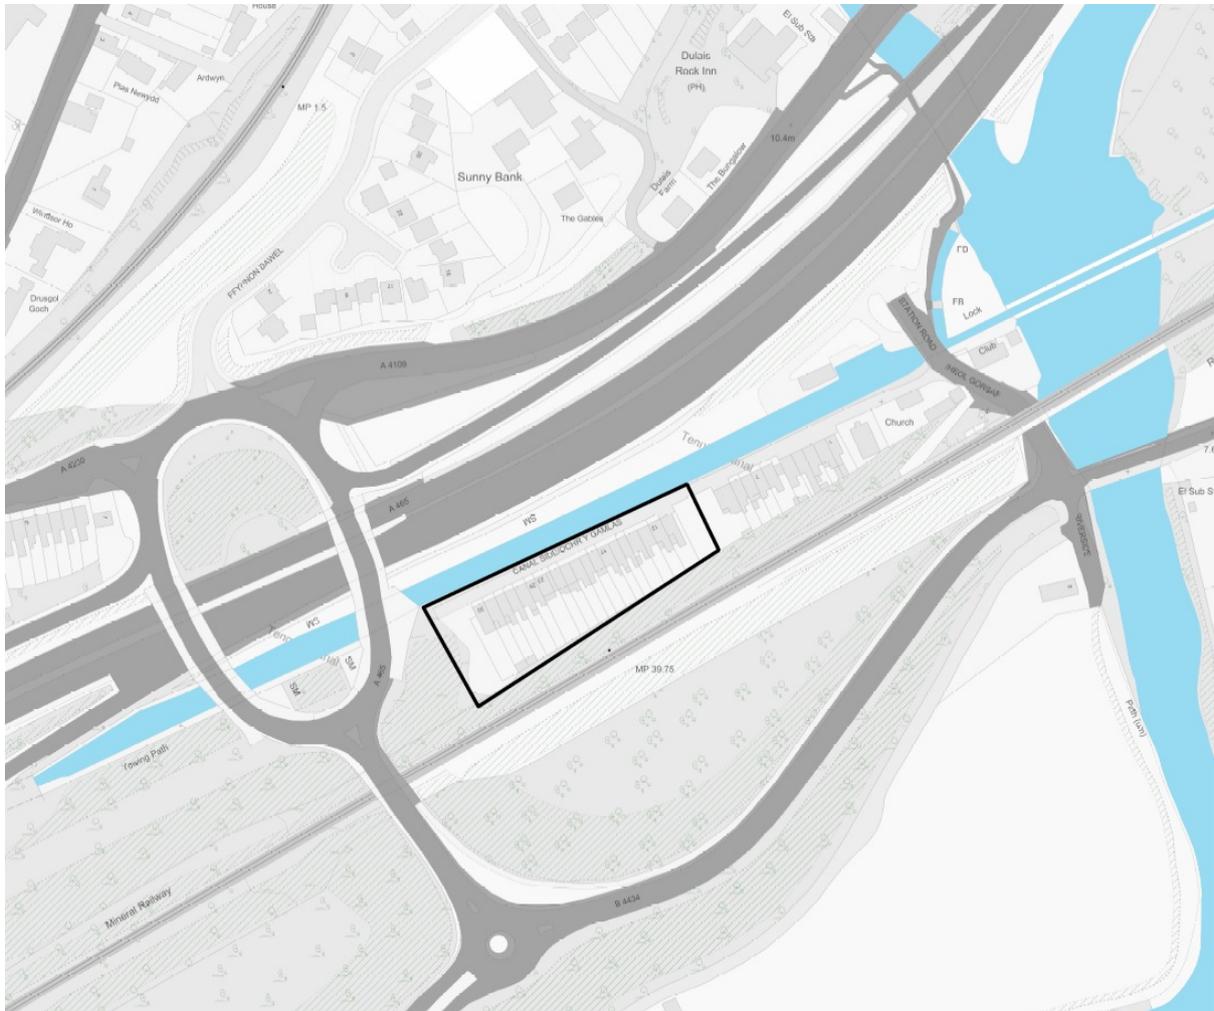
Figure 6 - Location of Properties affected by the flood event on 13th October 2018.

A number of properties suffered internal flooding on 13th October at Canal Side, Figure 6 illustrates the general location of the properties that were affected.
