# Neath Port Talbot Flood Alleviation Schemes: Caenant Terrace

## Ground Investigation Report

Neath Port Talbot County Borough Council

08 June 2022

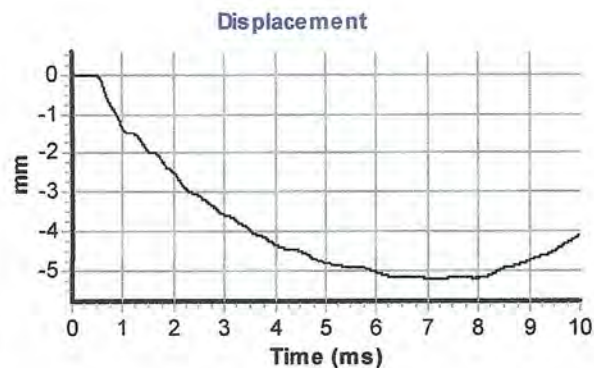
## Comments / Location

Hammer Mass  $m$  (kg): 63.5  
Falling Height  $h$  (mm): 760  
String Length  $L$  (m): 10.0

Area of Rod A ( $\text{mm}^2$ ): 905  
Theoretical Energy  $E_{\text{theor}}$  (J): 473  
Measured Energy  $E_{\text{meas}}$  (J): 312
