*Report No. BC/MB/04.15.03.*

# **Mining Risk Assessment on Land West of Penrhiw Street, Bryn, Port Talbot.**

**Mr V. Price.**

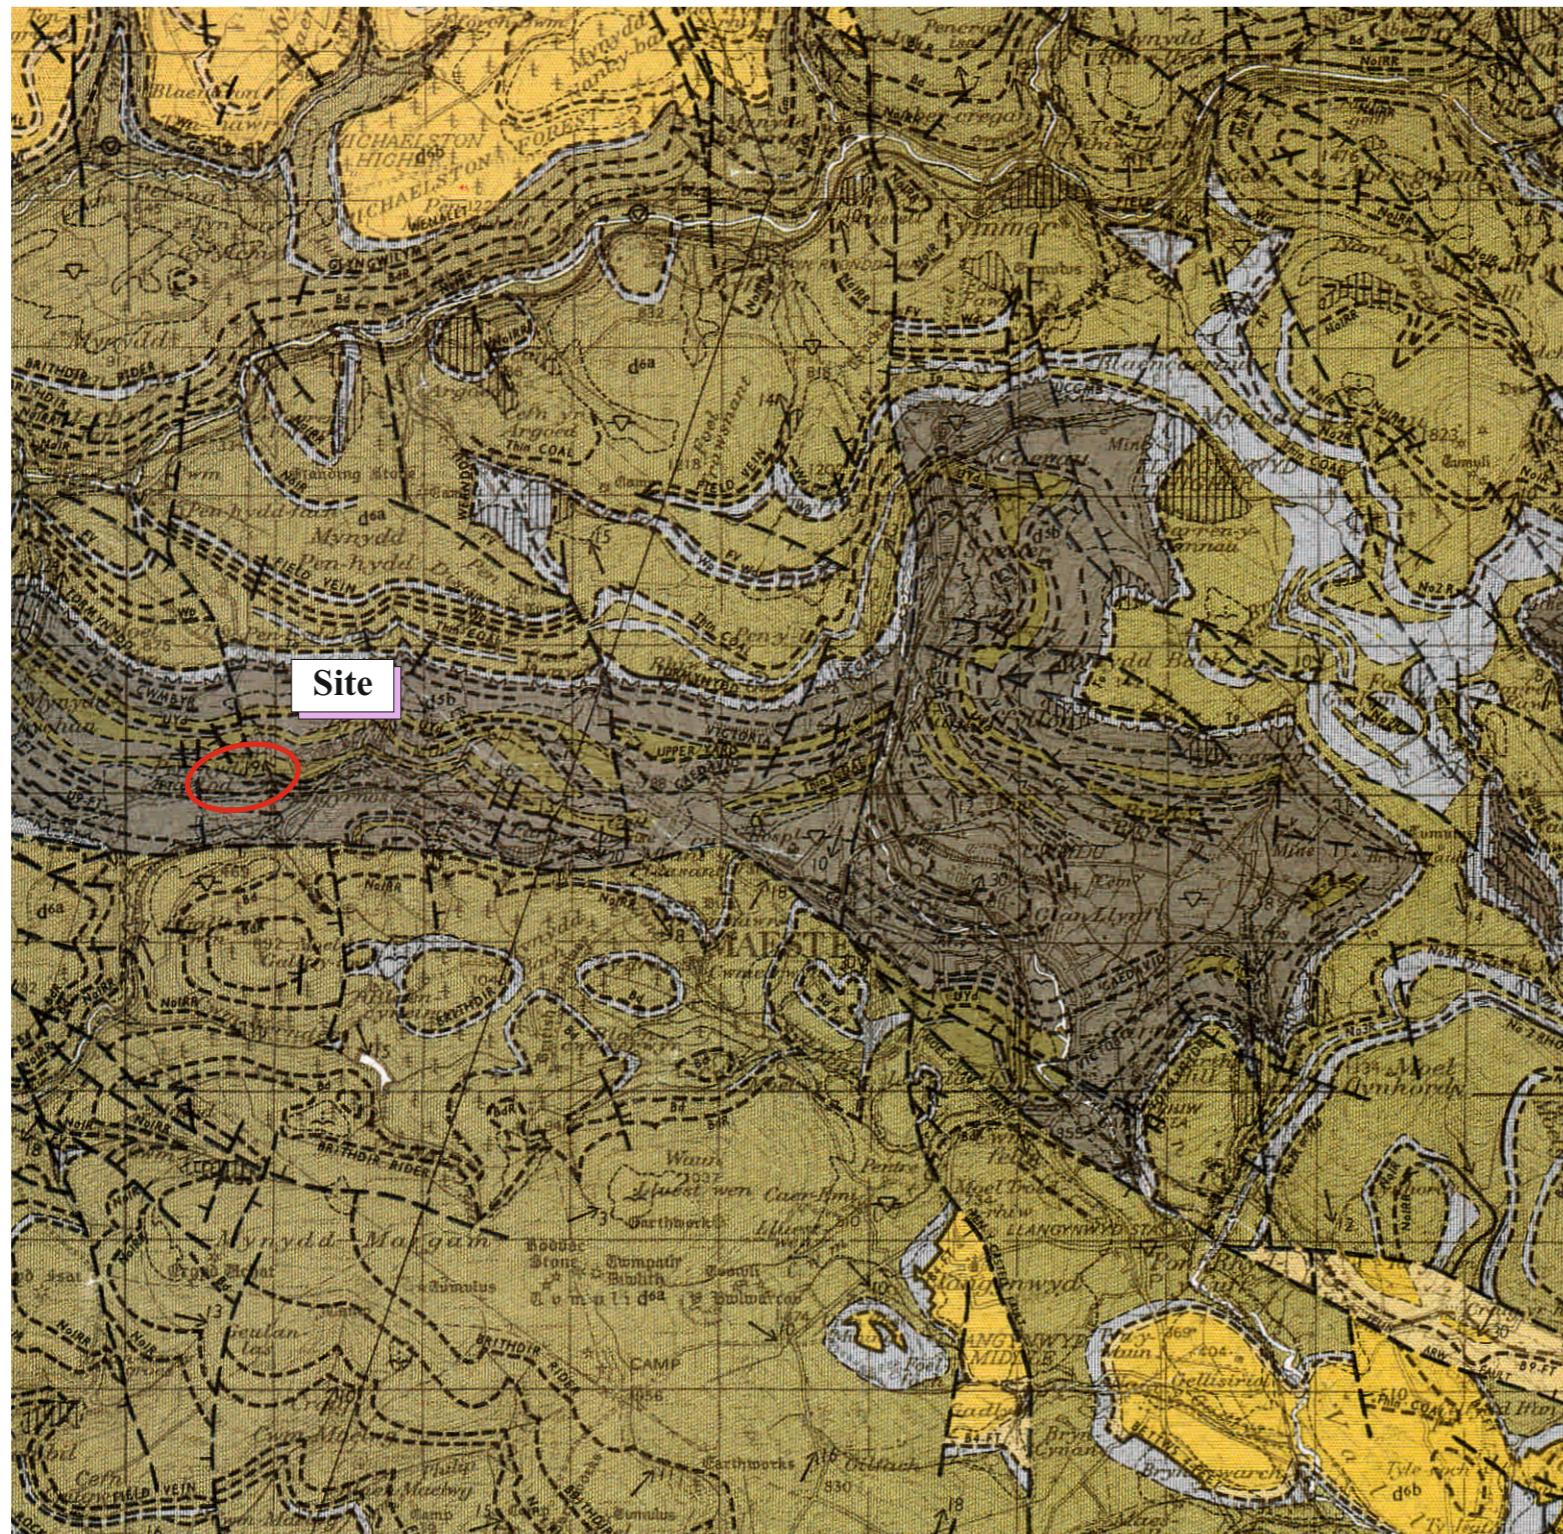
## Geology Plan.

Carboniferous Measures (see *Geology Plan, drawing no. BC/MB/04.15.03.02*). The most recently published geological sheet (Pontypridd Sheet 248 at 1:50,000 scale) shows the inferred positions of the outcrops of the Two Feet Nine and Six Feet Seams to pass immediately to the south of the Site (see Figure 1, Part of the Stratigraphic Column). The average dip of the strata in the district is between 1 in 2 and 1 in 4 towards the north, but the rate and direction of dip of the strata is locally affected by faults and folds.

Published geological data indicates the inferred positions of three faults that variously cross parts of the Site. Faults can act as loci for differential ground movement as a result of collapsing shallow mine workings, particularly where the pattern of mining is different on the two sides of the fault. Faults planes can also act as loci for differential movement during earthquakes. The presence of faults is not uncommon in South Wales and developments can take place in close proximity to faults subject to certain precautions being taken place. It is recommended that prior to development the faults are examined using exploratory boreholes in order to determine the precise locations of the faults. Wherever possible buildings should not be constructed where they straddle a fault plane.

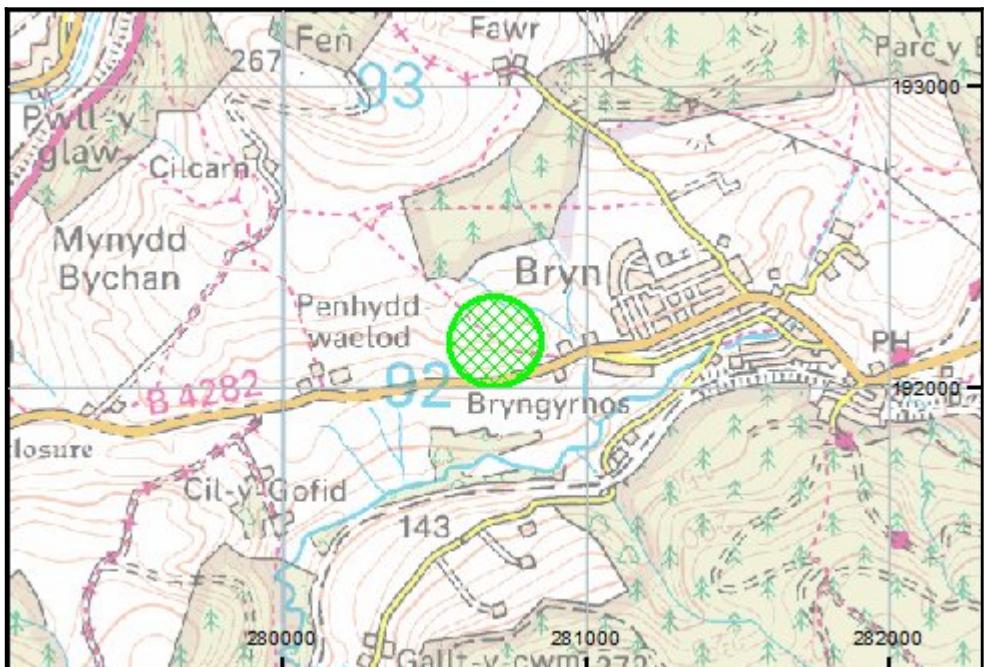
Our searches found records of two disused mine entries, one shaft and one adit, within the confines of the Site or within 20m of it (see plan included in The Coal Authority’s mining report). The shaft is shown to be present outside the southern boundary of the Site and the adit is

Our searches found records of two disused shafts or adits within the confines of the Site or within 20m of its boundaries. A shaft is recorded a short distance outside the southern boundary of the Site and outside of the control of the current land owners/developers. An exclusion zone could be calculated for the shaft, within which no building should take place. To calculate the exclusion zone a request should be made to The Coal Authority in order to determine whether or not they have any records of any work that has been carried out to stabilise the shaft. In addition at least one exploratory borehole should be drilled within the Site as close to the shaft as is practical.

280192-004. Subsequent to a reported hazard in March 2011 this shaft location was mounded with 20 tonnes of clean stone and secured with 22m of timber post and rail fence..
