## Godre'r Graig Primary School, Godre'r Graig Preliminary Landslide Hazard and Risk Assessment

Report Reference: ESP.7234e.3221

## Godre'r Graig Primary School Preliminary Landslide Hazard and Risk Assessment

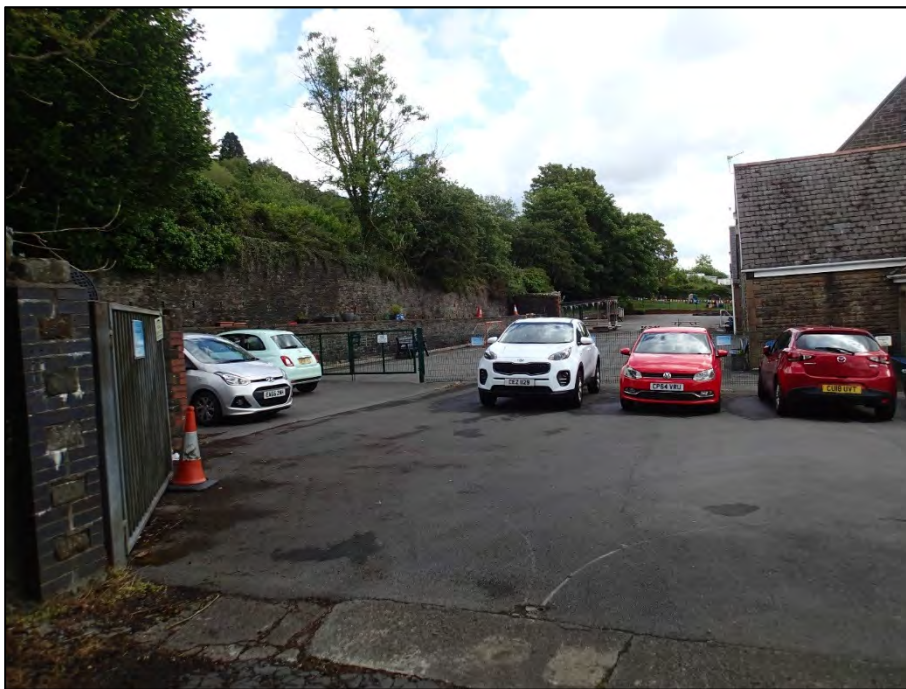
The elements at risk are the school building (temporally and spatially fixed) and the population of the school (temporally and spatially variable). The school was built between 1899 and 1918 (Section 4.3) and is of masonry construction. The school playground is located at the rear of the school below a masonry retaining wall (Plate 1).

**Plate 1:** Retaining wall between the school playground and the natural slope.

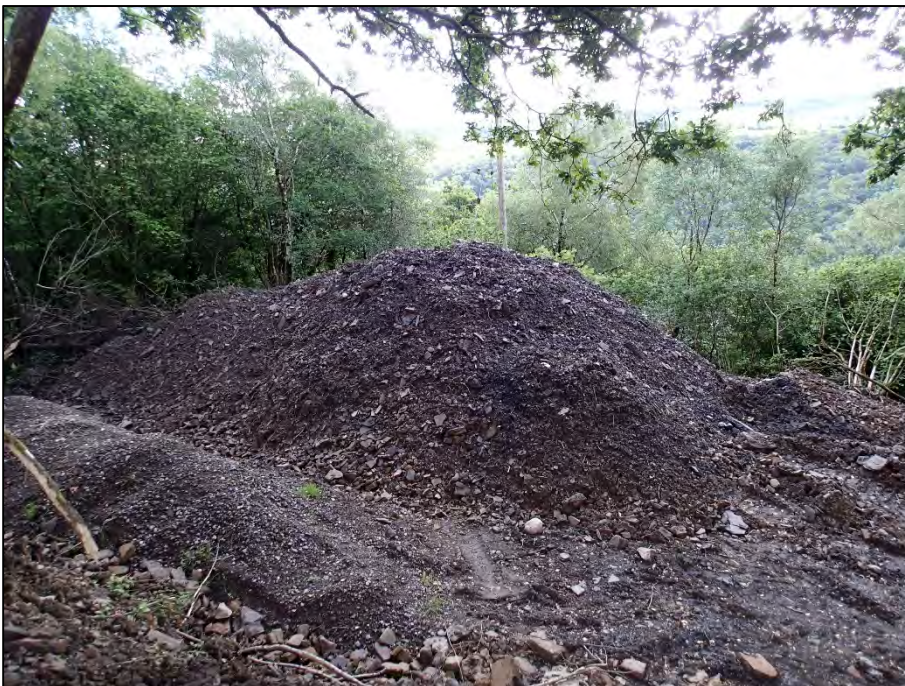
**Plate 6:** Recently deposited spoil from work in the quarry to the NW of the School.

Recent works have been undertaken in the NW quarry with an improved access road constructed. Spoil from this work has been end tipped below the quarry entrance (Plate 6).

As discussed in Section 3.2.1, recent evidence that quarrying has taken place at Cwar Pentwyn (Plate 6). A review of the ownership, activities, permissions and conditions should be undertaken.

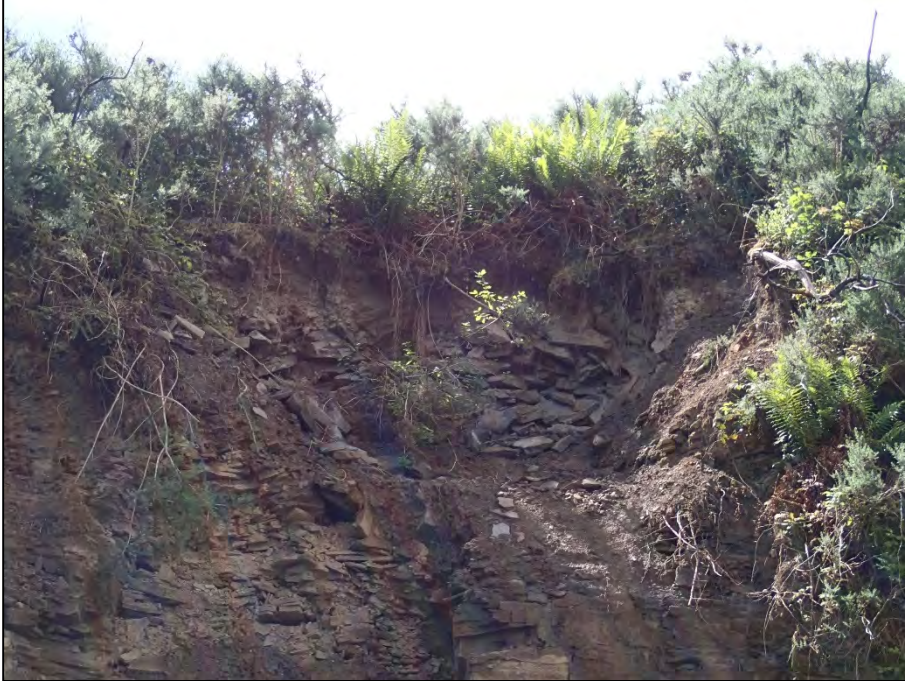
Based on the exposure in the NW quarry, the spoil comprises interlocking, angular and tabular boulders and cobbles of weak to medium strong sandstone (Plate 7). The spoil associated with both quarries is associated with very dense vegetation, especially brambles limiting access.

*Plate 7: Spoil exposed in the NW quarry*

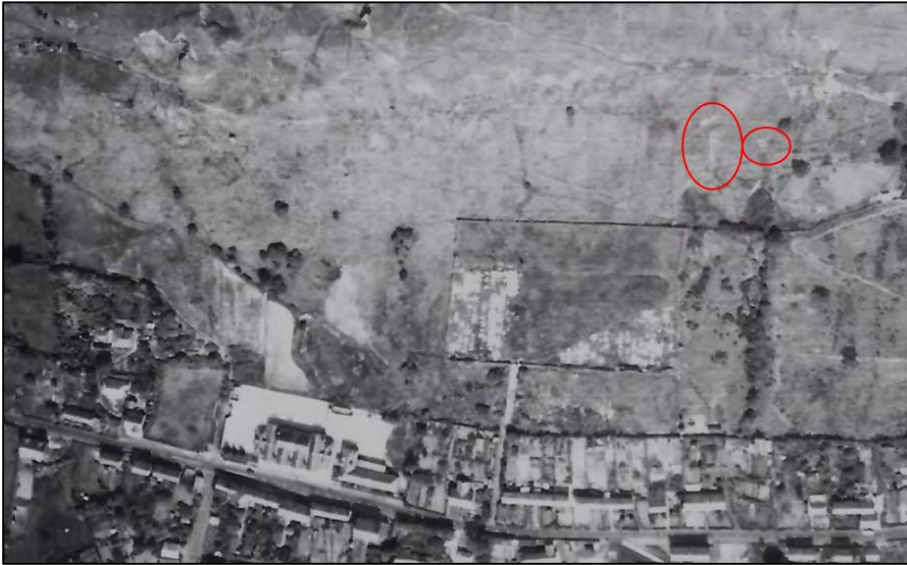
There was very limited evidence for previous landslides from the API. These possible landslides were tentatively identified in the 1952 aerial photographs (Insert 5). Three arcuate depressions are located below these features that, based on the API, were considered to have been possible formed by landslide processes.

**Insert 5:** Extract from 1952 photograph with possible landslides circled

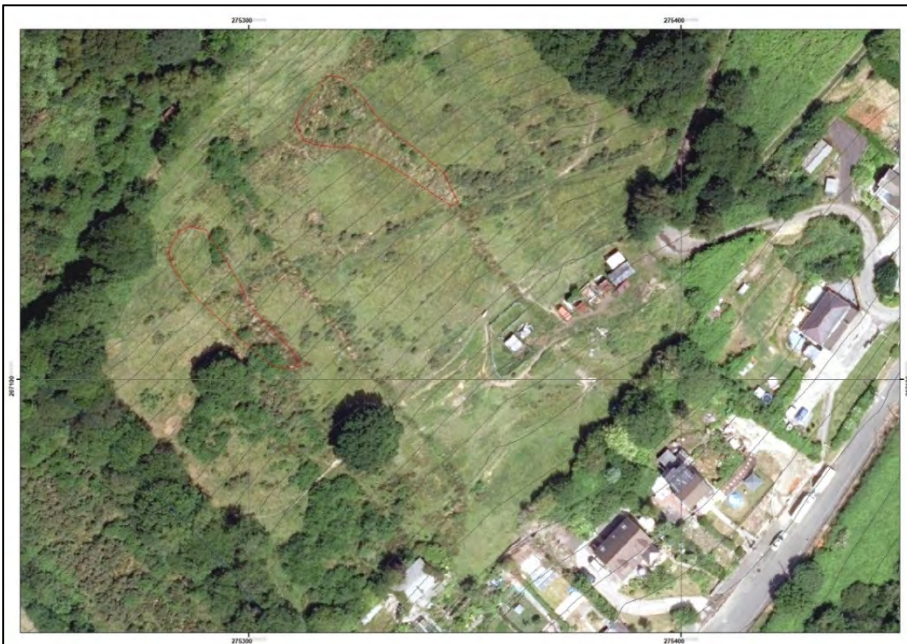
The “shallow slips” recorded on the geological map are not apparent on the historical aerial photographs. However, two areas interpreted as being associated with hydrophilic vegetation are evident in the 2013 orthophotograph (Insert 6).

**Insert 6:** Enlargement of 2013 Orthophotography showing possible landslides identified in the area of “shallow slips” recorded on the geological map

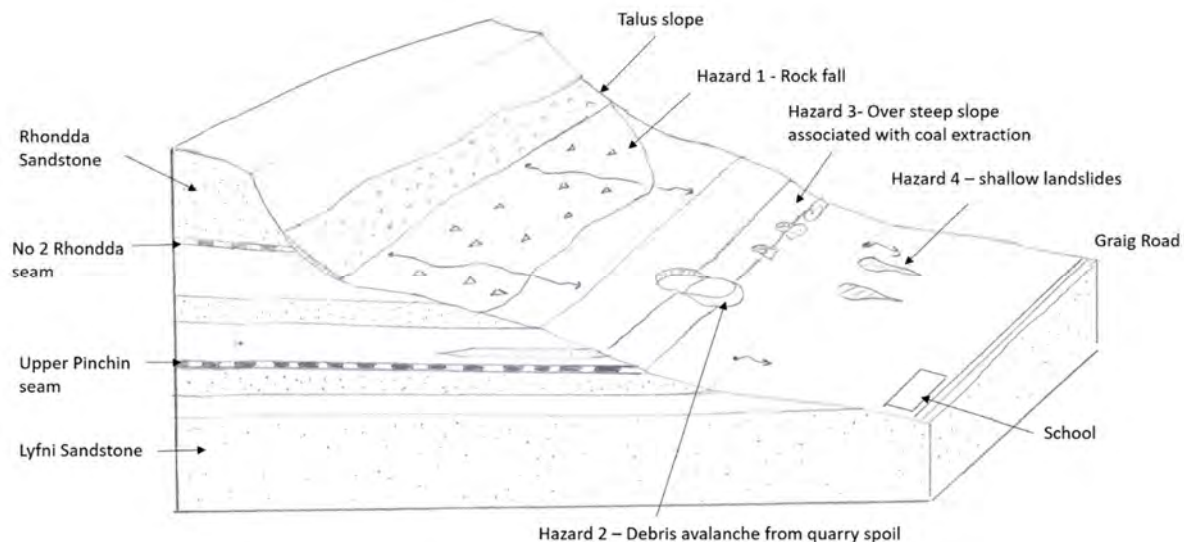
Based on the initial API, four possible hazard types were identified (Insert 7):

- Hazard type 1. Rock fall - possible structural damage, impact on people;
- Hazard Type 2. Debris avalanche initiating from quarry spoil – impact loading on structures, impact/burial of people outside building, burial of people inside buildings (ground floor) if sufficient volume;
- Hazard Type 3. Debris avalanches initiating from over steep slope – impact loading on structures, impact/burial of people outside building, burial of people inside buildings (ground floor) if sufficient volume; and
- Hazard Type 4. Shallow earth slides - slow ground displacement leading to vertical or lateral displacement, or undermining of structures and infrastructure.

**Insert 7:** Conceptual Engineering Geological Model of site from API

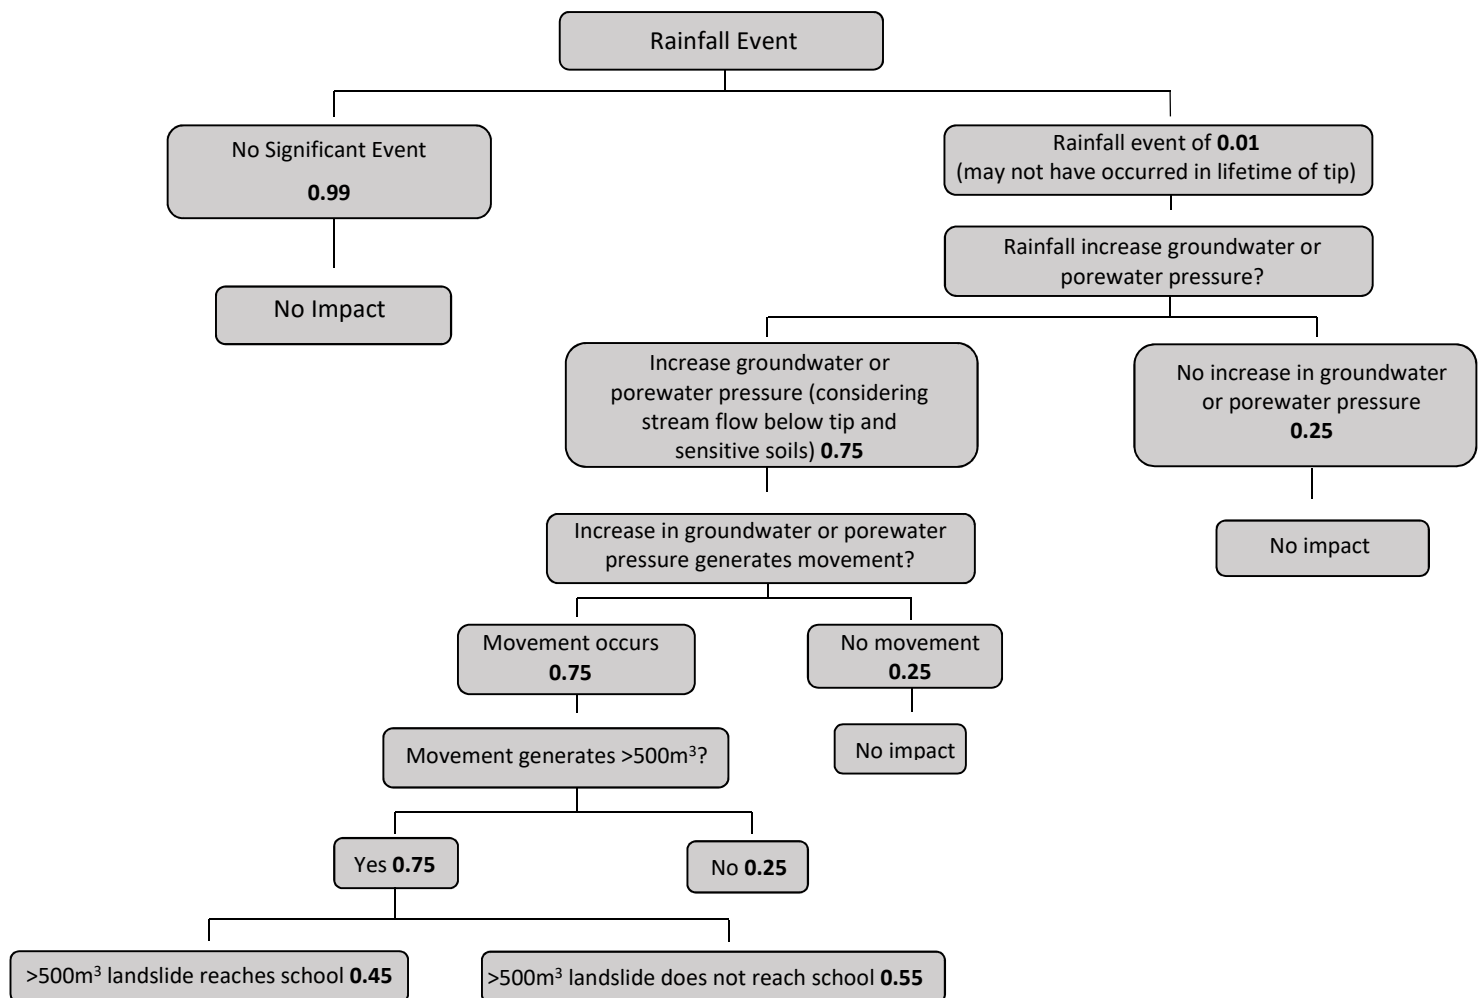
As discussed in Section 7.1, an event tree has been used to provide a qualitative, indicative value of approximate annual probability for such an event occurring. The event tree is presented below.

Using the probabilities assigned in the event tree, it suggests that the estimated annual probability of a landslide hitting the school is 0.0019, or  $1.9 \times 10^{-3}$ . Using Table 6 above, this annual probability correlates to a 'possible' likelihood i.e. the event could occur under adverse conditions over the design life. Table C7 in the Commentary of the AGS guidelines provides some further information on a  $\times 10^{-3}$  order of magnitude, which is that 'the occurrence of the condition or event is not observed in the available database. It is difficult to think about any plausible failure scenario; however, a single scenario could be identified after considerable effort'. We consider that this statement has similarities with our assessment for Hazard Type 2, as this observations made on site and some probable conditions (such as the coarse free draining nature of the tip) suggest that instability may not be possible, however, these conditions are unproven and cannot be assumed.

We consider that a  $>500\text{m}^3$  debris avalanche reaching the school could cause moderate damage to some of the structure, and/or significant part of the site which would require large stabilisation works. Such a consequence is described as medium using Table 7 above.

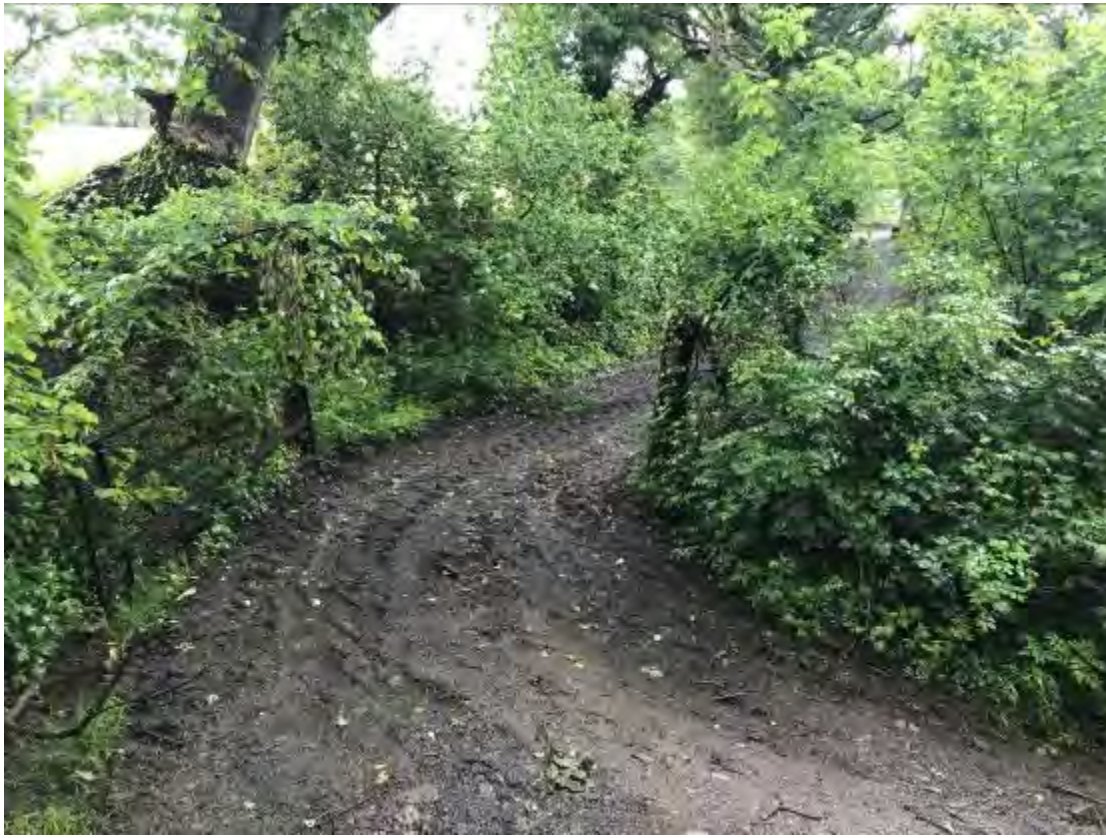
**Photograph 1 – Access road to Pentwyn Farm**

Inspection on the 13<sup>th</sup> June 2019 began at the south-western extremity of Site 1, at the access track leading to Pentwyn Farm and the entrance to Cwar Pentwyn (photographs 1 and 2). It was noted that flows from the mine adits above were entering the roadside drainage channel along the Pentwyn Farm access road (photograph 3). The quarry access track was well used and mounds of what appeared to be quarried material were present over the location of the mine adits and the colliery spoil tip to the south of the track (photographs 4, 5 and 9).

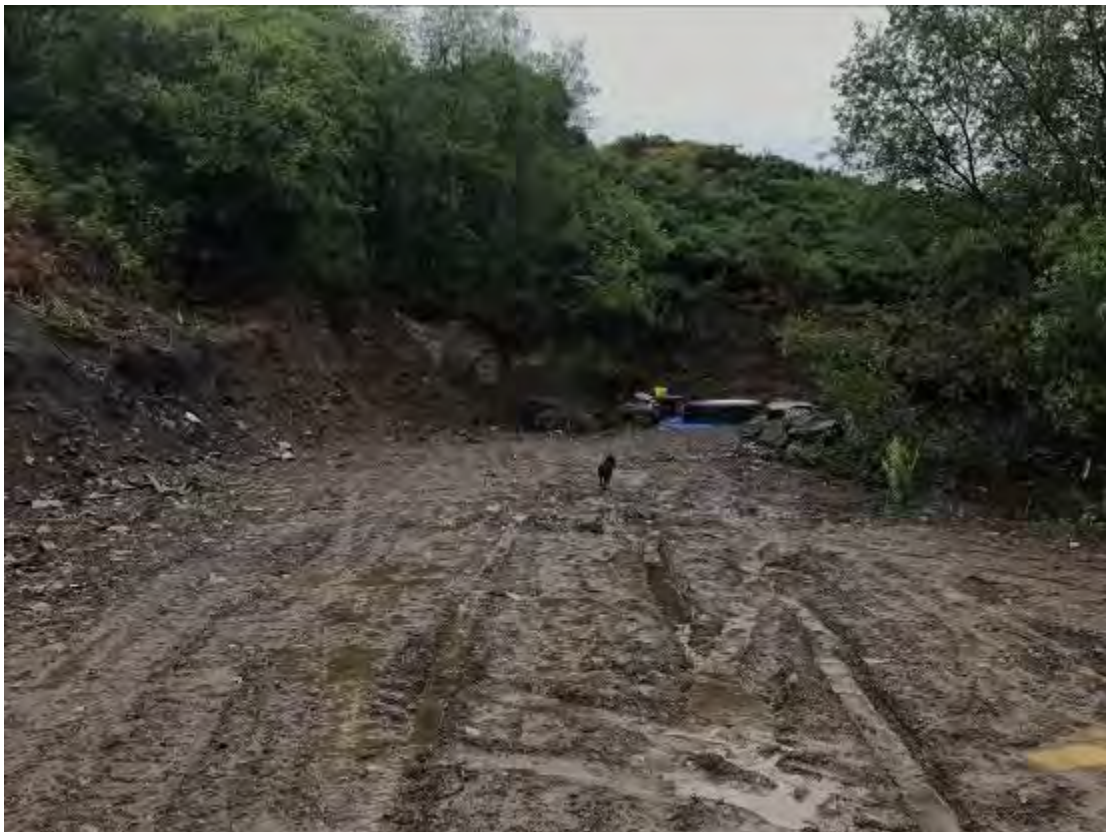
**Photograph 12 – Pentwyn Quarry floor**

The inspection then viewed the floor and high walls of Cwar Pentwyn. Recent quarrying activity appeared to have taken place, with mounds of excavated material present. Evidence of human activity was also observed as a 'Lazy Spa' type pool, tent and camp bed were present, along with electricity extension cables leading downslope toward the properties named 'Glander' and 'Darren View' (photographs 11 to 16).

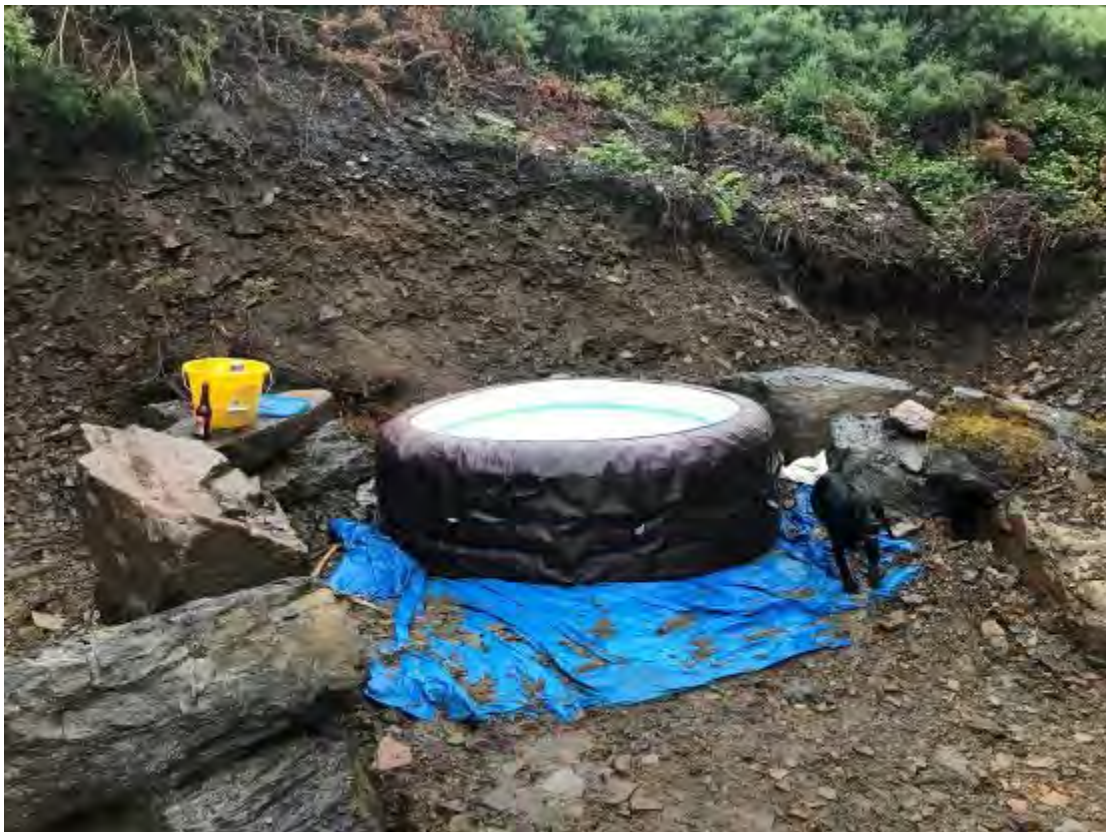
**Photograph 14 – ‘Lazy Spa’ located in quarry floor**

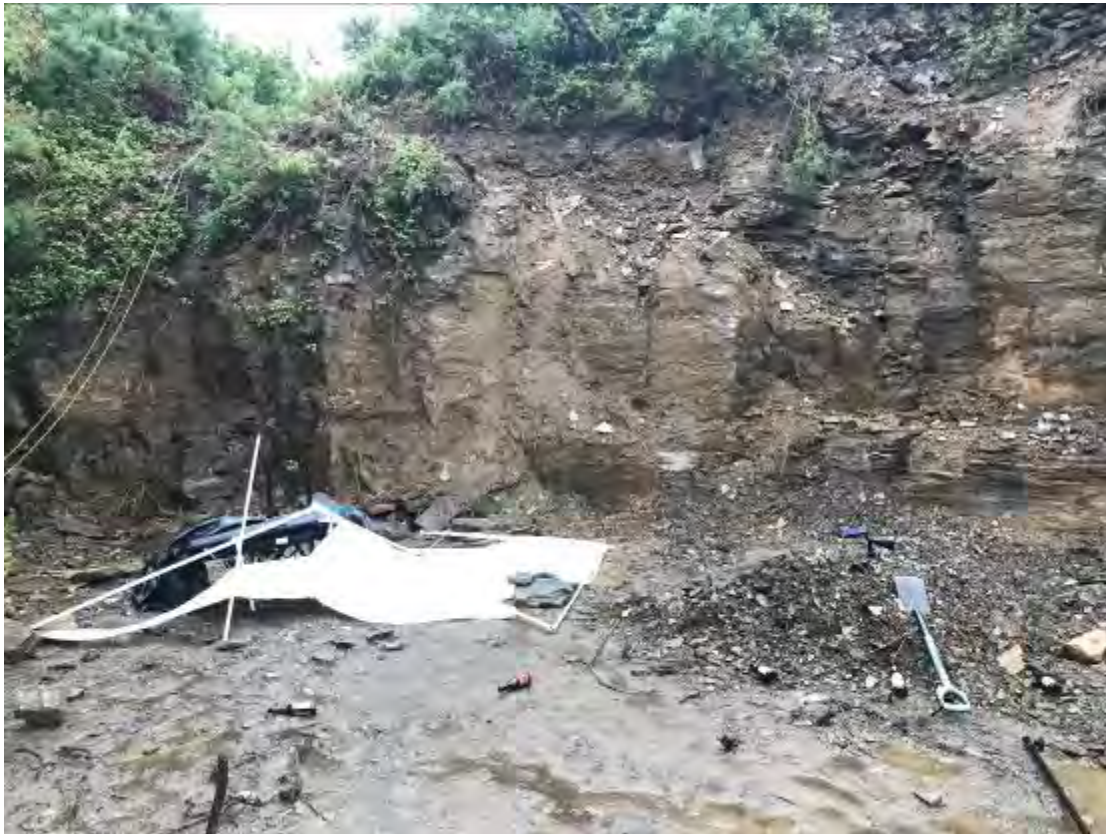
**Photograph 15 – Recently used shelter in quarry floor**

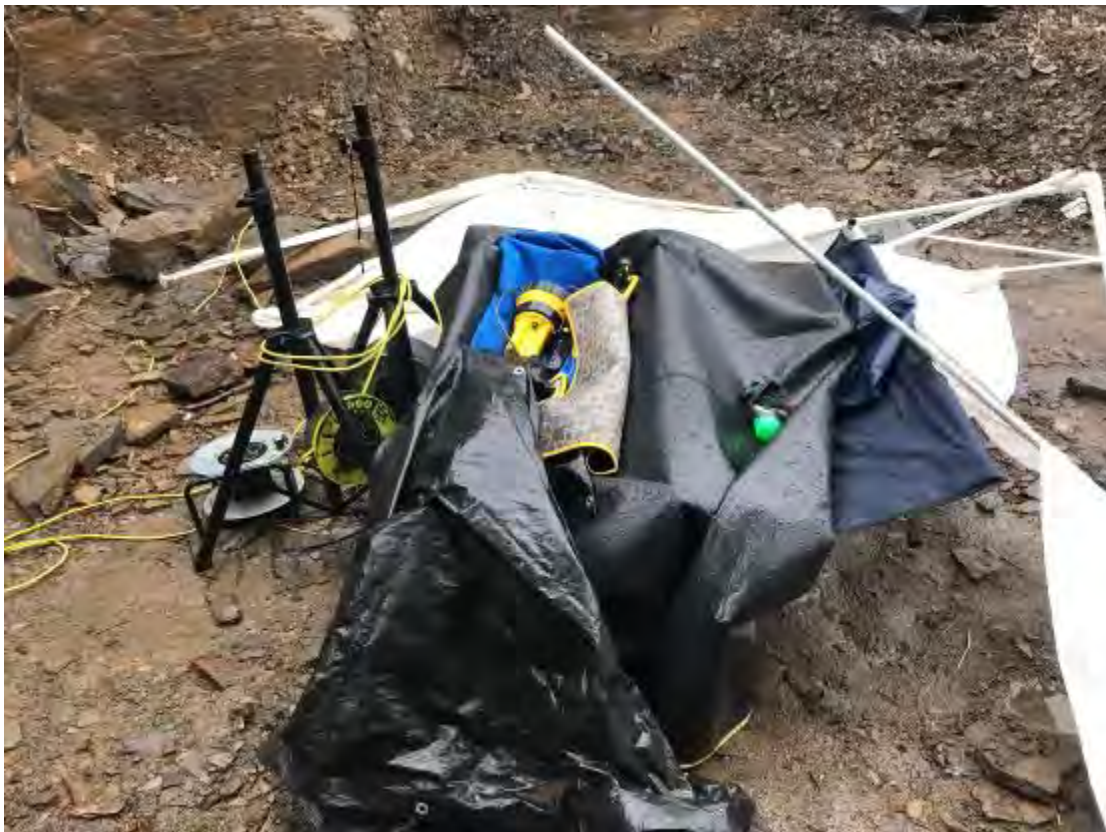
**Photograph 16 – Shelter showing electricity cables**

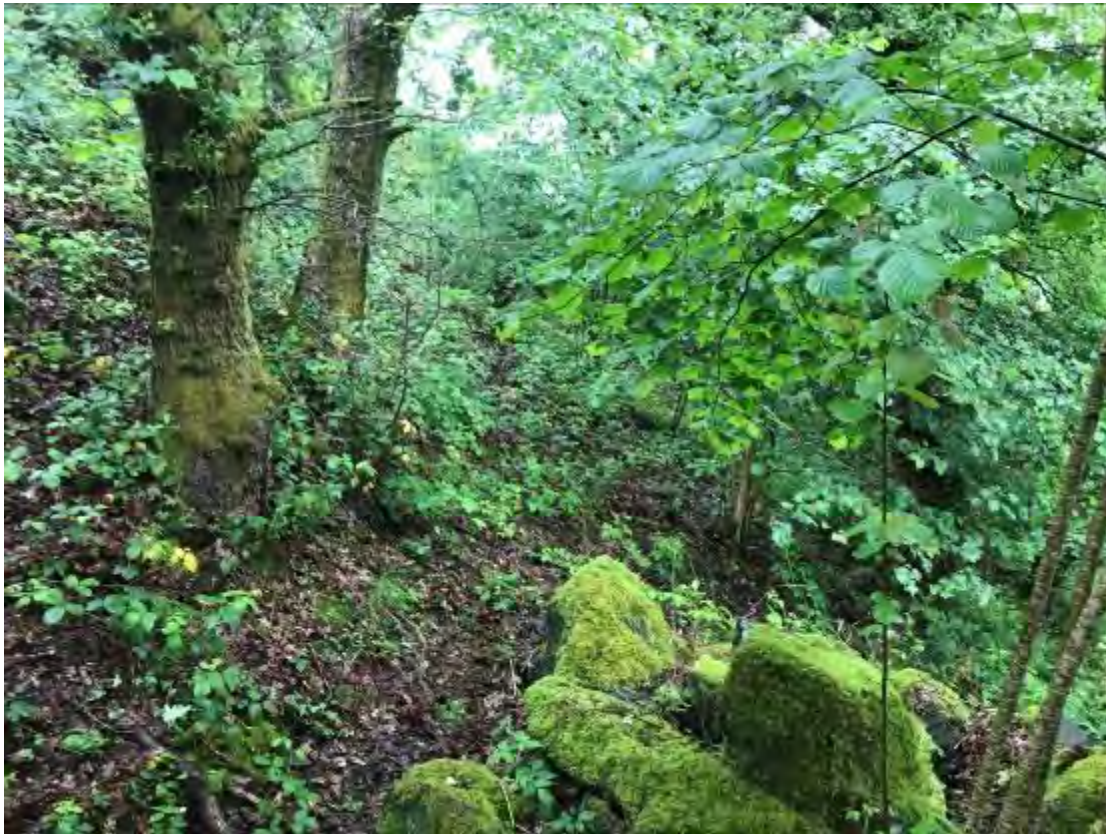
The flanks of the colliery and quarry spoil mounds were very steep and densely vegetated, preventing a close inspecting of material and topography (photographs 8, 17, 18 and 19).

**Photograph 17 – Steep densely vegetated flanks of Site 1**

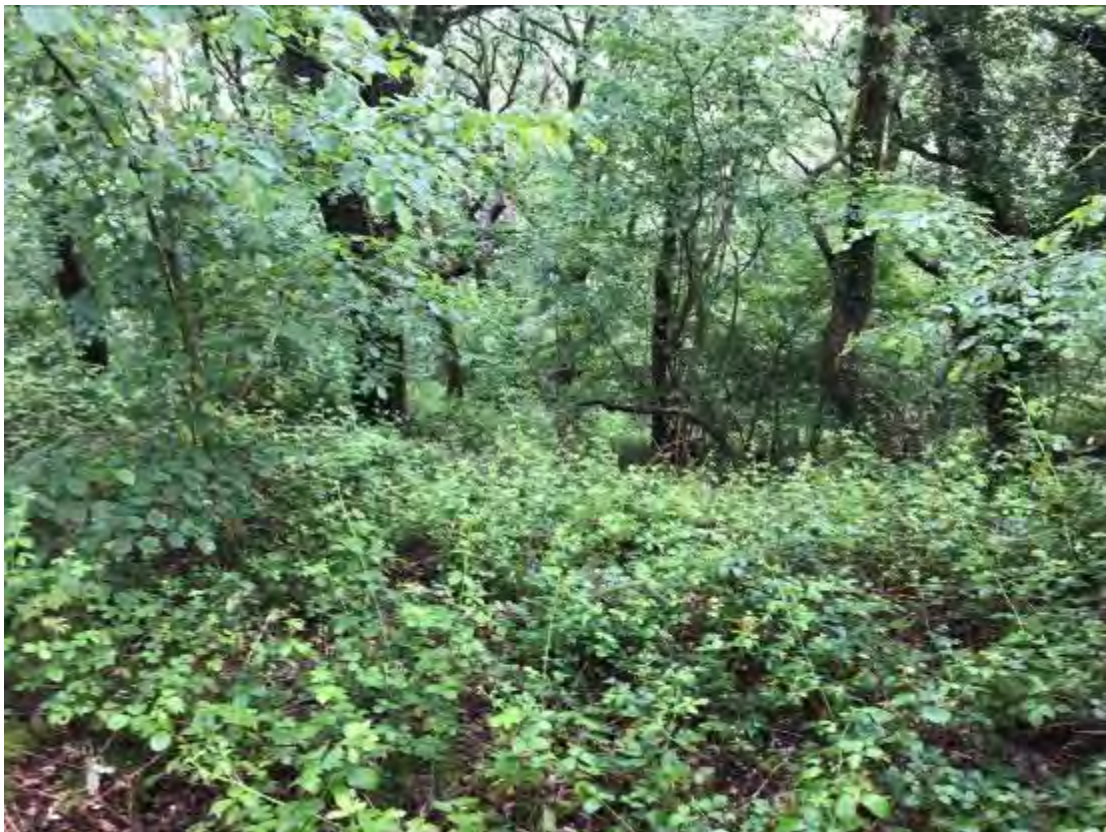
**Photograph 18 – Steep densely vegetated flanks of Site 1**

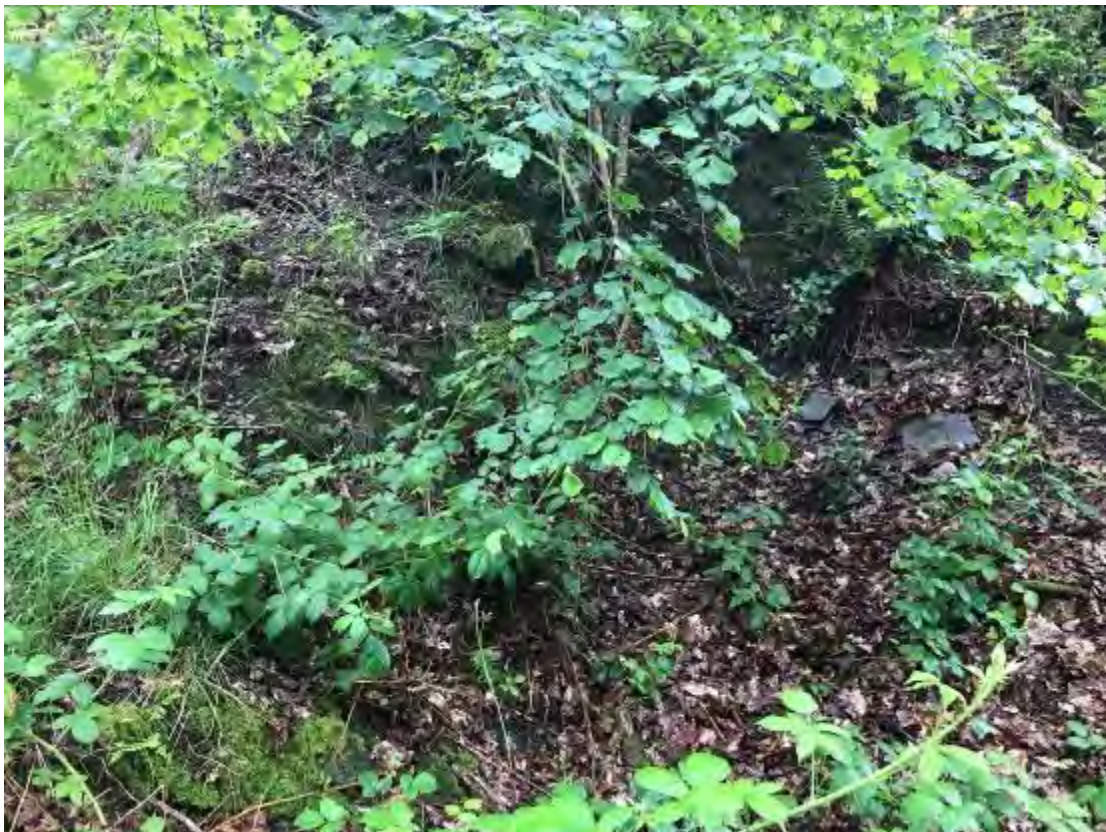
Very little evidence of recent instability was observed, with the exception of a small degraded shallow slip at approximate NGR 274910E 206861N (photograph 20) and some areas of soil creep.

**Photograph 20 – Small slip on flank of Site 1**

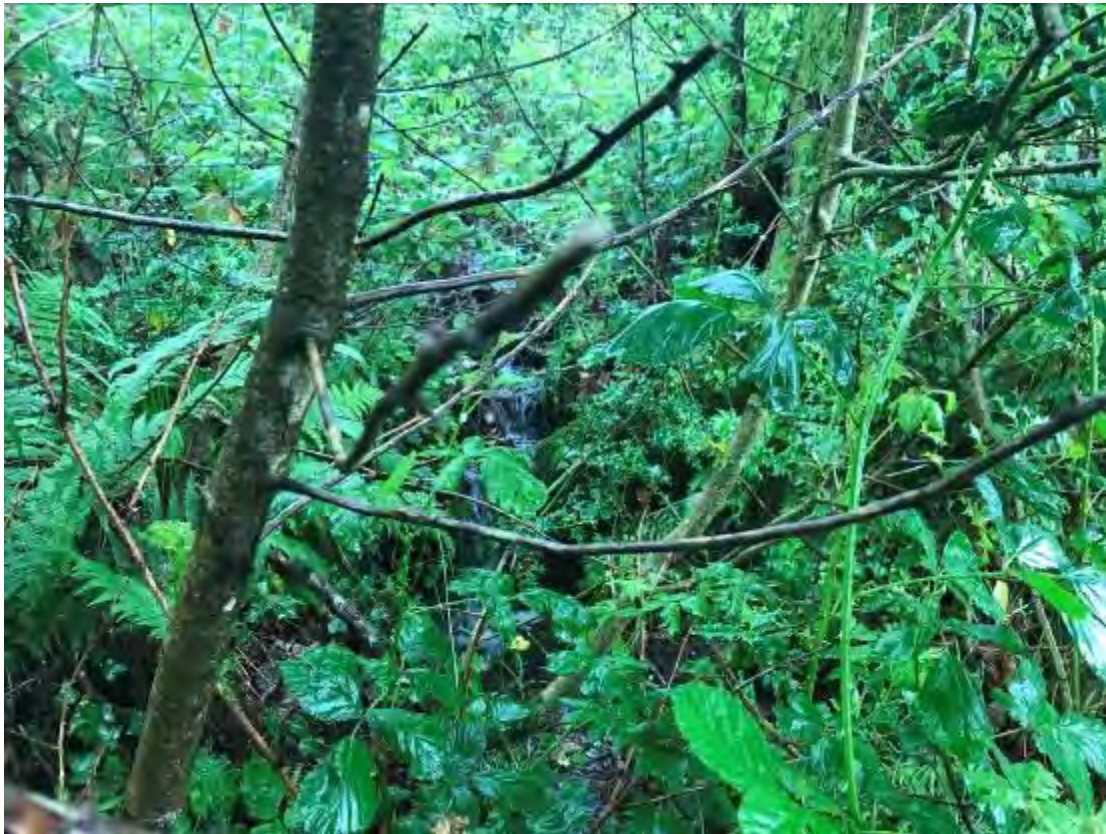
A spring was observed emanating from the vicinity of mine adit reference 274206-026 at NGR 274988E 206957N (photograph 21). The spring was observed as forming a small marshy area, subsequently flowing overland and downslope in a south-easterly direction.

**Photograph 21 – Minor watercourse at head of Site 2**

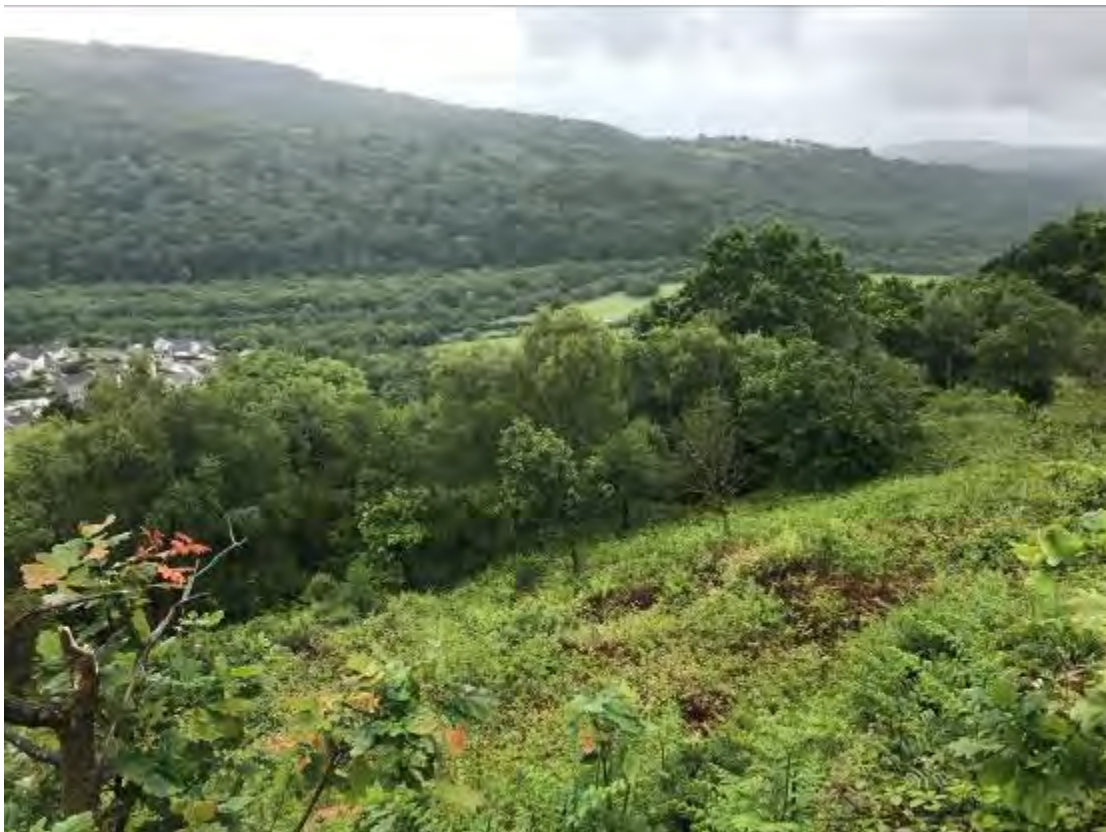
The inspection route then accessed the area encompassed by Site 2, crossing a derelict fence-line and heading east across an area of dense fern and bramble vegetation with a sporadic cover of trees. The density of vegetation prevented close inspection of materials or topography and access was extremely difficult (photographs 22, 24 and 25).

**Photograph 22 – General view of Site 2 showing dense vegetation coverage**

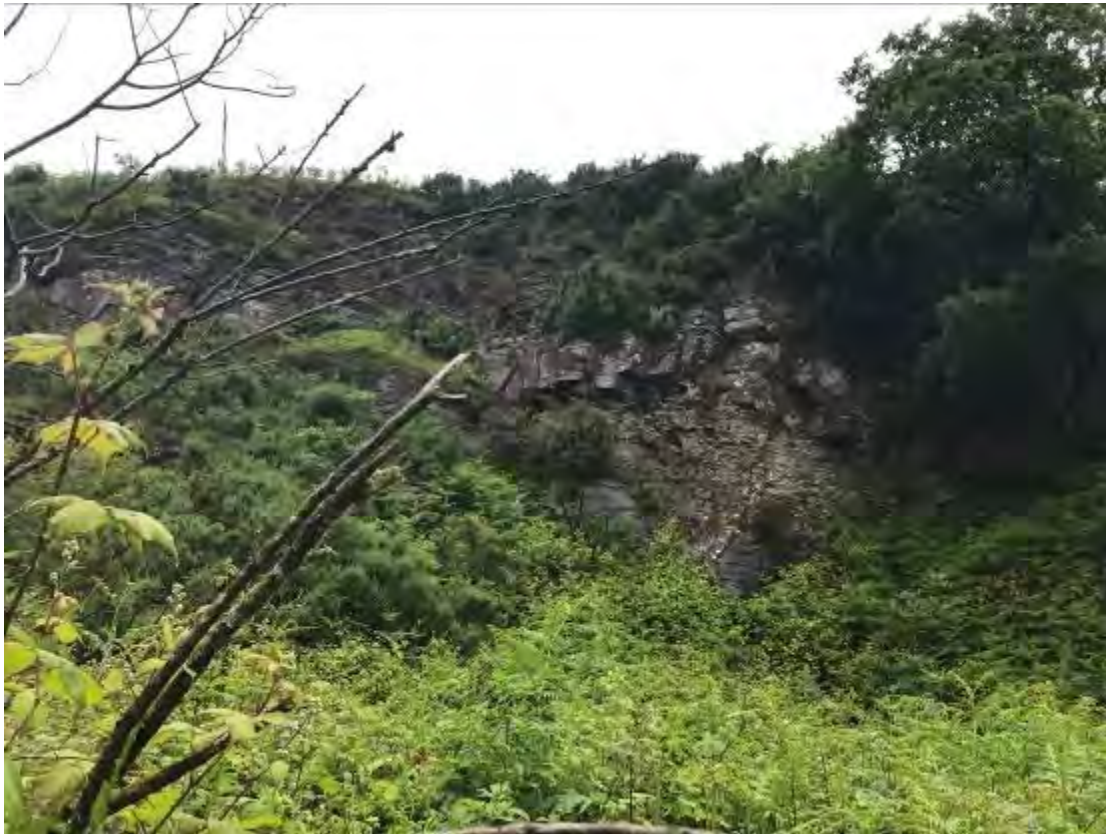
**Photograph 23 – Quarry face above Site 2**

At the northern boundary of the site, the overgrown remains of a former access track, presumably leading to the un-named quarry, appeared to be present (photograph 23).

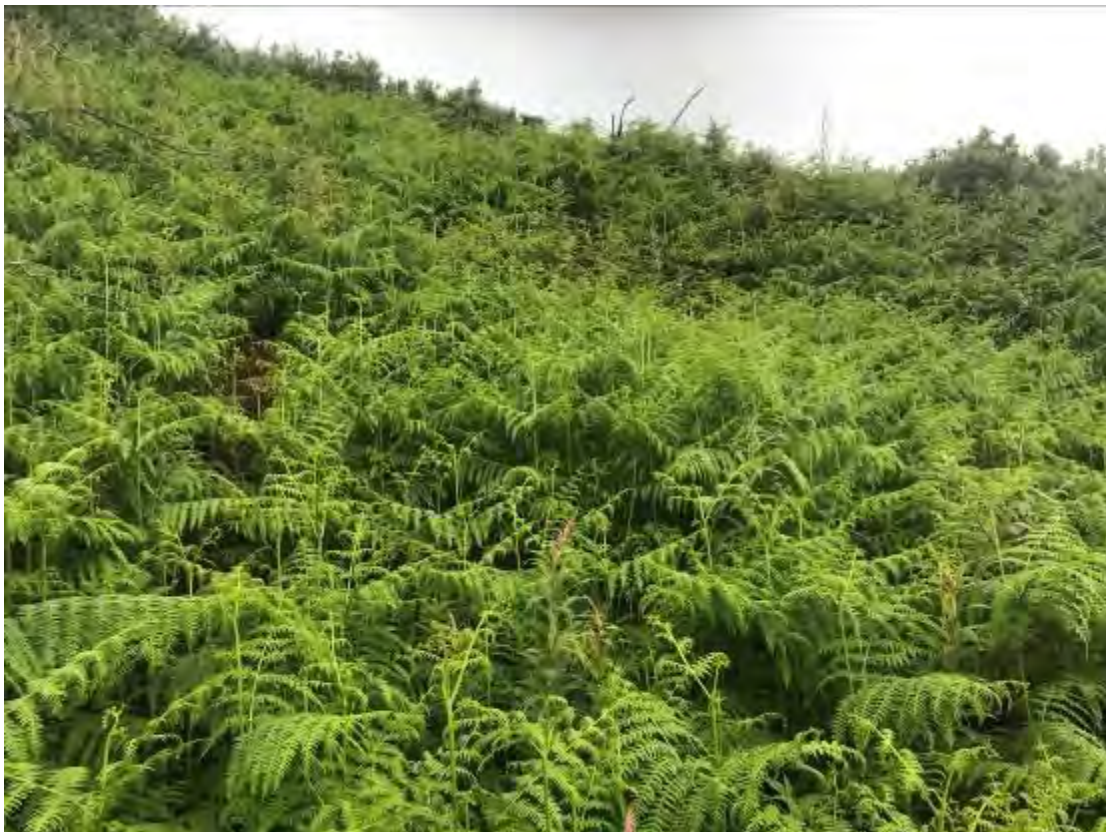
**Photograph 24 – Mid point of Site 2 showing dense undergrowth**

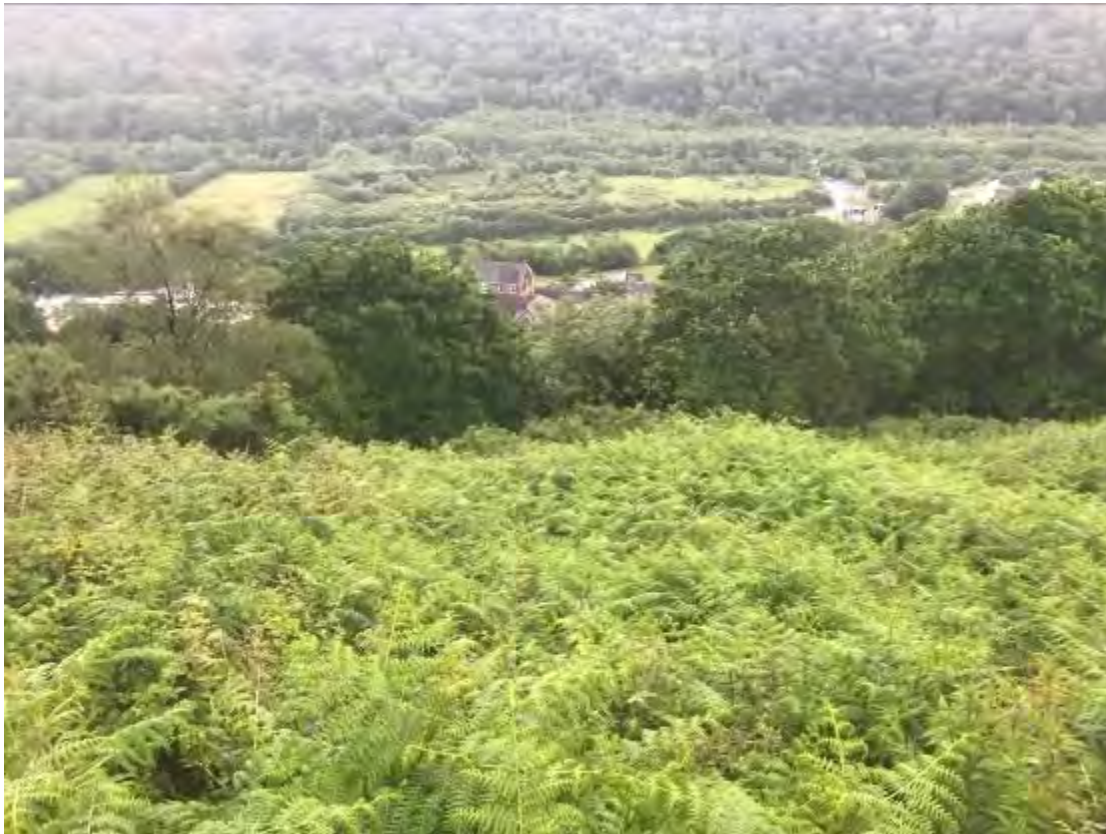
The inspection route then turned north east and viewed the series of recorded mine adits above Site 3, the entrances to which appeared to have collapsed many years ago. The colliery tips associated with these mine entries comprised a liner low mound of spoil forming a ridgeline at the head of Site 3 (photographs 26 to 28).

**Photograph 26 – View of Site 3 from toe**

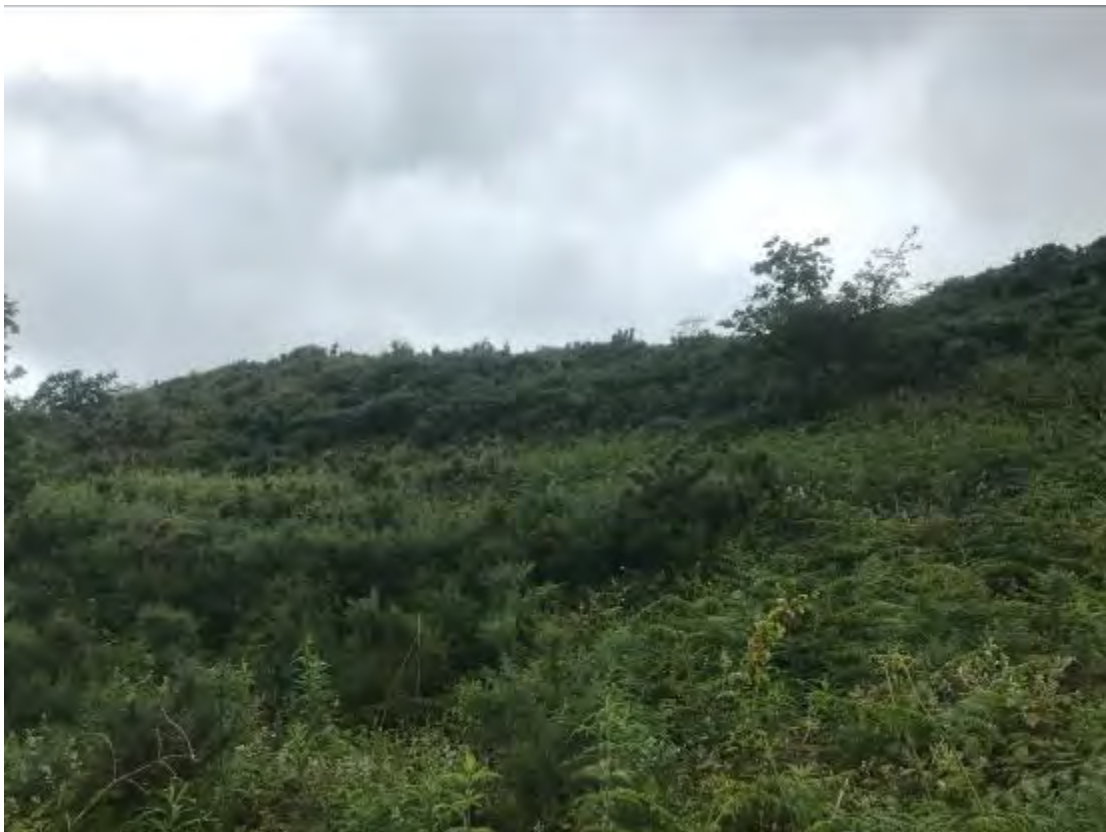
**Photograph 27 – View of Site 3 from toe**

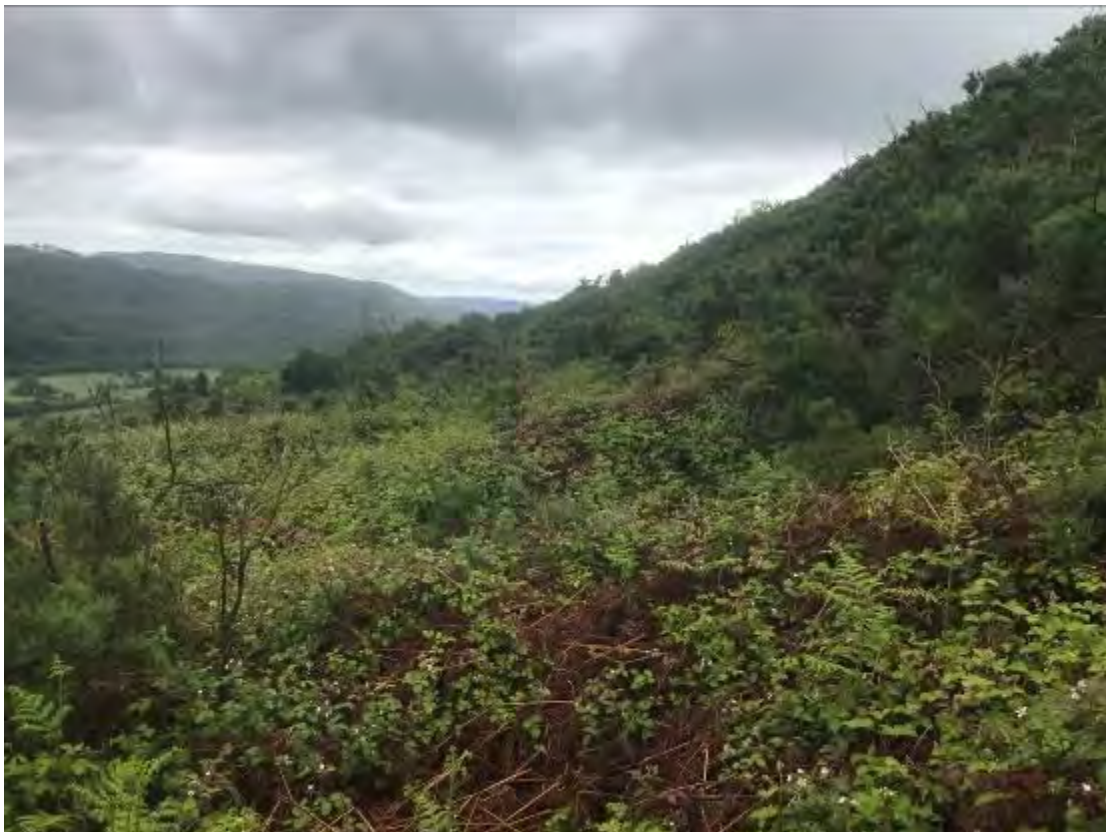
The watercourse disappeared and reappeared at several locations, probably through the coarse quarry spoil present, appearing again as a spring type feature at NGR 275067E 206915N (photograph 29). The watercourse then flowed in an unlined channel to enter a screened chamber at NGR 275135E 206891N (photograph 30), before entering a final chamber to the rear of Godre'r Graig Primary School at NGR 275157E 206892N (photograph 36). The watercourse then appeared to be culverted beneath the school.

**Photograph 29 – Moderate seepage at SW section of Site 2**

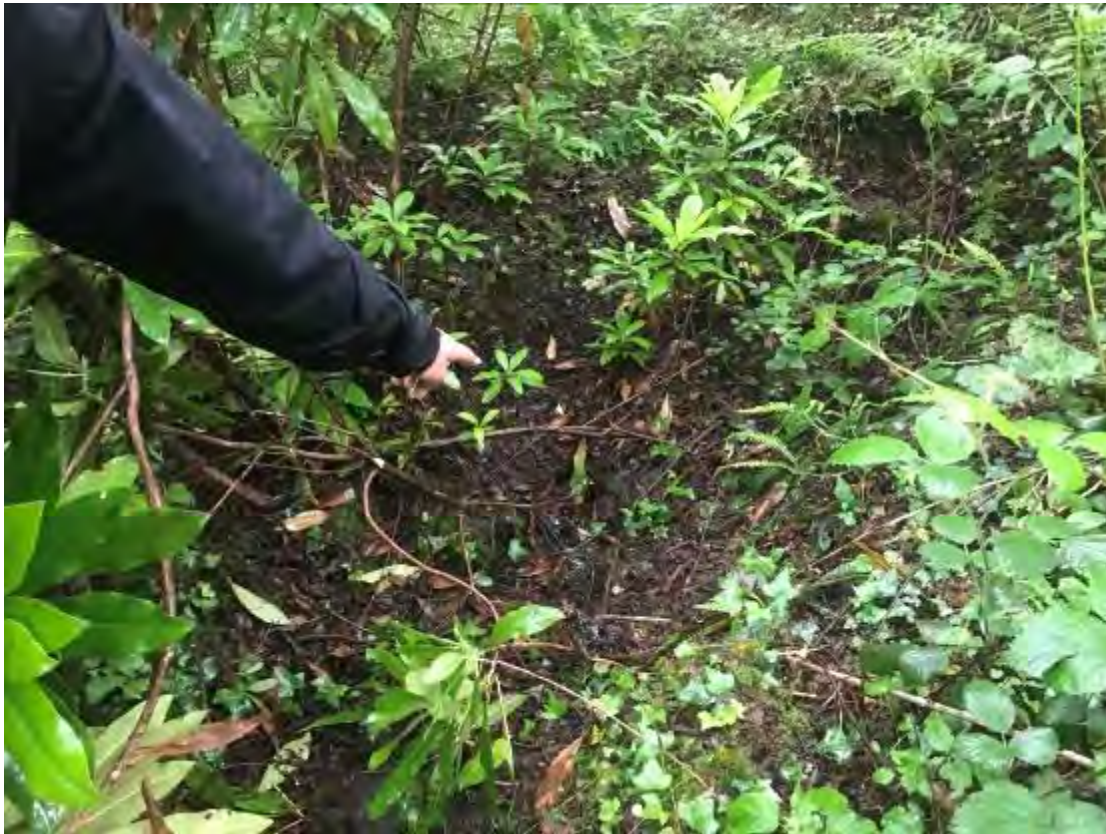
**Photograph 30 – Inlet chamber to rear of school**

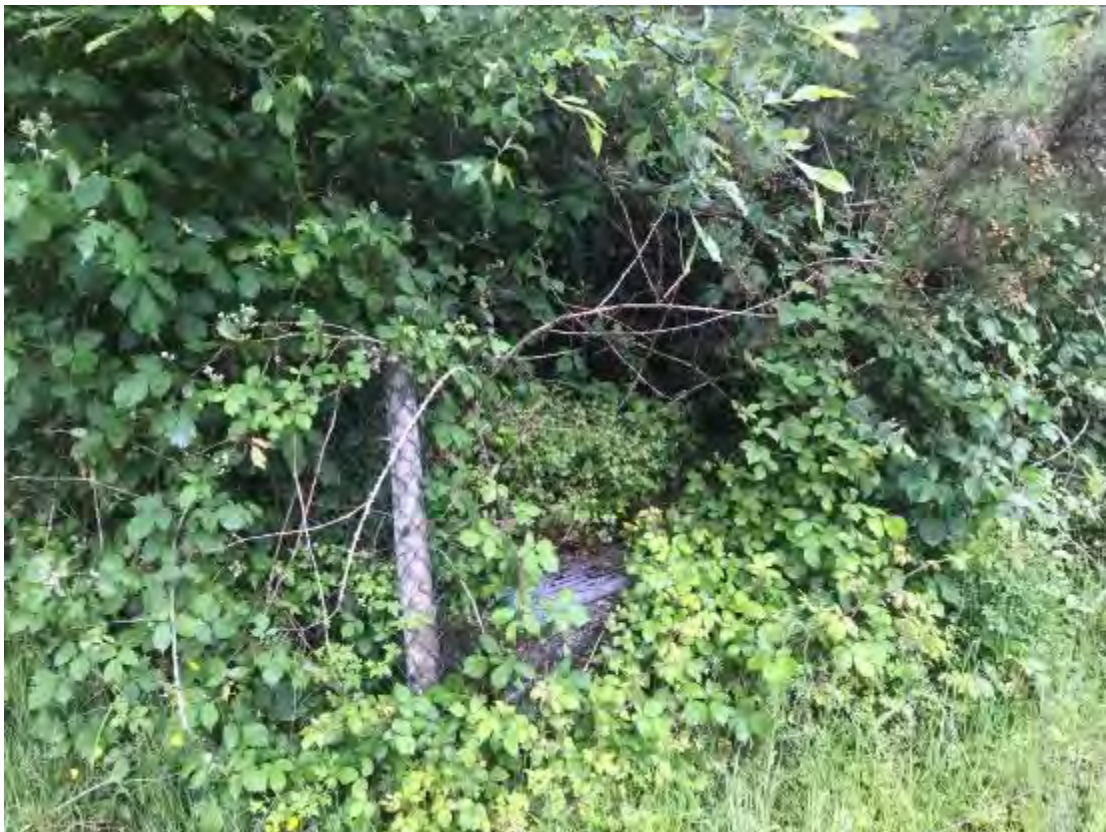
**Photograph 31 – Field to rear of school**
