## Godre'r Graig Primary School, Godre'r Graig Preliminary Landslide Hazard and Risk Assessment

Report Reference: ESP.7234e.3221

## Godre'r Graig Primary School Preliminary Landslide Hazard and Risk Assessment

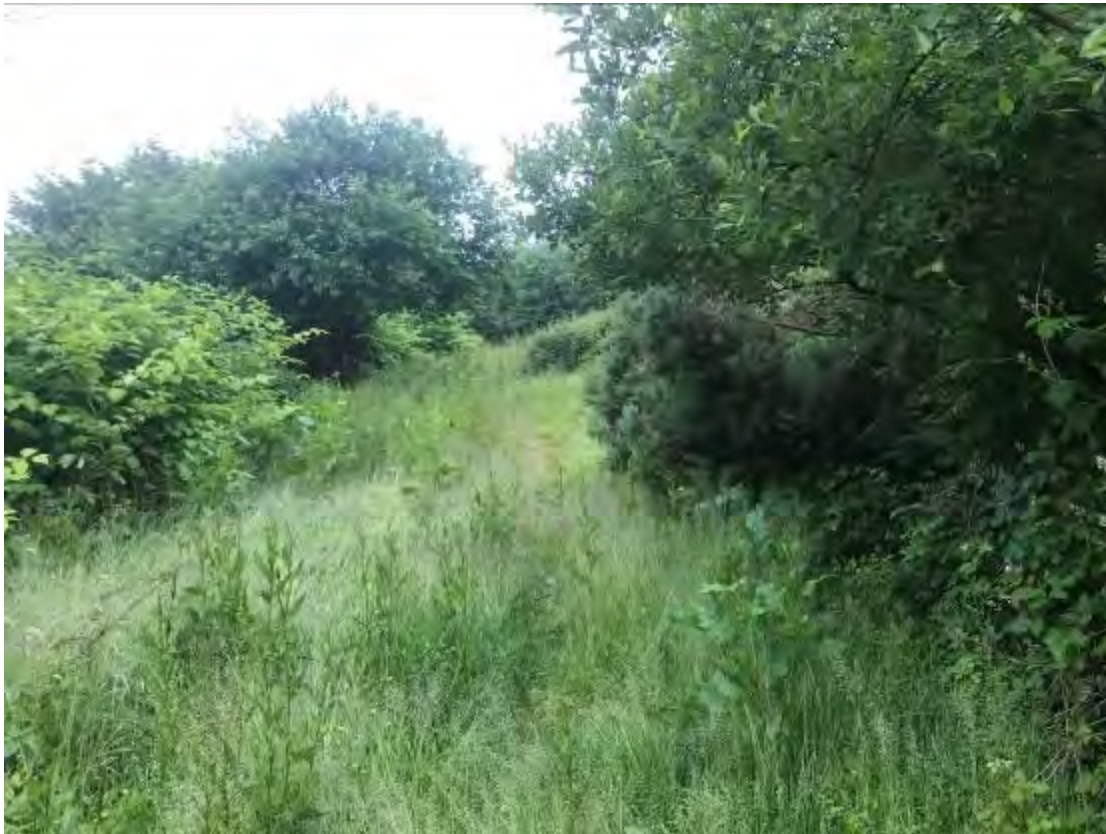
A derelict stable and several stands of Japanese Knotweed were observed present in this area (photographs 32 to 34).

**Photograph 32 – Field to rear of school showing Japanese Knotweed**

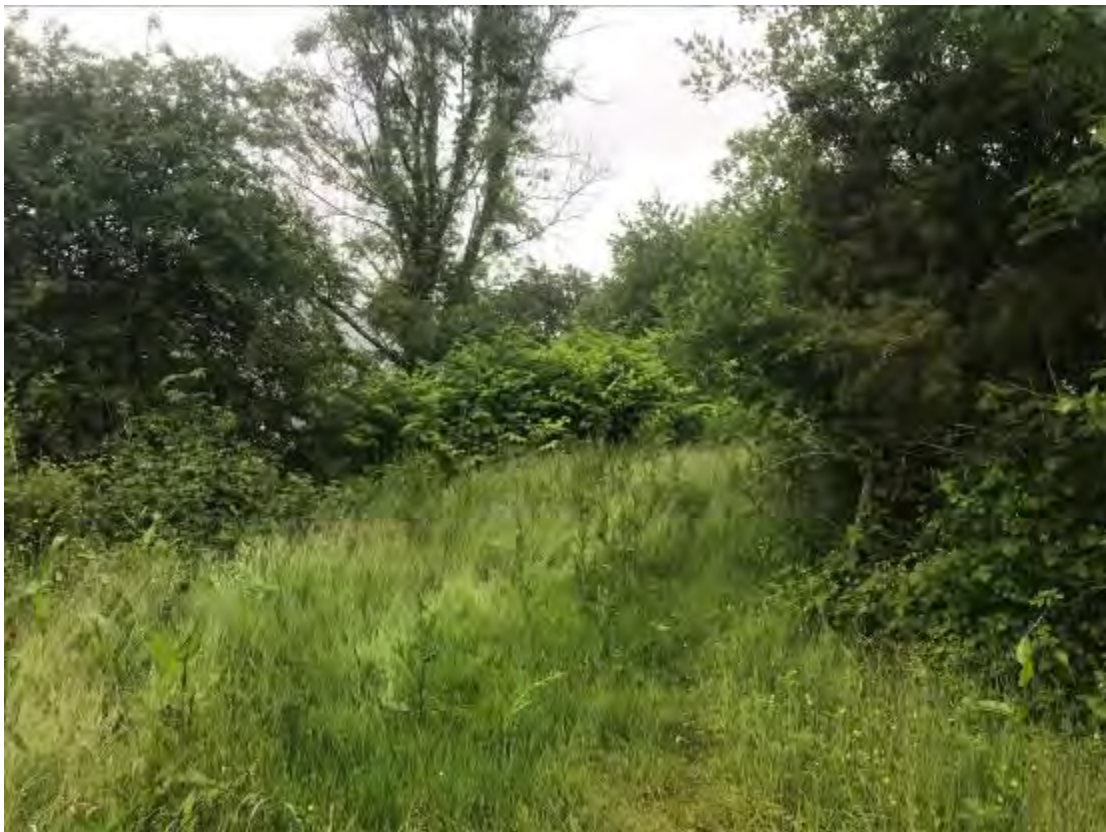
The inspection route traversed the slope behind Godre'r Graig Primary School, viewing the route of the watercourse referenced above and the drainage chambers to the rear of the school. A stone filled cut off drain with several manhole chambers was observed in the grazing field to the rear of the school, along with a spring located at approximate NGR 275164E 206992N. Flows from the spring were captured by the stone cut off drain (photographs 33, 35 and 37).

**Photograph 33 – Stone filled cut off drain to rear of school**
