Site Inspection Report

Pen y Graig Arw Quarry, Ystalyfera

Client: Neath Port Talbot County Borough Council

Date: November 2017

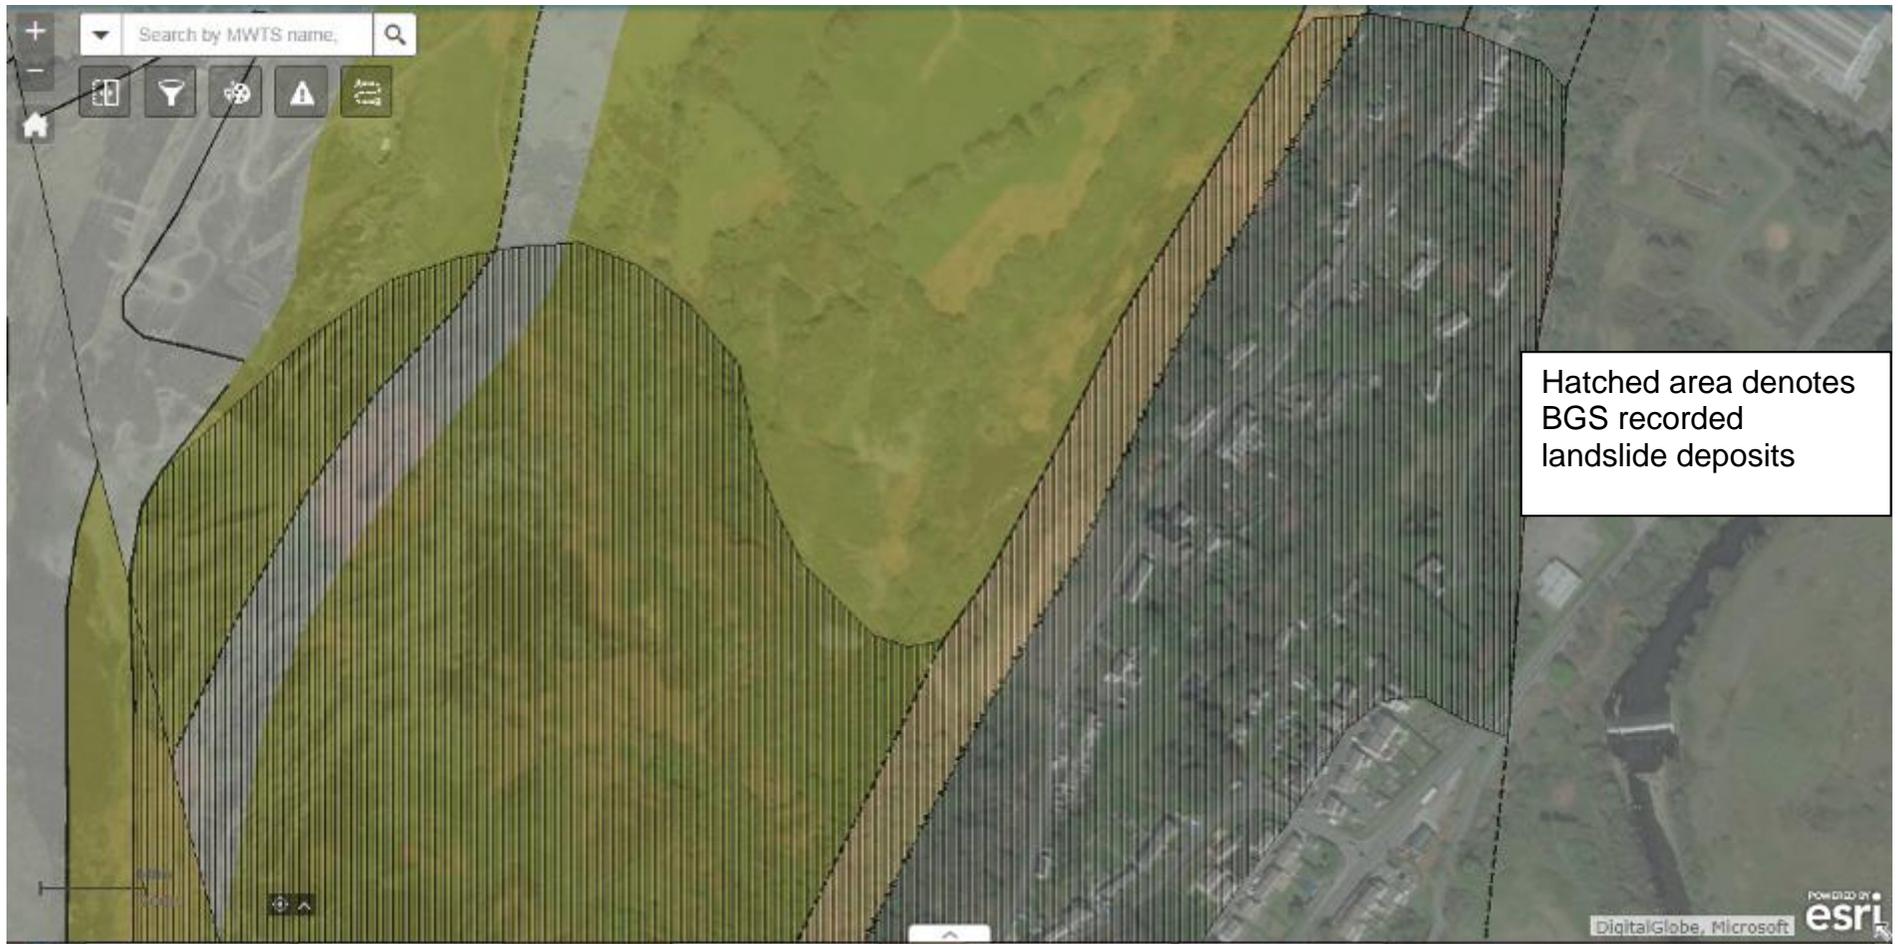
Figure 5 – Geological Plan

Inspection of the British Geological Survey sheet (Figure 5) for the area indicates the strata at the site to comprise Llynfi Beds sandstones with interbedded siltstones, dipping south at relatively shallow angles. The stratigraphic boundary of this sandstone unit is identified on the geological plan as being approximately at the base

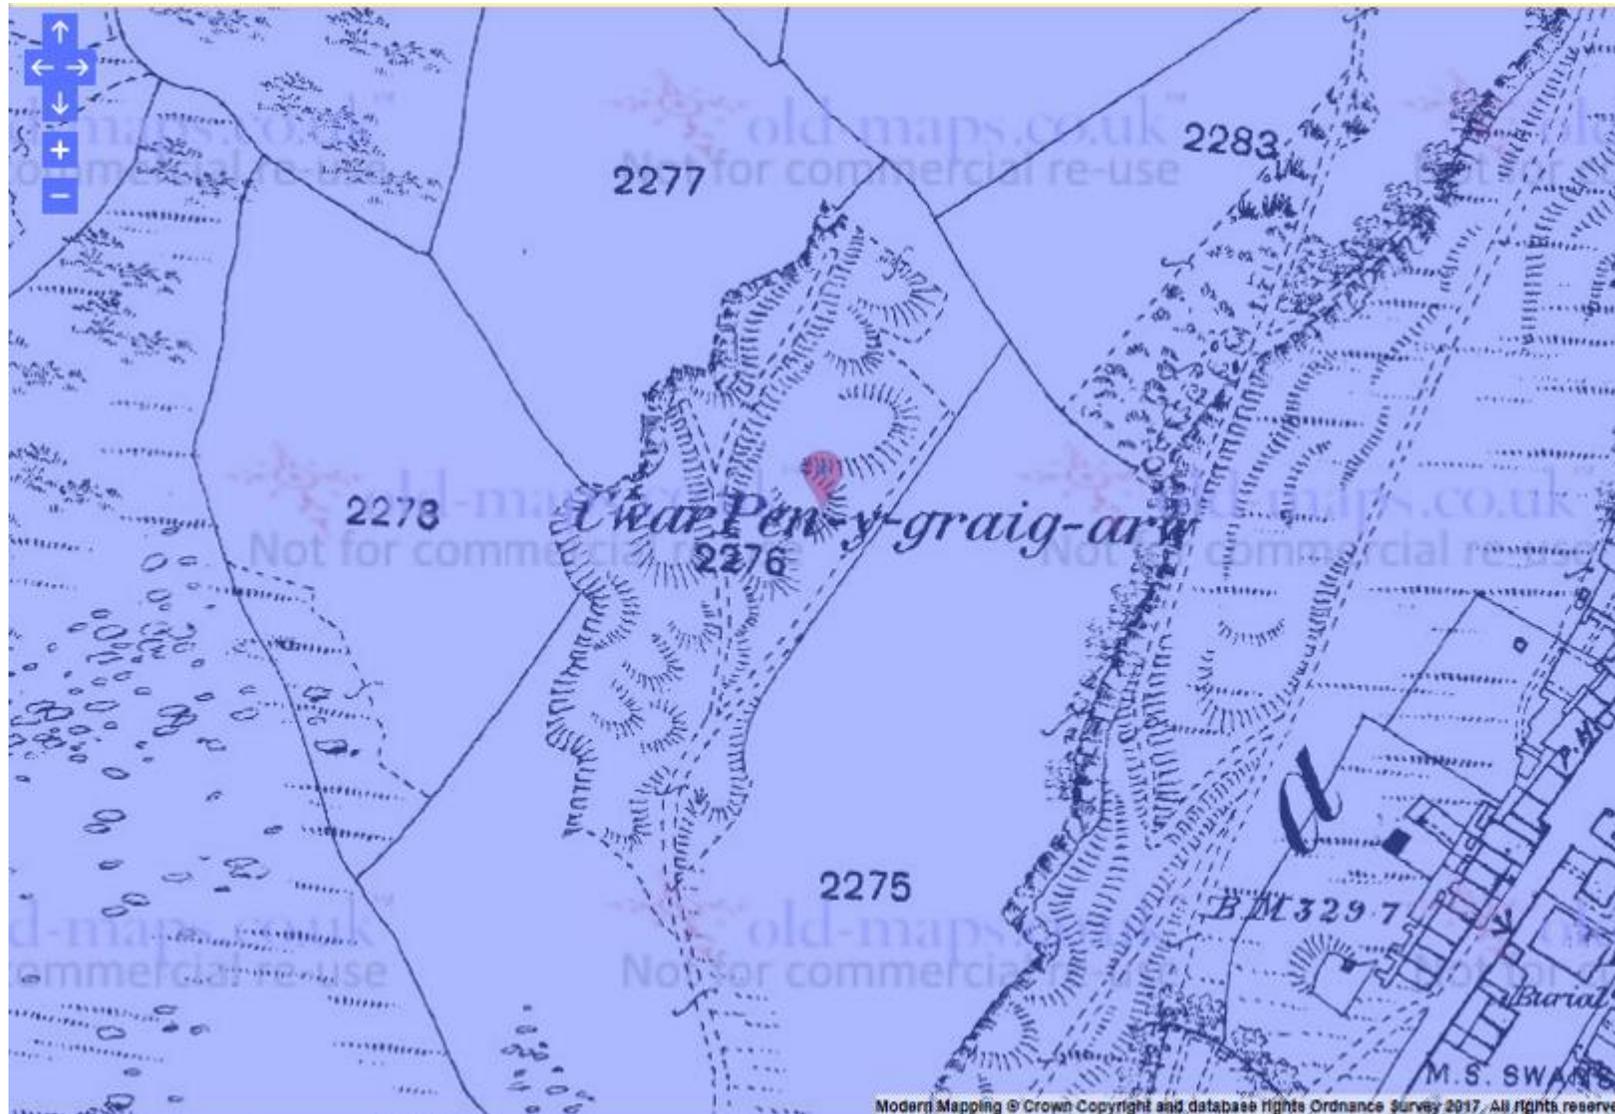
Figure 6 – 1877 Ordnance Survey (www.old-maps.co.uk)

Inspection of historic Ordnance Survey plans dating from 1877 to present indicates the quarry to have developed from some time prior to 1877, being noted as 'disused' by 1961. The historic plans show the site to have developed to its current position by the early 19th Century, with very little obvious changes since.
