**The Coal
Authority**

Site Inspection Report

Pen y Graig Arw Quarry, Ystalyfera

Date: May 2018

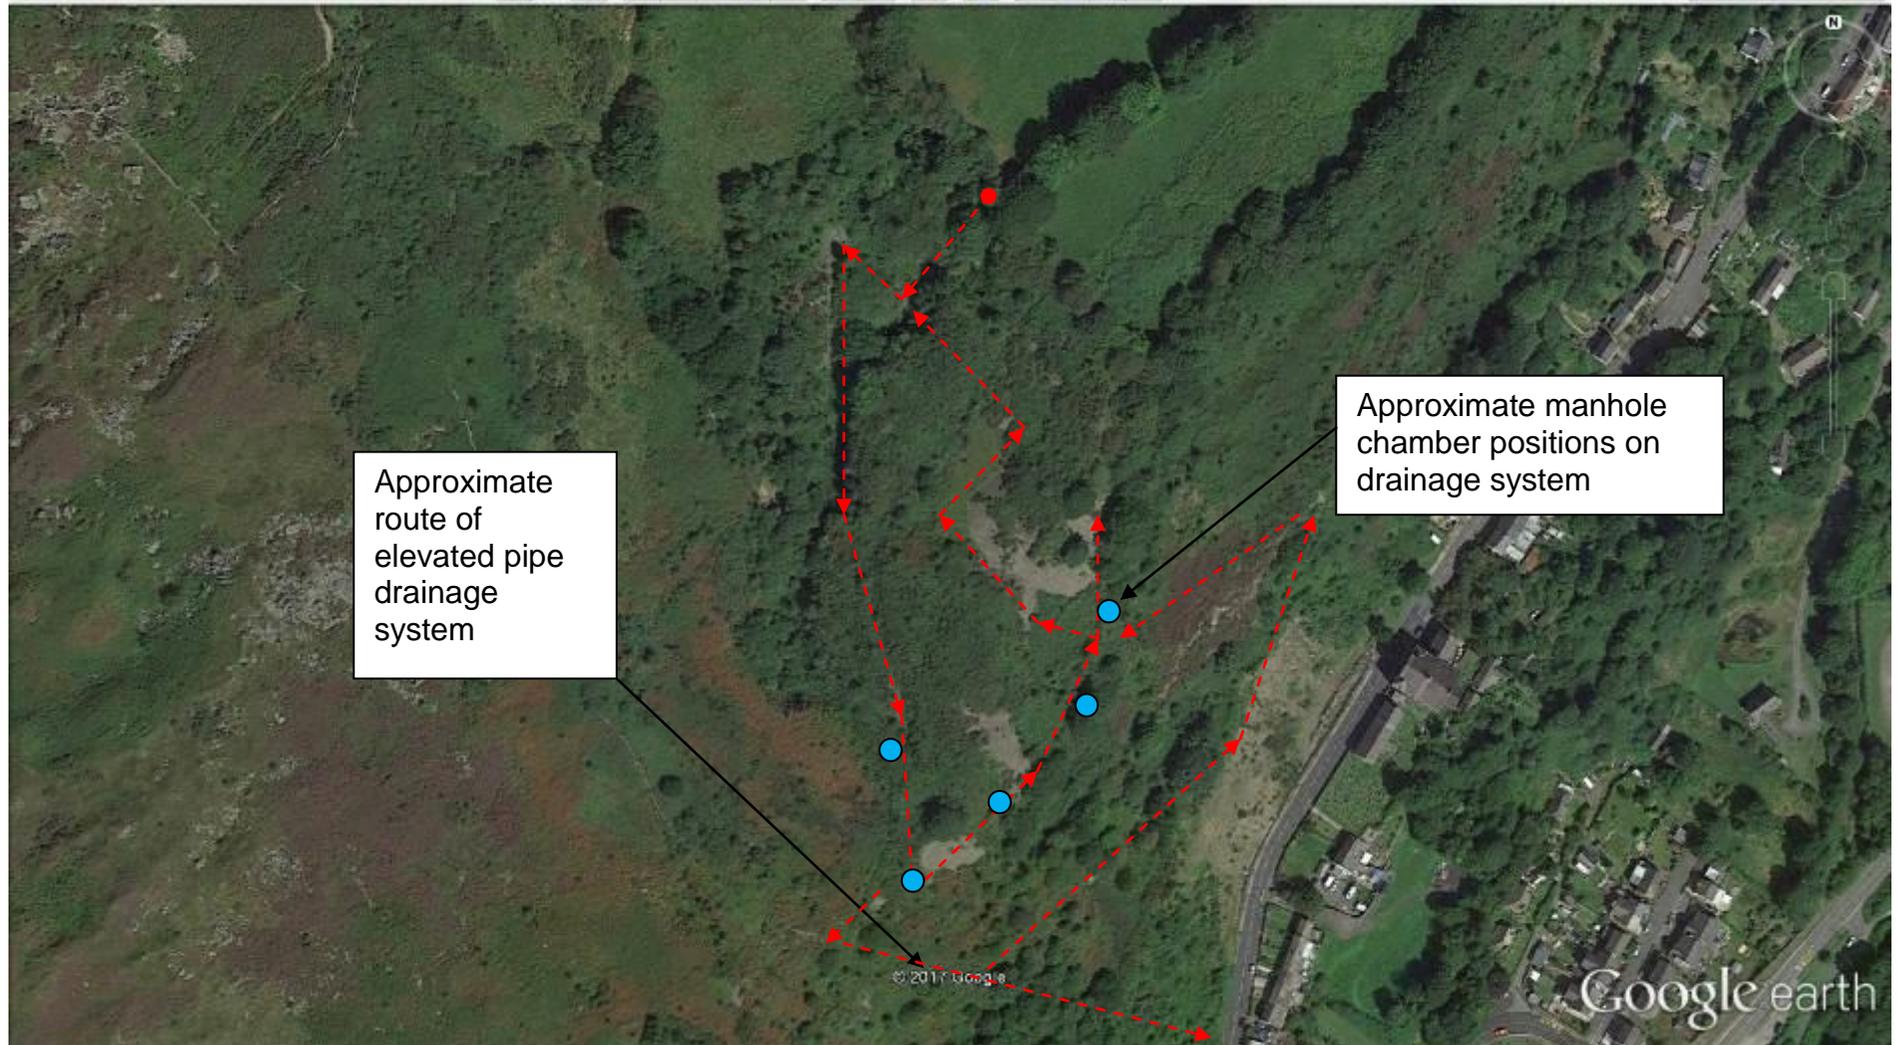
Figure 10 – Inspection Route and Key Locations

A drainage system comprising a series of manhole chambers and pipes (both above and below ground) is located at the approximate locations shown on Figure 10. This system is understood to have been installed during the 1950's / 1960's and is recorded in previous reports as the 'Penygraig System'. The drainage system is understood to collect surface water flows from the quarry area and also to convey minewater from recorded mine adits within the area.

Inspection on the 8th May 2018 began at the north-eastern boundary of the site, within the quarry floor, at the foot of the high wall. The inspection then took an anti-clockwise route through and around the quarry, followed by an inspection of the various spoil mounds and drainage features present. The approximate route is shown on Figure 10.

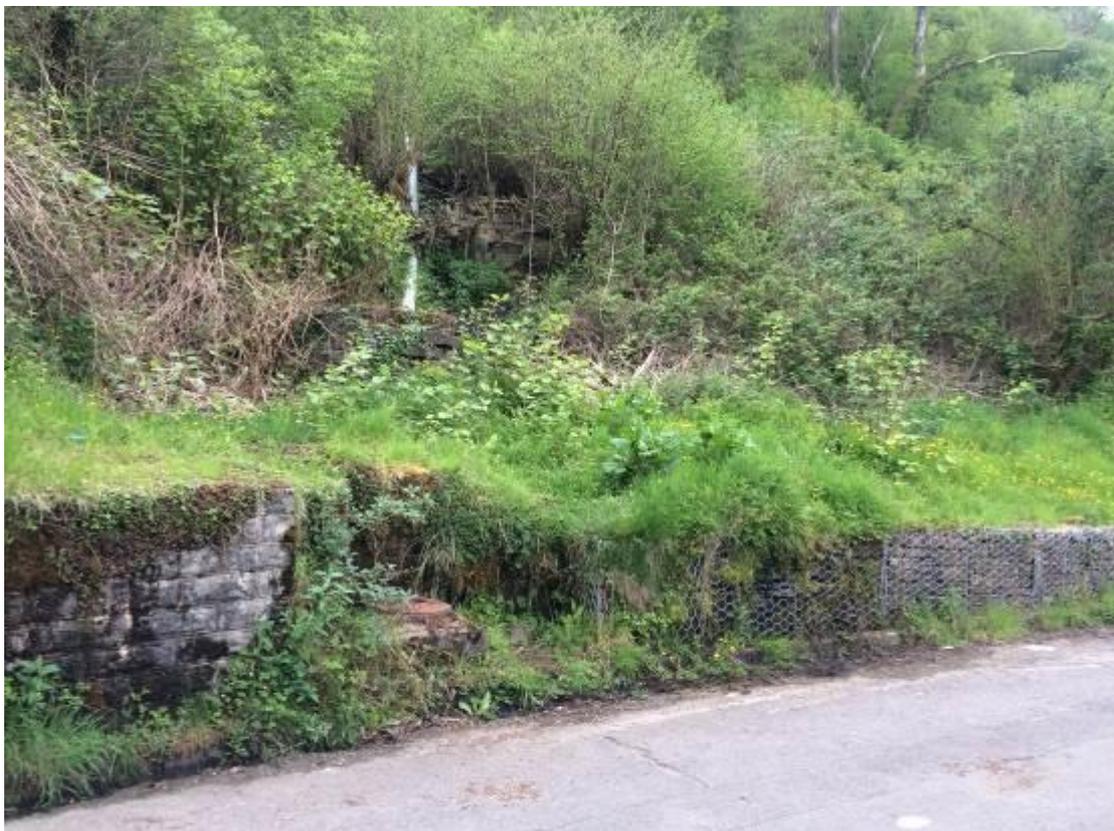
On leaving site, it was noted that a new gabion basket wall has been constructed at the carriageway edge at the toe of the most recent Panteg landslide (Photograph 35).

Photograph 35 – New gabion basket wall at toe of Panteg landslide
