# Investigation Report into Flooding Incident of 3rd September 2016 Varteg Road, Ystalyfera

Highways and Drainage Services  
Environment Directorate  
Neath Port Talbot County Borough Council  
The Quays  
Brunel Way  
Briton Ferry  
Neath  
SA11 2GG

Version	Prepared by	Reviewed by	Approved by	Date
Rev 1	James Davies (Drainage Officer)	Steve Owen (Highways and Drainage Manager)	Mike Roberts (Head of Streetcare)	February 2017

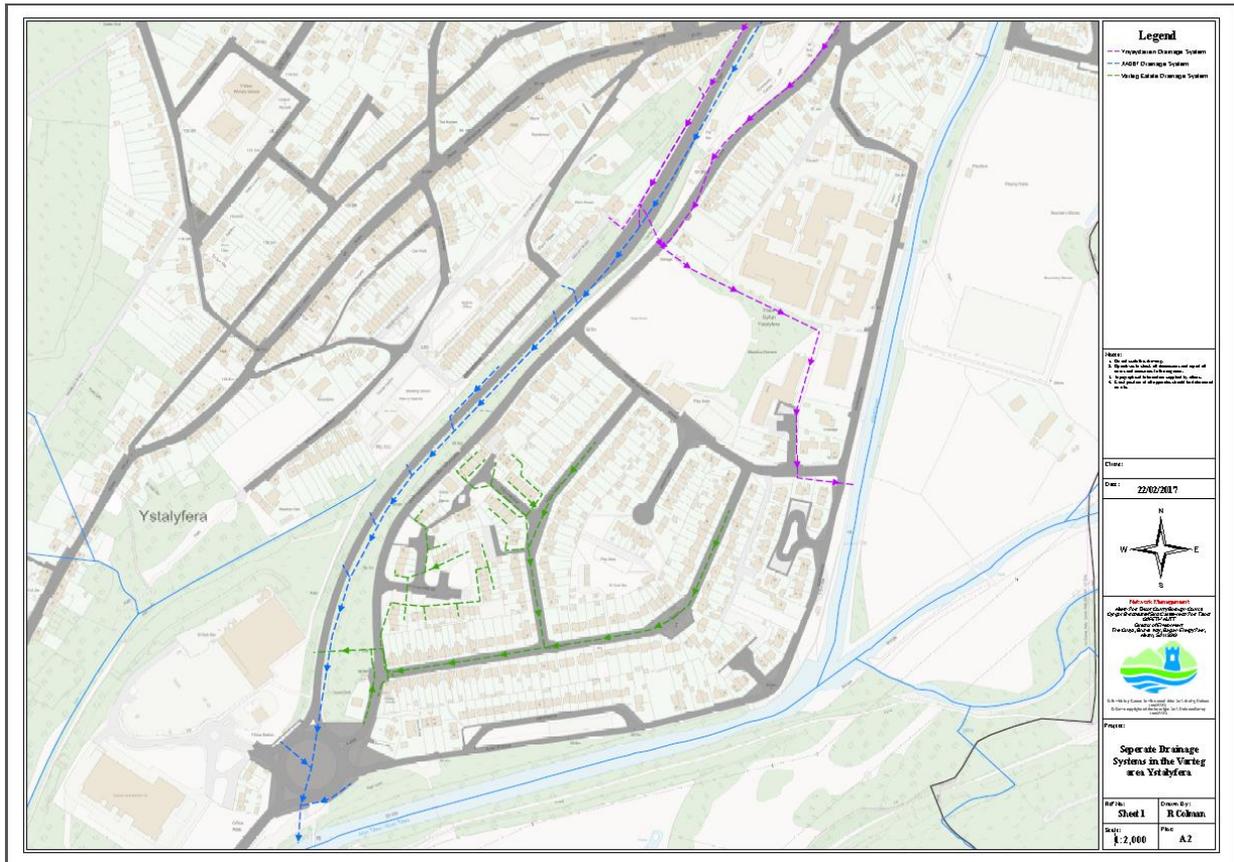
Figure 4, Map identifying the drainage infrastructure relevant to the flooding at Varteg Road

Figure 4 identifies three separate surface water and land drainage networks in the vicinity of the flooding incident, as identified in the legend.

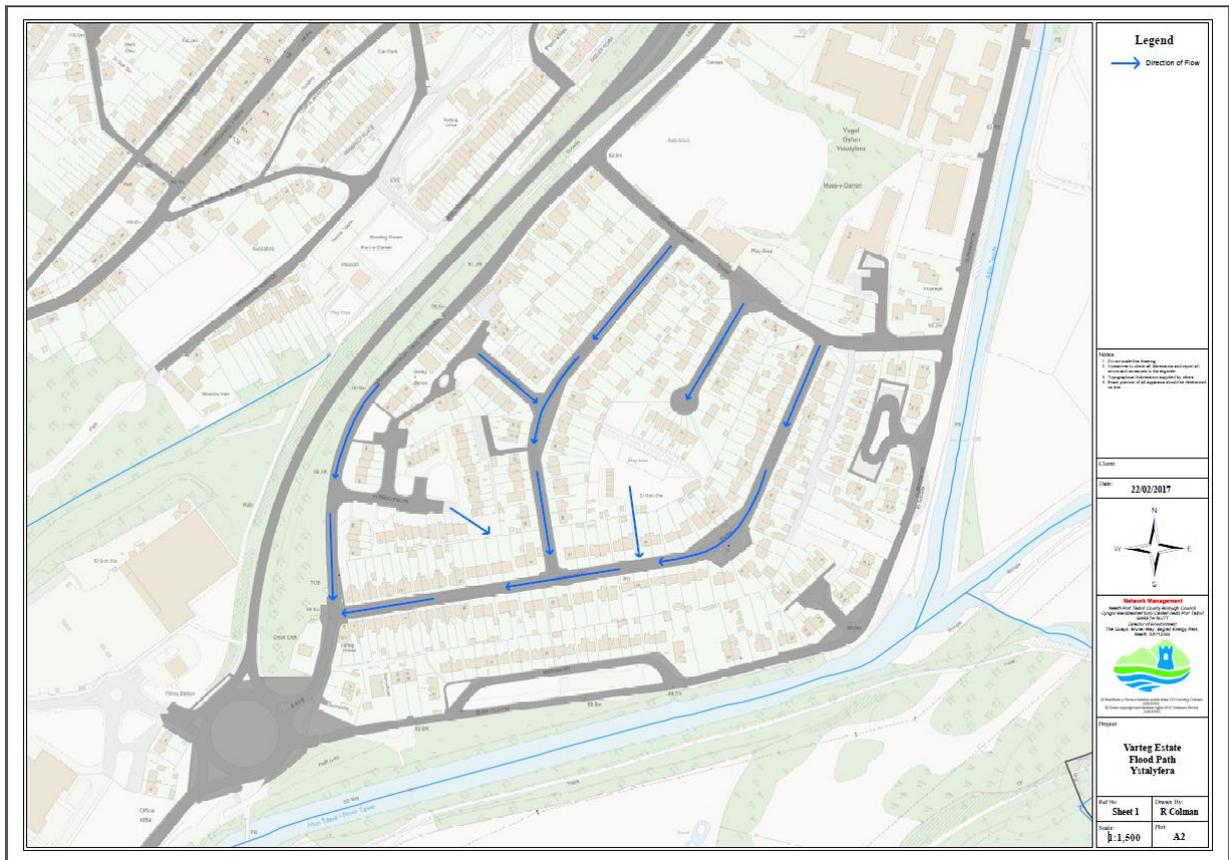
Figure 5, map showing the flow route of water through the Varteg Estate

The surface water drainage network in the area is extensive, conveying highway, private residential roof and yard water run-off as well as public surface water to a single point before discharging into a 1.2m diameter culvert which runs under the A4067. (See general flow paths within the estate shown in

Figure 5).
