# Investigation Report into Flooding Incident of 3<sup>rd</sup> November 2022 St Catherines Close, Melyn

Highways and Drainage Services  
Environment & Regeneration Directorate  
Neath Port Talbot County Borough Council

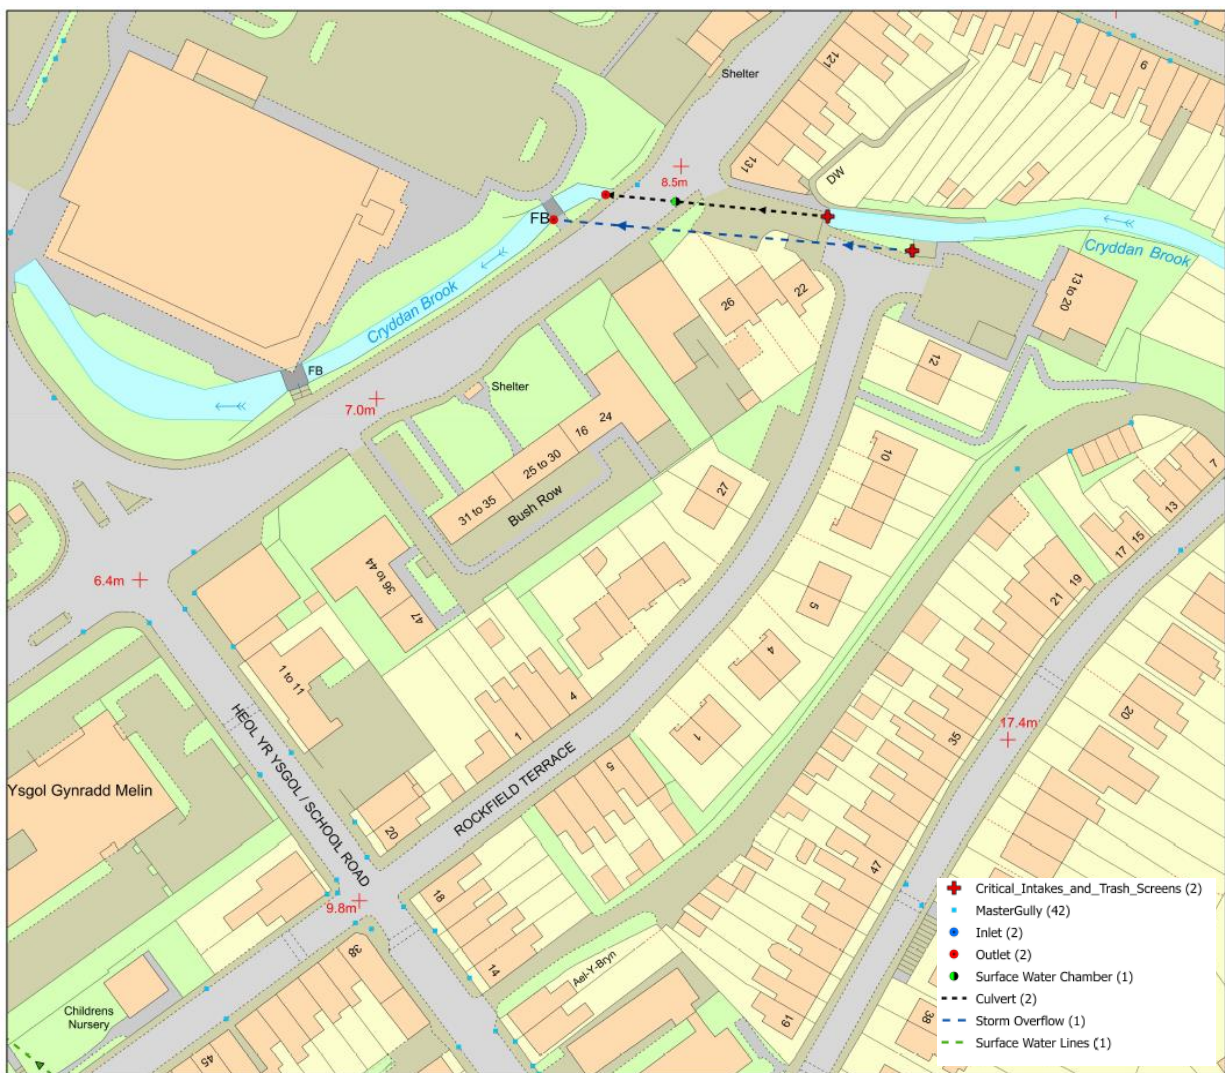
Figure 7 - Map identifying the surface water drainage infrastructure in the St Catherine's Close area.

Figures 7 and 8 identify surface water, land drainage and DCWW networks in the vicinity of the flooding incident, as identified in the corresponding legends.
