**The Coal  
Authority**

## **Site Inspection Report**

### **Pen y Graig Arw Quarry, Ystalyfera**

**Date: November 2017**

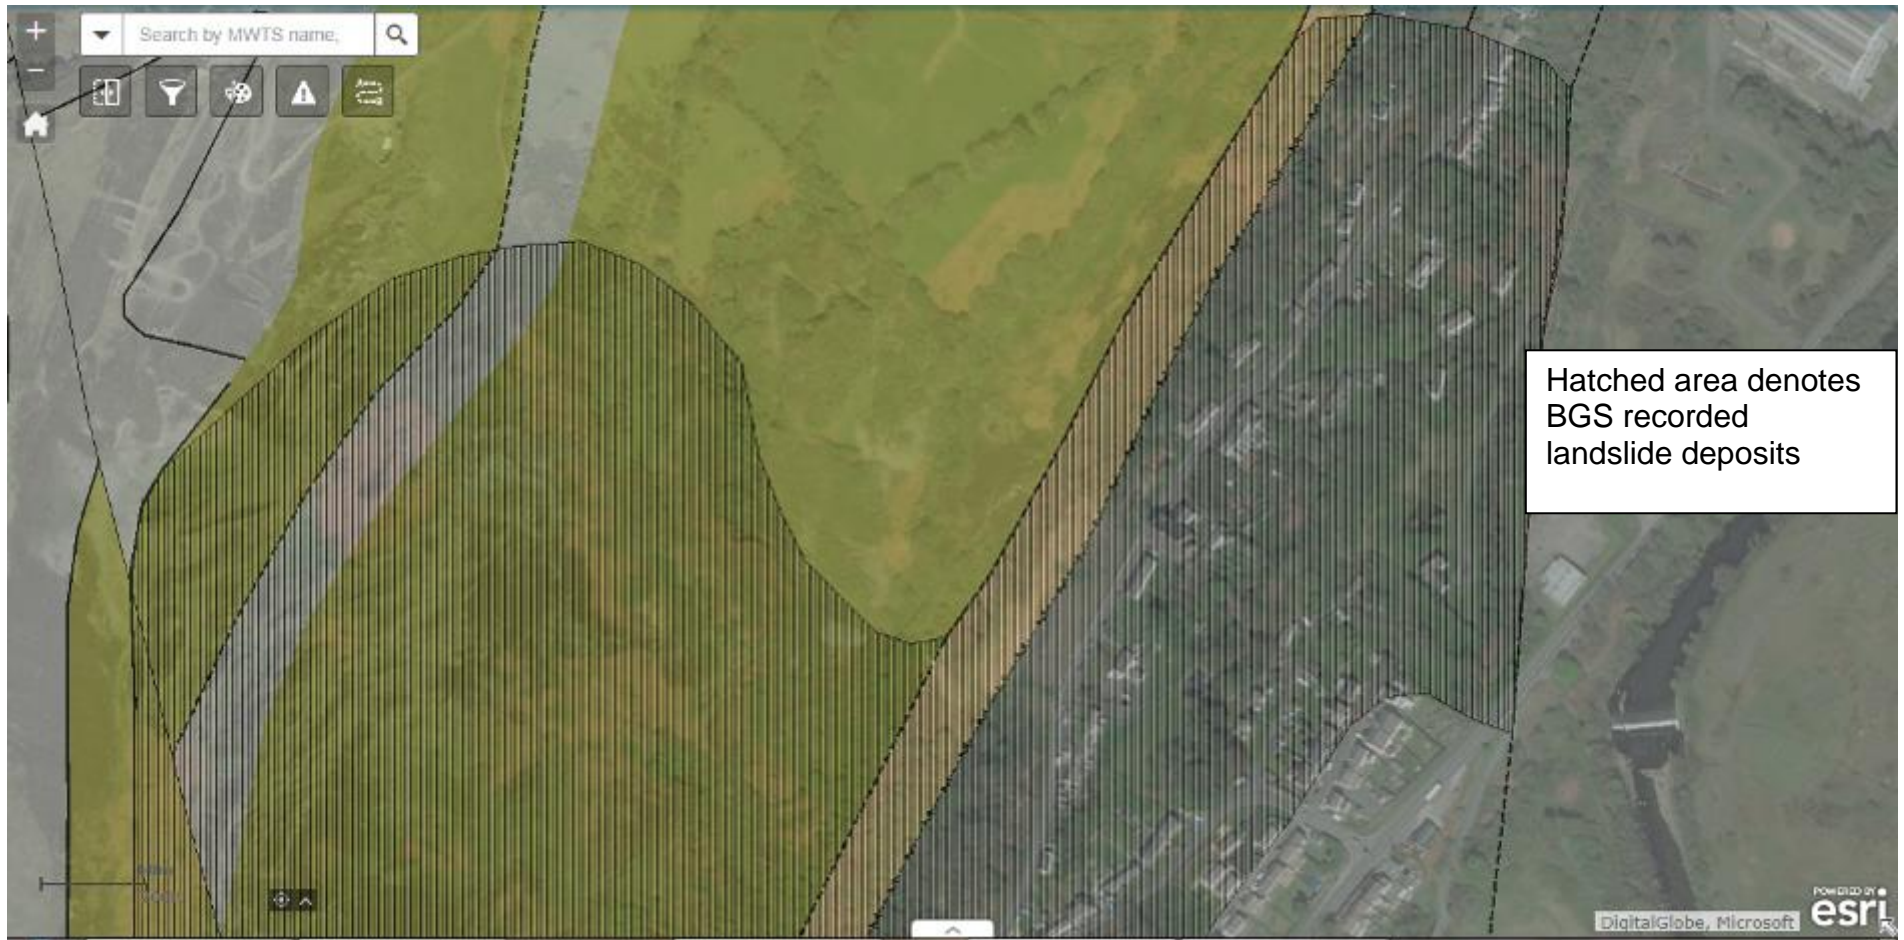
**Figure 5 – Geological Plan**

Inspection of the British Geological Survey sheet (Figure 5) for the area indicates the strata at the site to comprise Llynfi Beds sandstones with interbedded siltstones, dipping south at relatively shallow angles. The stratigraphic boundary of this sandstone unit is identified on the geological plan as being approximately at the base

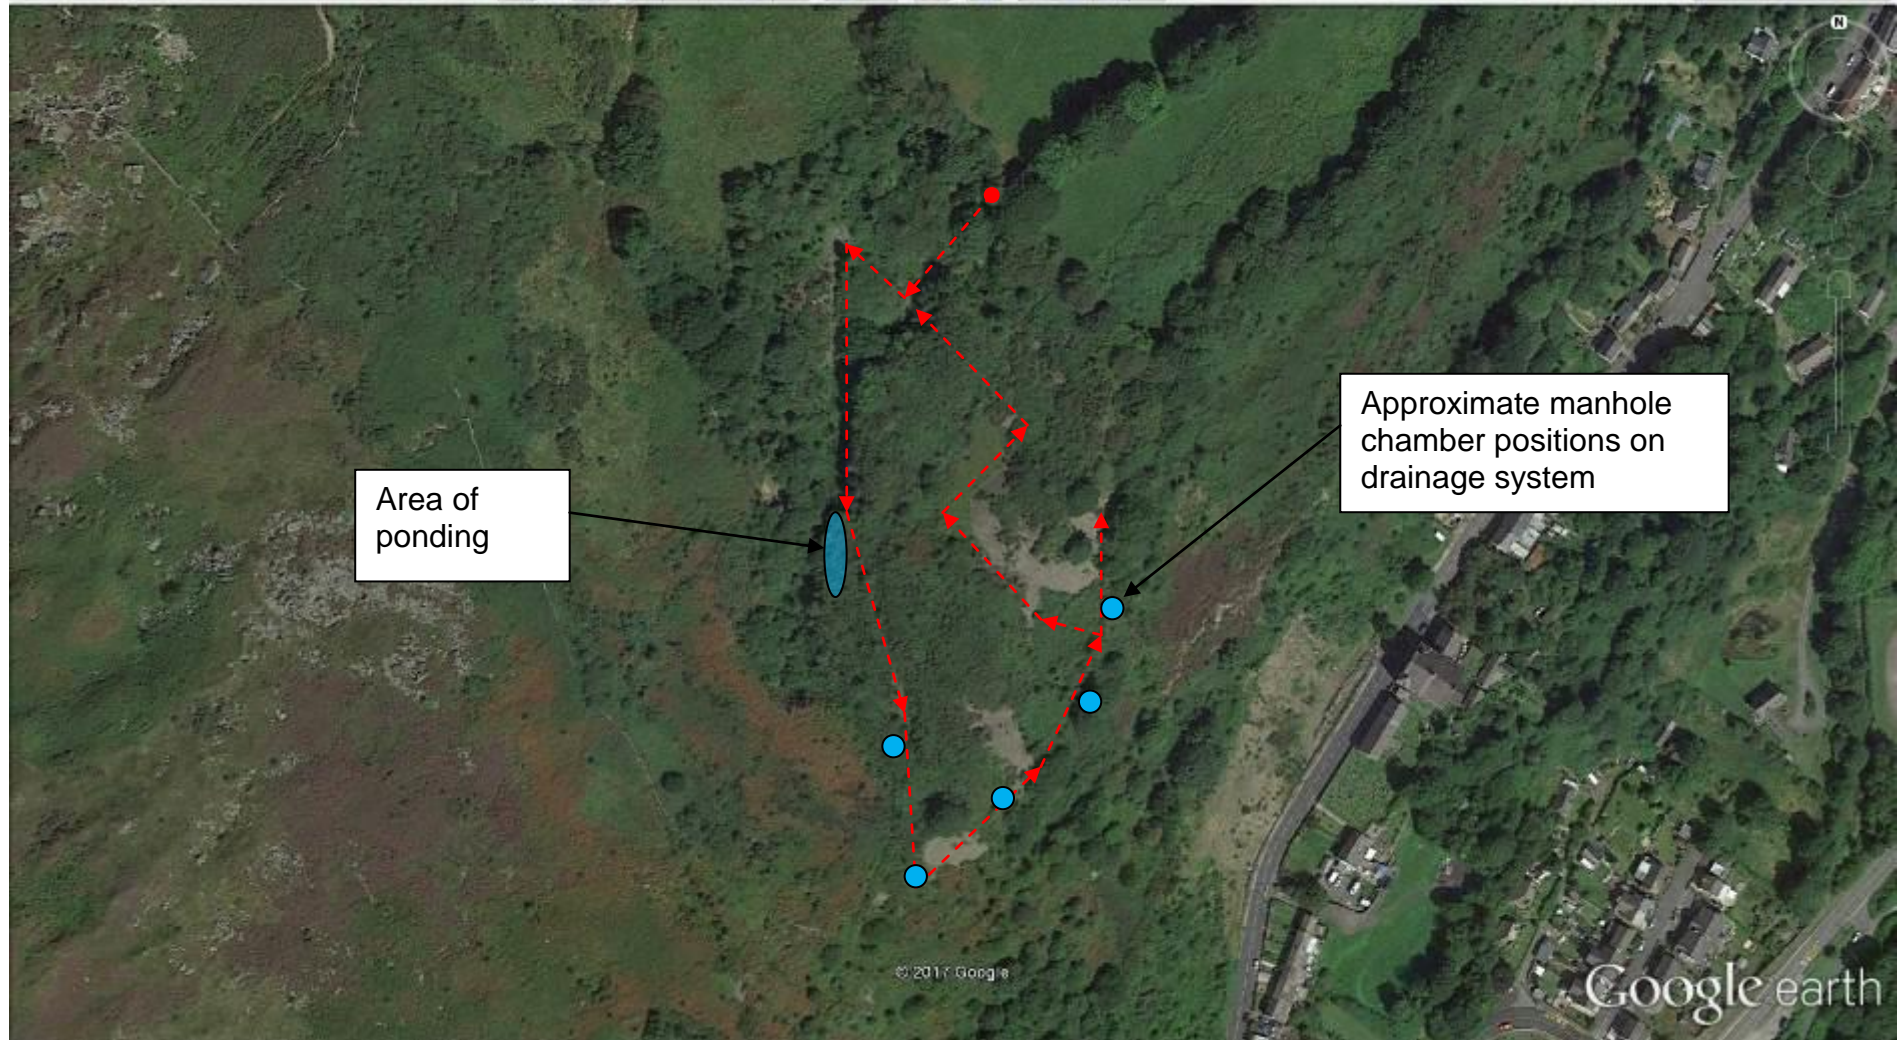
Figure 10 – Inspection Route and Key Locations

A drainage system comprising a series of manhole chambers and pipes (Photographs 13 to 18) is located at the approximate locations shown on Figure 10. This system is understood to have been installed during the 1950's / 1960's and is recorded in previous reports as the 'Penygraig System'. The drainage system is understood to collect surface water flows from the quarry area and also to convey minewater from recorded mine adits within the area.

Inspection on the 20<sup>th</sup> November 2017 began at the north-eastern boundary of the site, within the quarry floor, at the foot of the high wall. The inspection then took an anti-clockwise route through and around the quarry, followed by an inspection of the various spoil mounds present. The approximate route is shown on Figure 10.
