**NEATH PORT TALBOT LOCAL DEVELOPMENT PLAN EXAMINATION
Hearing Sessions**

Baglan Bay

Briefing Note on Geomorphological Study (Examination Document ED031)

Submitted on behalf of **St. Modwen Developments Limited (SMDL)**
by **Savills (Reference: 0042)** with the support of **Atkins**

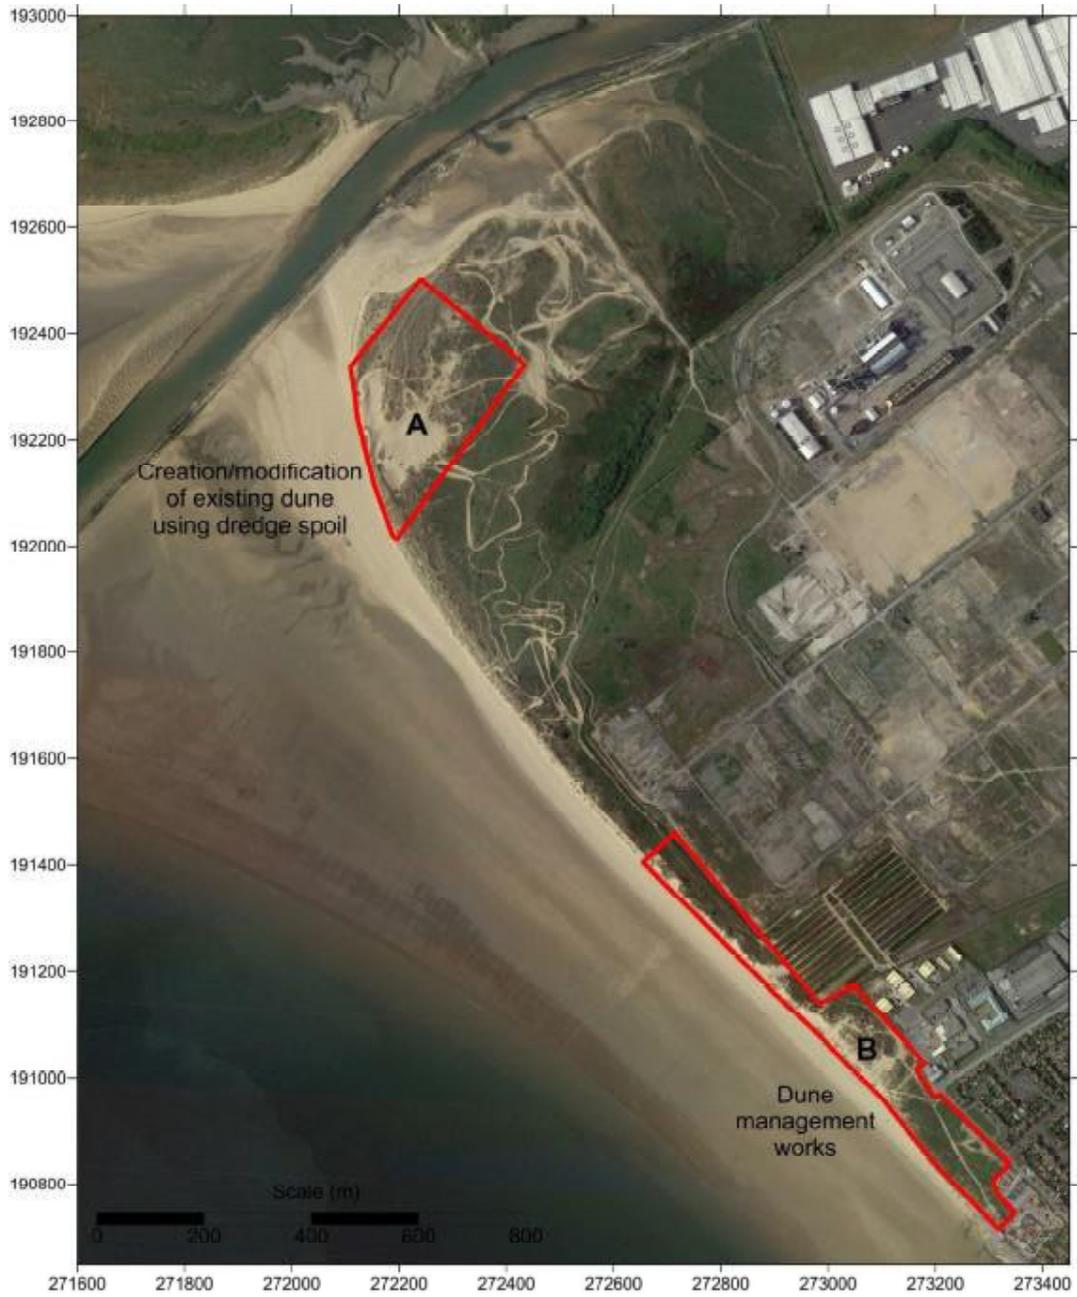
Appendix 2
Extract: Page 60 of Report

Figure 57. Proposed restoration and management works at Baglan Burrows, shown on aerial photograph flown in July 2013.

- 5. The six points above (i – vi), provide a useful basis to examine the implications of the Assessment for the EN1 designation.
- 6. Matters i and ii (dune composition and the need for management) raise two points. The first comes from the areas that the study recommends should be the focus of intervention. Two areas are identified and these are shown on pages 60 and 61 (page 60 is attached as **appendix 2** at the end of this report).

- 7. Area A is not of concern. Part of Area B sits alongside part of Baglan Bay. However:
 - a) Most of it lies alongside the ragworm/bait farm or the area to the south (beyond or outside the Baglan Bay area)

- b) The small part that does lie alongside Baglan Bay is west of the previously developed area (it includes the dunes not the cleared petrochemicals complex)

- c) It is much smaller and has no relationship to the extent of the EN1 area proposed in the LDP
- 8. The second point (on i and ii) comes from the measures proposed in these areas. The report describes these as:

In view of the above, there is a stronger case for further management intervention at Baglan Burrows than at Crymlyn Burrows. Two areas have been identified in this study as being suitable for further geomorphological engineering: (A) the north-western corner of the dune system near the east training wall (Figure 58), and (B) the frontal dune ridge and associated blowouts to the north and south of the Naval Social Club (Figure 59).

Within Area A there is the opportunity to encourage the development of one or more large parabolic dunes by continued strategic placement of dredged material from the Neath estuary; this could be a progressive process over the next 20 years. Within Area B there is a requirement for selective and environmentally sensitive control works to limit sand invasion into the industrial areas behind, and to prevent the further development of a shallow embayment in the shoreline where recreational pressure is most intense. The dunes at the northern end of Aberavon Sands and the southern end of Baglan Burrows have been experiencing slow erosion for many years. Past attempts to control the erosion and blowout enlargement have not been successful, and localised problems of sand incursion into industrial areas behind the main dune ridge remain. The short and longer-term preferred management policy for this coastal frontage is managed realignment, but it is recognised that intervention measures may be required to control local problems of visitor access, tidal flooding and sand incursion (Halcrow, 2010).

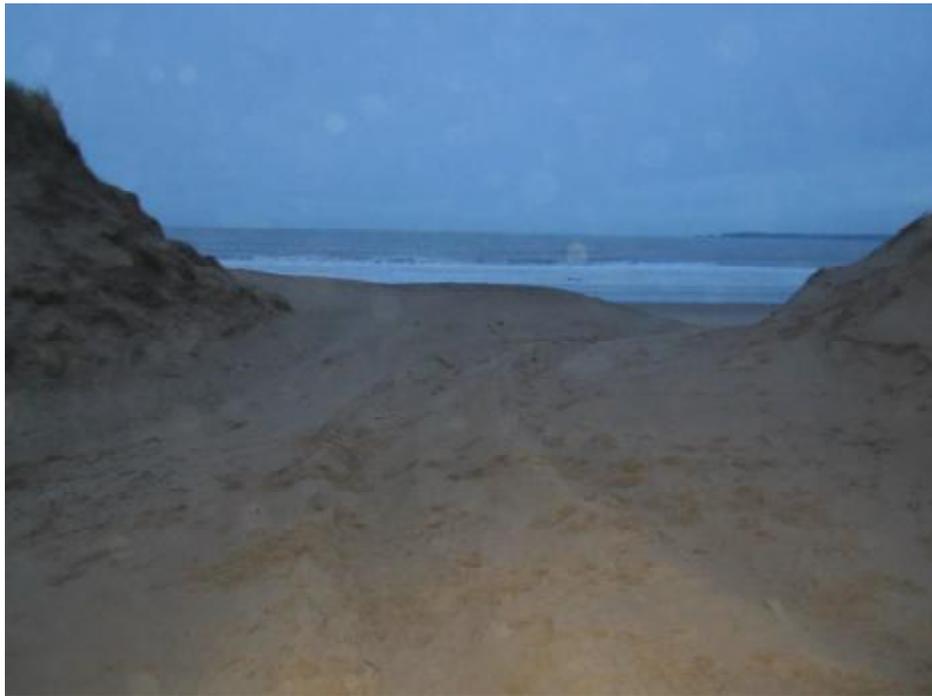
Photograph A1.21. Gap in frontal dune ridge opposite bait farm ponds which provides access for motocross bikes and vehicles

12. It is clear from the report that this is occurring only where there is a gap in the dunes which has been forced (or man-made) to allow access for motocross bikes and vehicles. The sand is simply blowing back through the gap in the frontal dunes and this is shown (and written) on page 73 of the report (see **appendix 3** to this note). It is this gap (and any gaps like it) that the intervention described in the report and summarised above is designed to tackle. This also takes care of point v above.

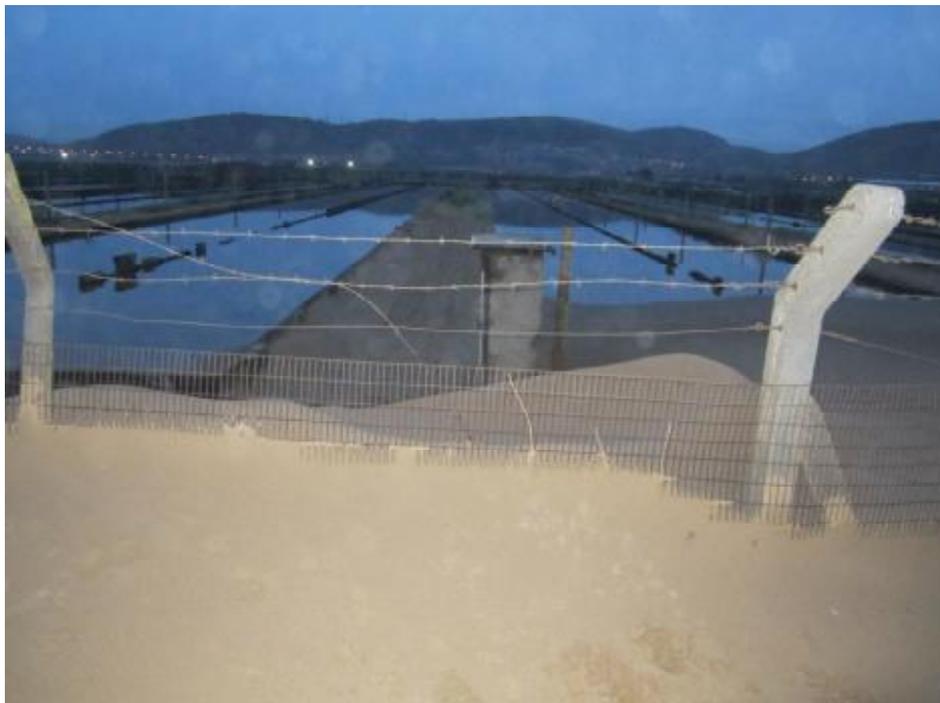
Photograph A1.22. blown sand incursion into bait farm ponds from gap in frontal dunes
