Godre'r Graig Village Executive Summary; Preliminary Landslide Hazard and Risk Assessment

Neath Port Talbot County Borough Council

Report Reference: ESP.7372e.3394

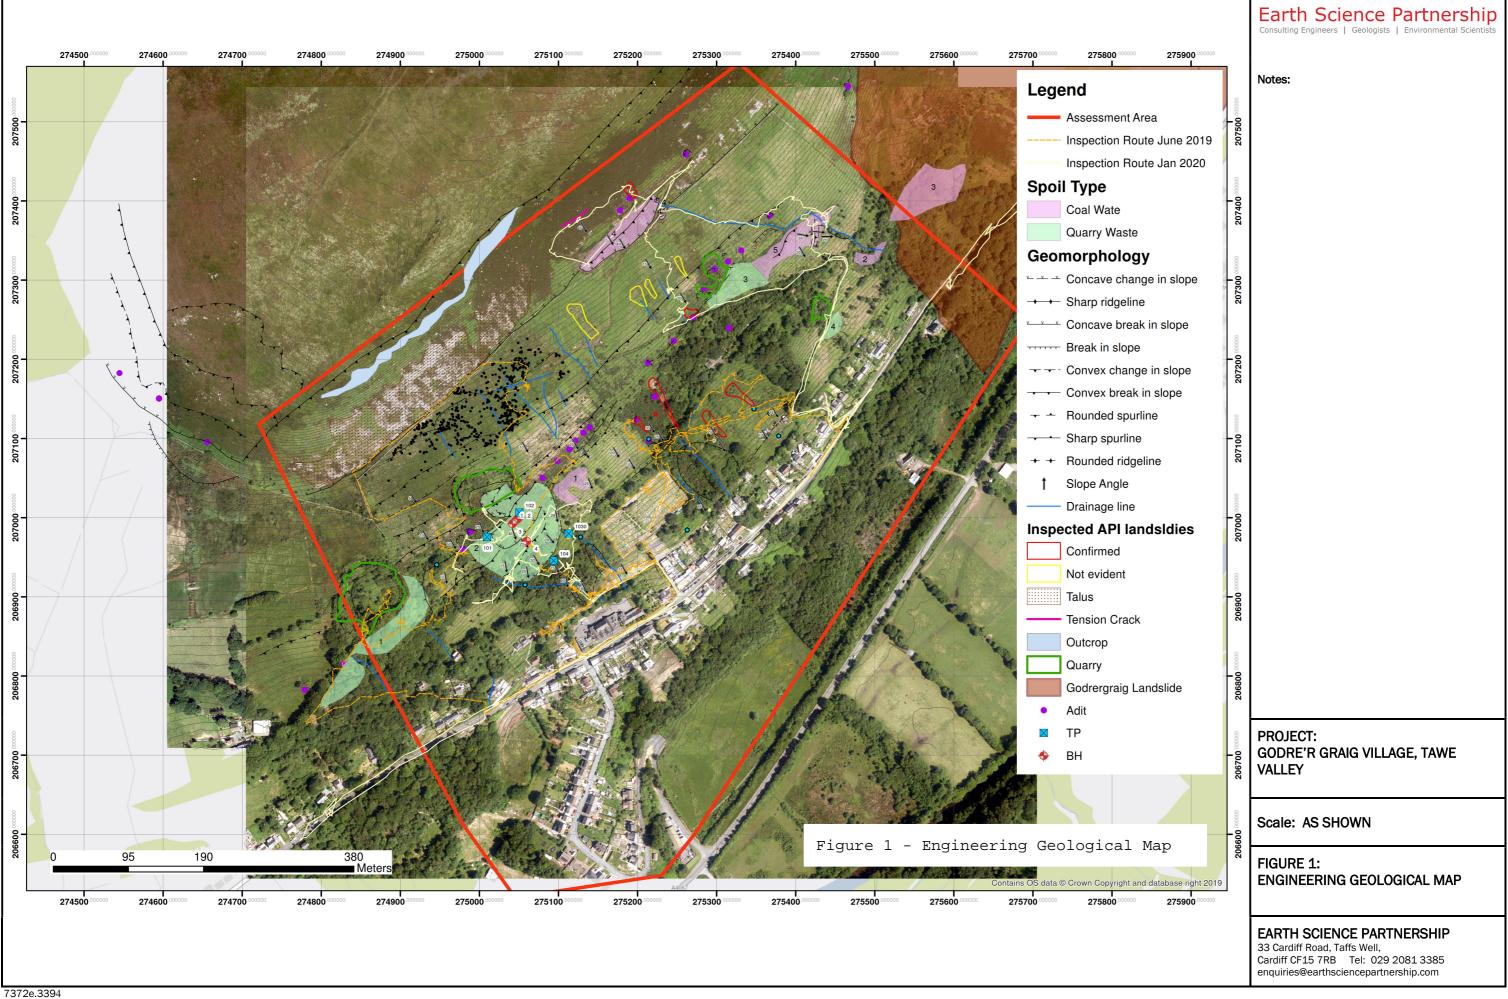
An Engineering Geomorphological Map of the area is provided as Figure 1.

A review of the historical maps shows a large amount of mining carried out in the surrounding area, with tips and spoils mounds from rock quarries and coal mines. The No. 2 Rhondda and Upper Pinchin seams are located above the village and were worked.

There are several springs and streams in the area, which flow downhill toward the east or southeast. Water has been noted issuing out of adits.

There is evidence of small landslides, instability associated with former adit locations. Shallow depressions associated with springs may be the 'shallow slips' noted on the geological map.

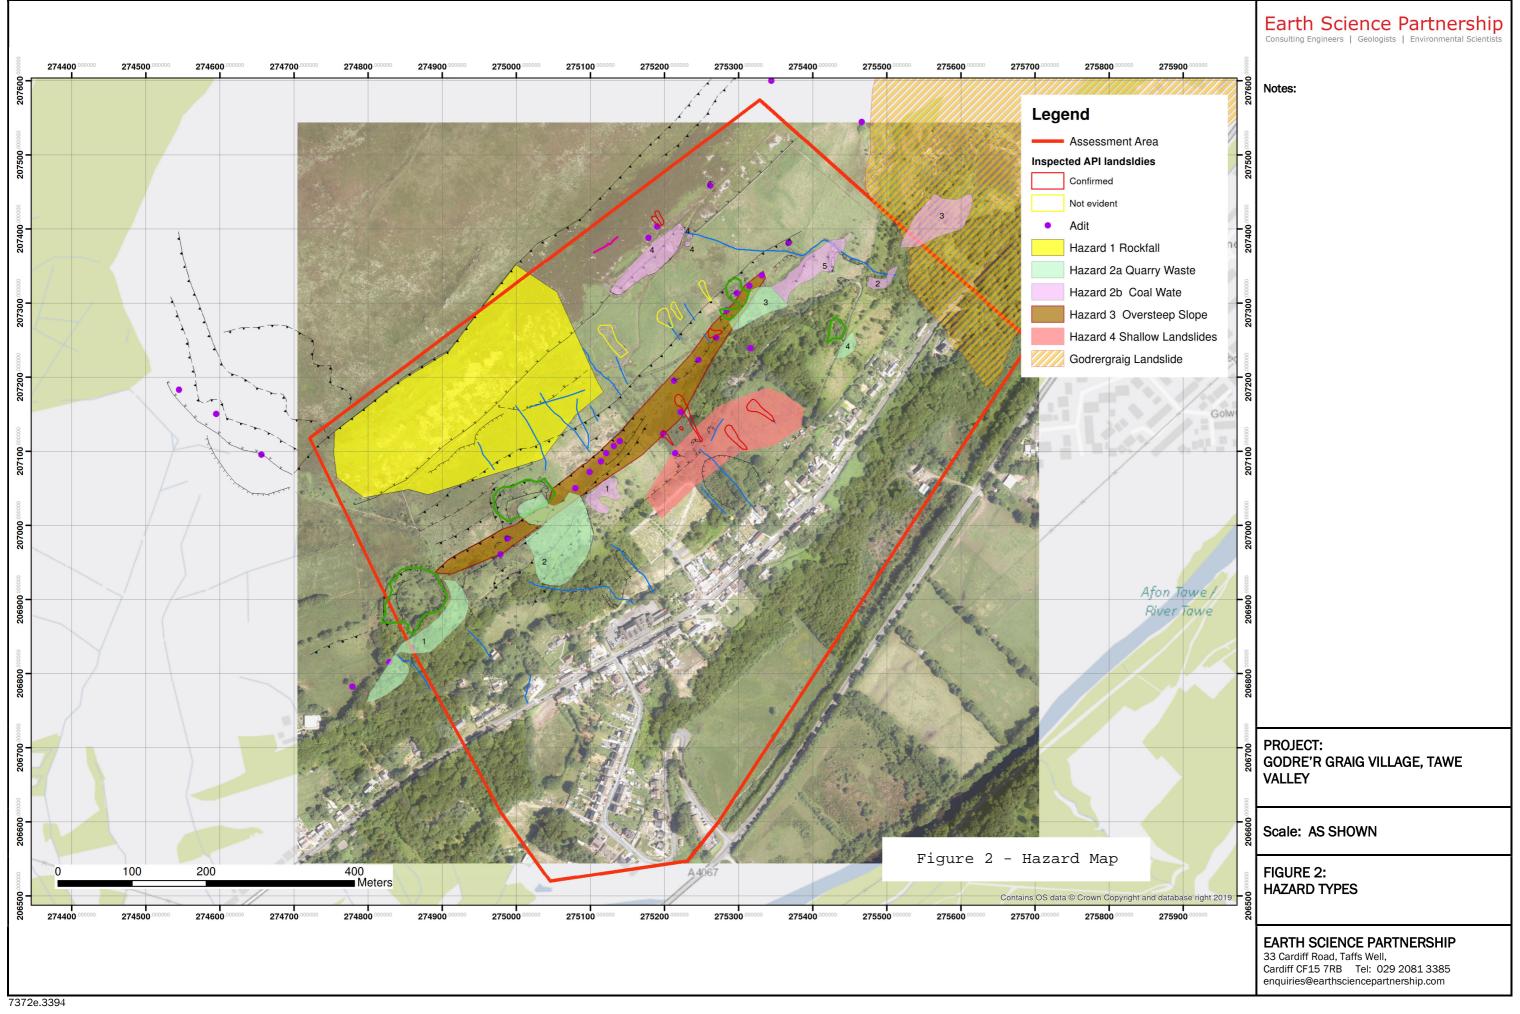
The assessment showed five hazard types, which are detailed below and shown on Figure 2. It should be noted that the hazard types occur in different areas, and they do not represent a hazard to each individual house in the village; for example Hazard Type 2a and 2b will not impact all of the village, only the school or houses near the school as they are proximal to those hazards.

- Hazard Type 1 Rock fall initiating from outcrops of the Rhondda Sandstone
- Hazard Type 2a impact from debris avalanche initiating from quarry spoil
- Hazard Type 2b Impact from debris avalanche initiating fom colliery spoil
- Hazard Type 3 Impacts from debris avalanches originating from over steep slopes associated with the workings of the Upper Pinchin Seam
- Hazard Type 4 Shallow earth slides

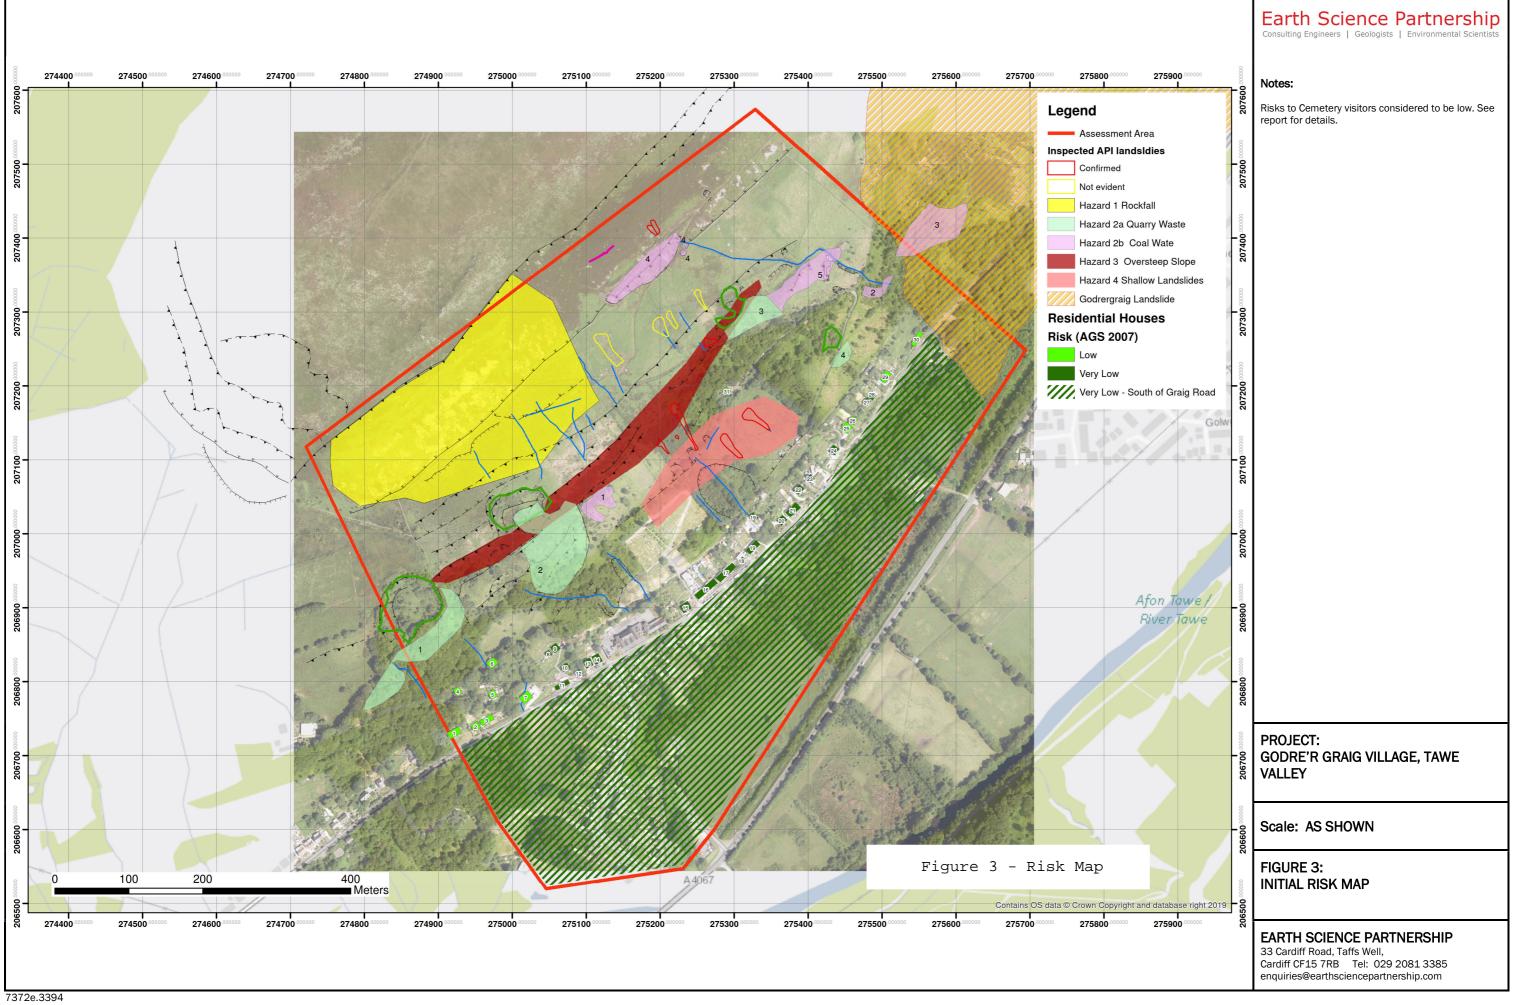
The risk assessment information is included in our main report, however, the findings of the assessment are presented in Table 1 below, and the Risk Map is presented as Figure 3.

Based on the above it has been assumed that the risk to residential properties to the south of Graig Road is very low.

The assessment has shown that there is a very low to low risk to residential properties in Godre'r Graig, which is normally "usually acceptable to regulators" (AGS, 2007). No specific remedial or mitigation recommendations are considered necessary. Risks to cemetery users is likely to be lower than the risks to residential properties surrounding the cemetery.
